## Preliminary Roost Assessment

43 Church Road, Reading, Berkshire, RG4 7AG

This report is prepared to inform a planning application with the Reading Borough Council. The proposal is described as:  
re-roofing the whole dwelling and re-tiling of the hanging tiles

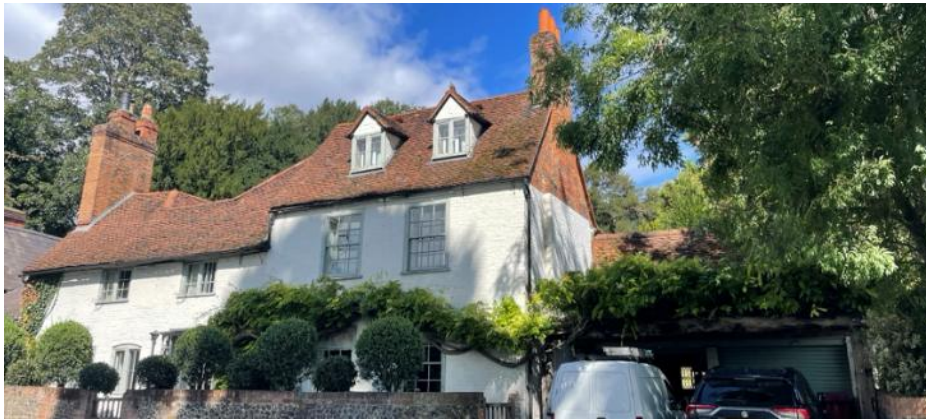
| Summary of Survey Findings | <b>B1 Exterior</b><br><br>B1 is a semi-detached two-storey brick-built building with a cross-pitched and gabled roof clad in clay roof tiles. The roof tiles are in relatively poor condition with many raised tiles under which bats could roost. Additionally, there is one missing tile on the south-western elevation of B1. There are flat roof sections located on the north-eastern elevation of the building. The flat roofs are bitumen felt lined and are in very good condition with no gaps in which bats could roost. The doors and windows are wooden framed and appear in excellent condition with no suitable bat roosting sites. The brickwork around the building appears in excellent condition with no gaps or cracks within which crevice-dwelling bats could roost. There are two chimneys located on the roof of the building. The brickwork on the chimneys is in good | | |

Photo 1: the south-eastern and south-western elevations of B1

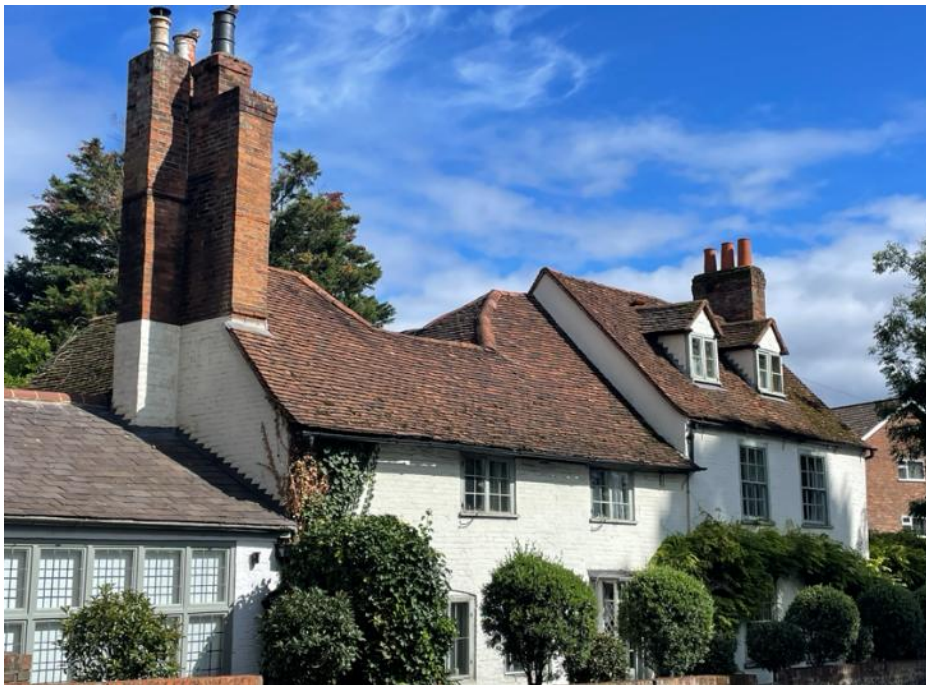
Photo 2: the south-western and north-western elevations of B1

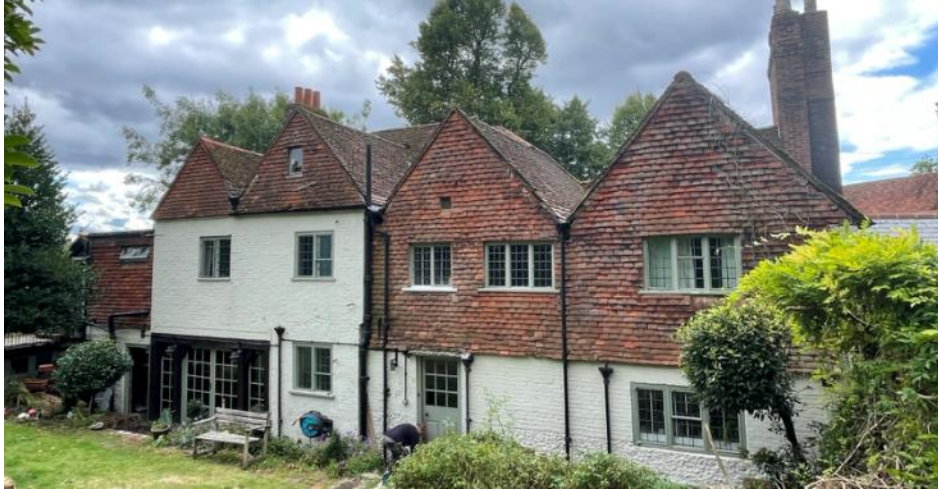
Photo 3: the north-eastern and north-western elevations of B1

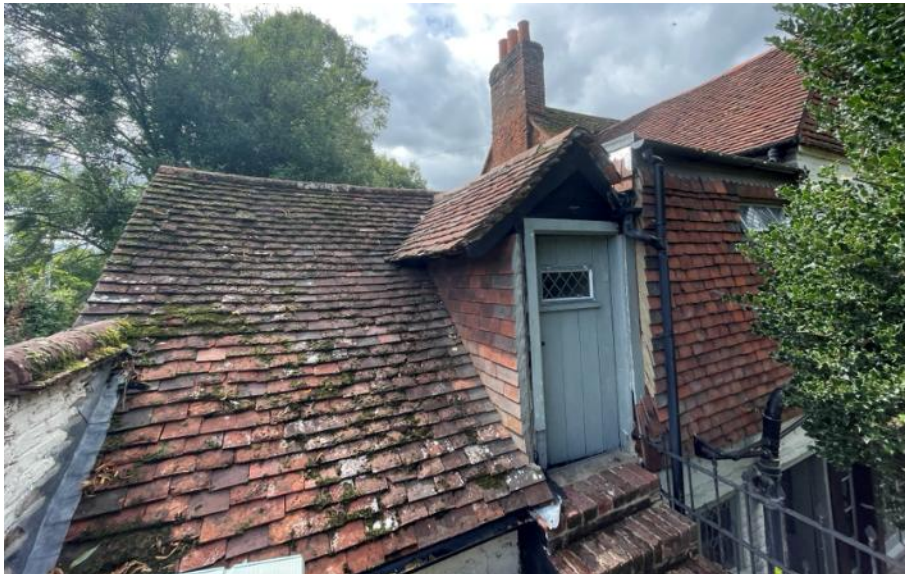
| <i>Foreseen Impacts</i> | <p><b>Roosting habitat</b></p> <p>B1 has moderate habitat value for roosting bats due to raised and missing roof tiles and raised hanging tiles. There was no evidence of bat activity located internally or externally on the survey building. This indicates a likely absence of void dwelling bats such as brown long eared bats but cannot be used to indicate a likely absence of crevice dwelling bats. This is because bats such as pipistrelles usually roost between tiles and felt and on wall tops, where any external</p> |

Photo 4: a close-up of the roof on the south-eastern elevation of B1

| <i>Recommendations</i> | <p><b>Roosting habitat</b></p> <p>Two bat emergence and re-entry surveys are required during the active bat season (May – September) to confirm presence or likely absence of a bat roost in the building. Both of the surveys should be completed during the optimal survey period mid-May to August inclusive. Surveys should be a minimum of three weeks apart.</p> <p>Four surveyors are required to provide coverage of B1.</p> <p>Surveys are likely to be required before planning permission can be granted.</p> <p>If bat roosts are confirmed in the building one additional survey will be required to inform an EPSL application to Natural England. The EPSL application requires that surveys have been undertaken within the most recent active bat season and planning permission must have been granted and all relevant wildlife-related conditions have been discharged prior to submission.</p> <p><b>Foraging and commuting habitat</b></p> <p>No further surveys are required.</p> <p><b>Artificial lighting</b></p> <p>A low impact lighting strategy will be adopted for the site during post-development which outlines the areas of the site that will be retained as dark corridors. Parameters can be found on the Bat Conservation Trust website: <a href="https://www.bats.org.uk/our-work/buildings-planning-and-development/lighting-2">https://www.bats.org.uk/our-work/buildings-planning-and-development/lighting-2</a></p> |

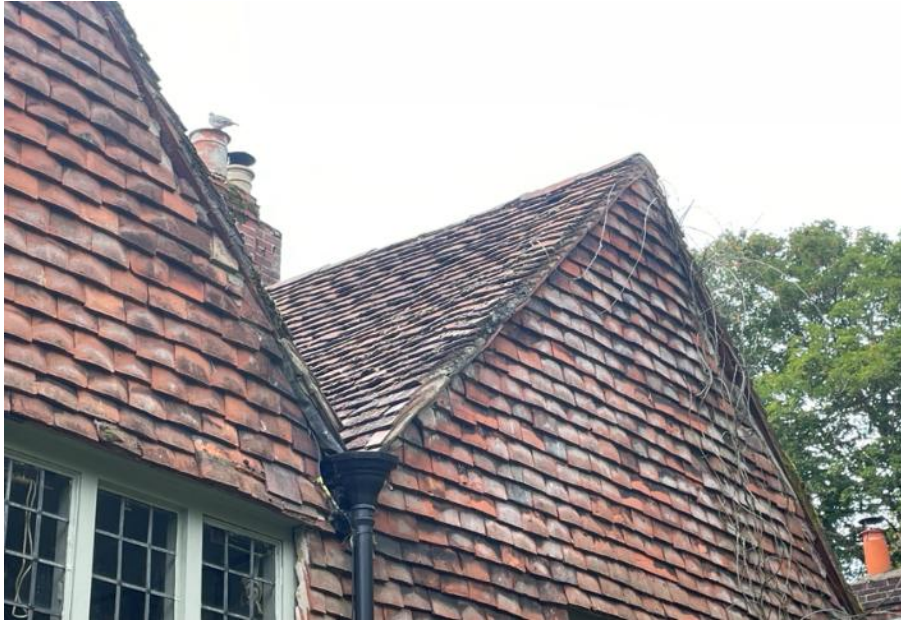
| | <p>condition. There is lead flashing around the bases of the chimney which is flat and without gaps. The four gable ends to the north-east of B1 and the flat roofed section are clad in hanging tiles. The hanging tiles are in poor condition with many raised under which crevice dwelling bats could roost. There are dormer window extensions on the south-western elevation of the building which are well sealed with no gaps that are suitable for roosting bats.</p> <p><b>B1 Interior</b></p> <p>There are two loft spaces within B1 which are separated by a vaulted ceiling. Loft space 1 is located to the north of B1 and loft space 2 is located to the south, in the southern-most pitch. The roof structure of both lofts are built from timber beams including the ridge beam. The roof is unlined in both lofts and the backs of the roof tiles can be seen internally. Within loft space 1, the backs of the hanging tiles are clad in bitumen, whereas, within loft space 2, the hanging tiles are unlined. The floor of the loft space is lined with mineral wool insulation. There are cobwebs around the ridge beam and roof to floor cobwebs which could indicate a lack of internal flying activity from void dwelling bats, such as brown long-eared bats. Daylight enters both the loft spaces as the roof tiles are unlined. There was no evidence, including droppings, fur or urine stains or bats themselves, observed within either loft space.</p> <p><b>Foraging and commuting habitat</b></p> <p>The site itself has scattered trees and hedgerows within the garden which could be utilised by foraging and commuting bats. The area is extremely built up, however, many of the gardens appear to have treelines and hedgerows which has created a network of suitable foraging and commuting routes. Additionally, the river Thames is located 115m south of the site, which could be used by foraging and commuting bats.</p> |

Photo 5: a close-up of the roof tiles on the south-eastern elevation and hanging tiles on the north-eastern elevation of B1

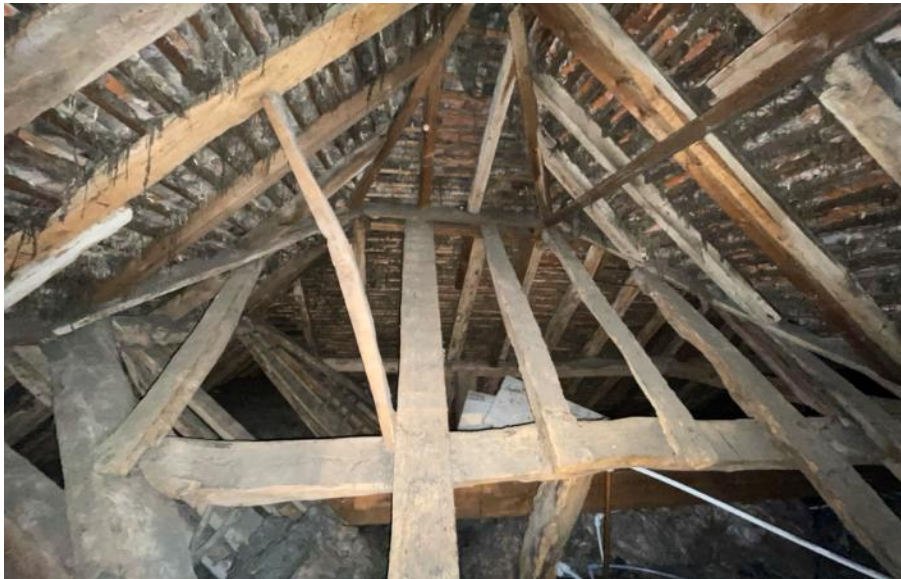
Photo 6: loft space 1, located to the north of B1

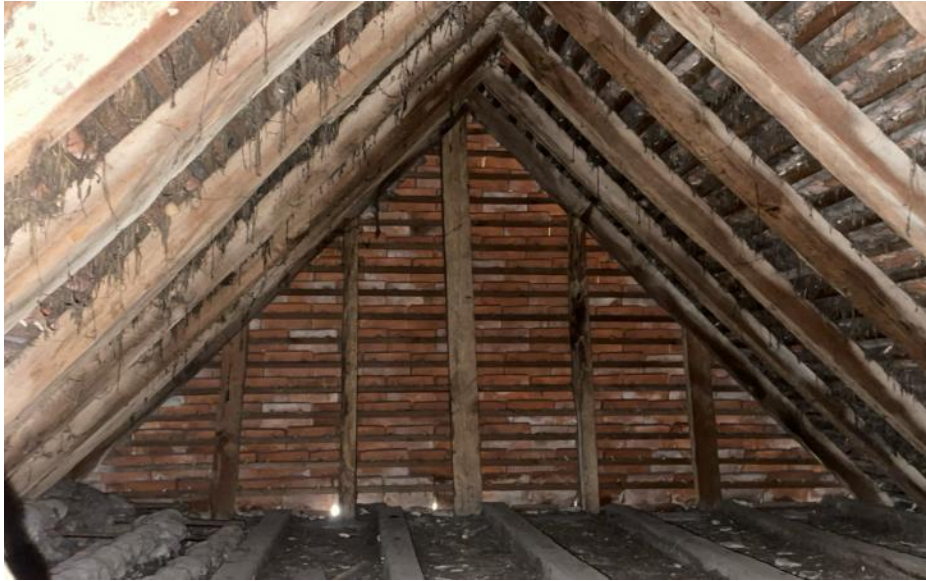
Photo 7: loft space 2, located to the south of B1. It also shows the backs of the southern most hanging tiles on the rear of B1

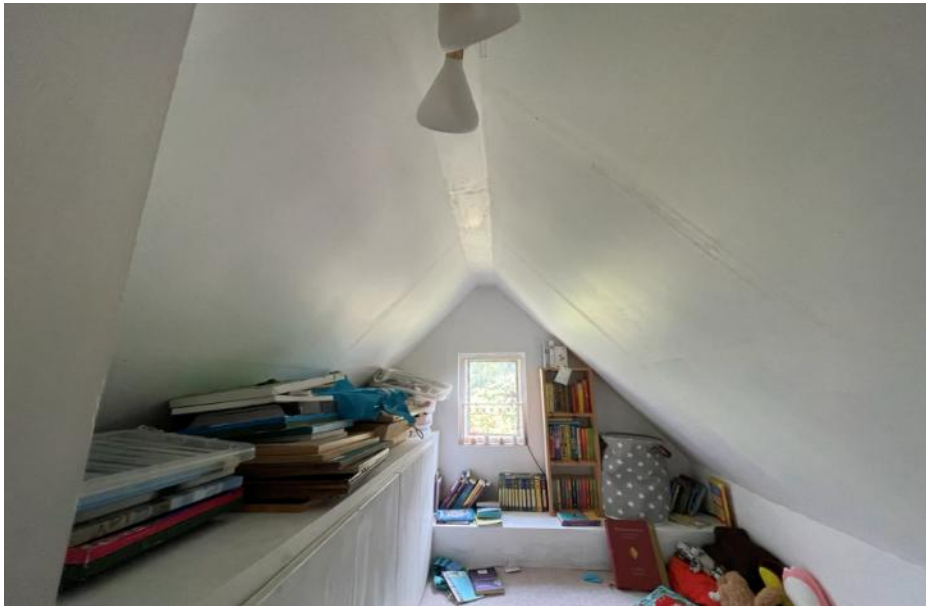
Photo 8: vaulted ceiling within the middle pitch to the rear of B1
