# Groundsure Screening (0 - 15 ha)

Property:  
97 York Road, Reading, RG1 8DU

## Contaminated land

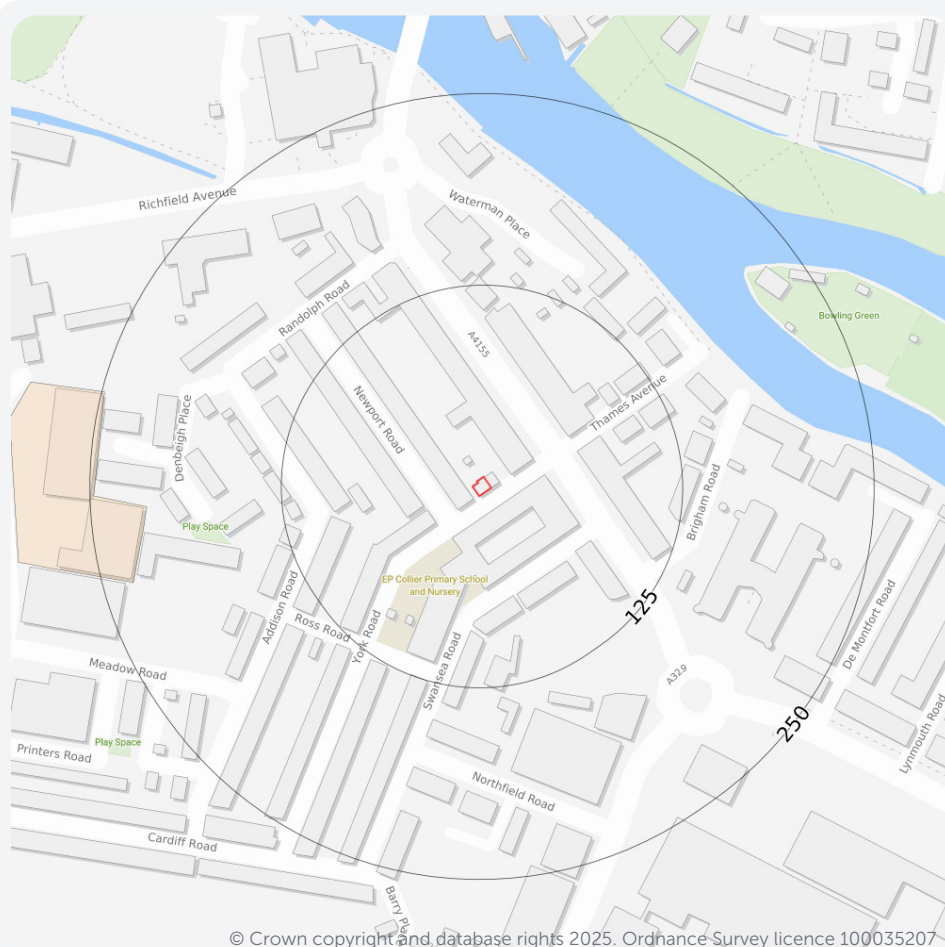
— Site Outline  
 Search buffers in metres (m)  
■ Waste site no longer in use

### Waste site no longer in use

These are records of former waste storage, treatment or transfer sites that have been identified from high detailed historical maps or Local Authority planning records. Depending on the nature of the waste that was handled and stored at these facilities, there may be a risk of ground contamination.

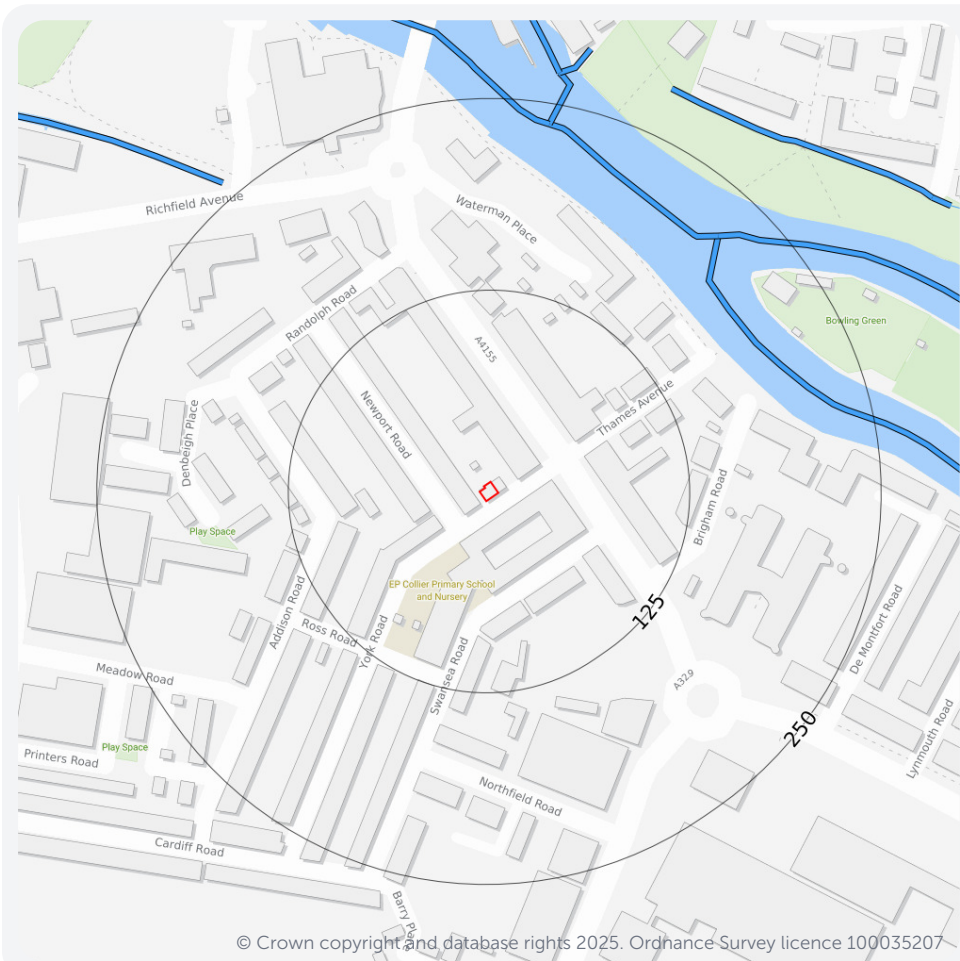
- Site Outline
- Search buffers in metres (m)
- Surface Water Abstractions (point)
- Surface Water Abstractions (area)
- Surface Water Abstractions (line)
- Tidal River
- Inland River
- Foreshore
- Canal
- Lock or Flight of Locks
- Lake, Reservoir or Marsh
- Drain or Transfer
- Type of watercourse:
  - At ground level
  - Elevated
  - Underground
  - Unspecified

Water courses from Ordnance Survey

These are water features such as ponds, lakes, rivers and streams that have been identified by Ordnance Survey. These features may be sensitive to contamination.
