## Preliminary Roost Assessment

The Roebuck, Oxford Road, Tilehurst, Reading RG31 6TG

This report is prepared to inform the conversion of a former hotel to create 8 apartments.

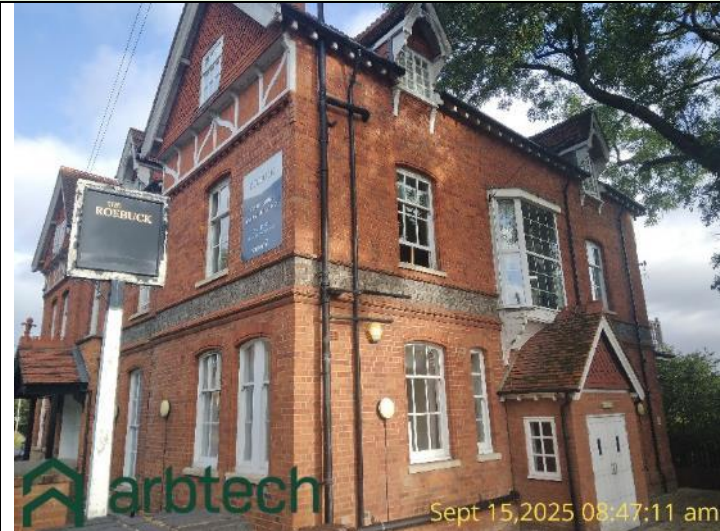
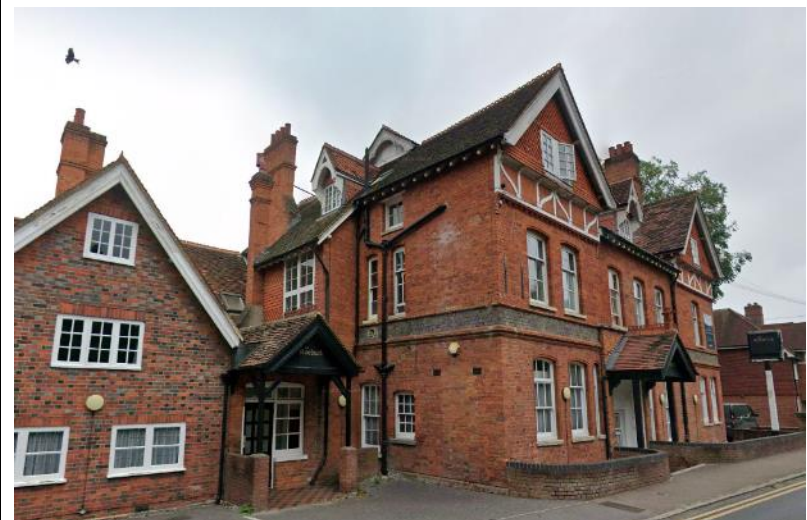
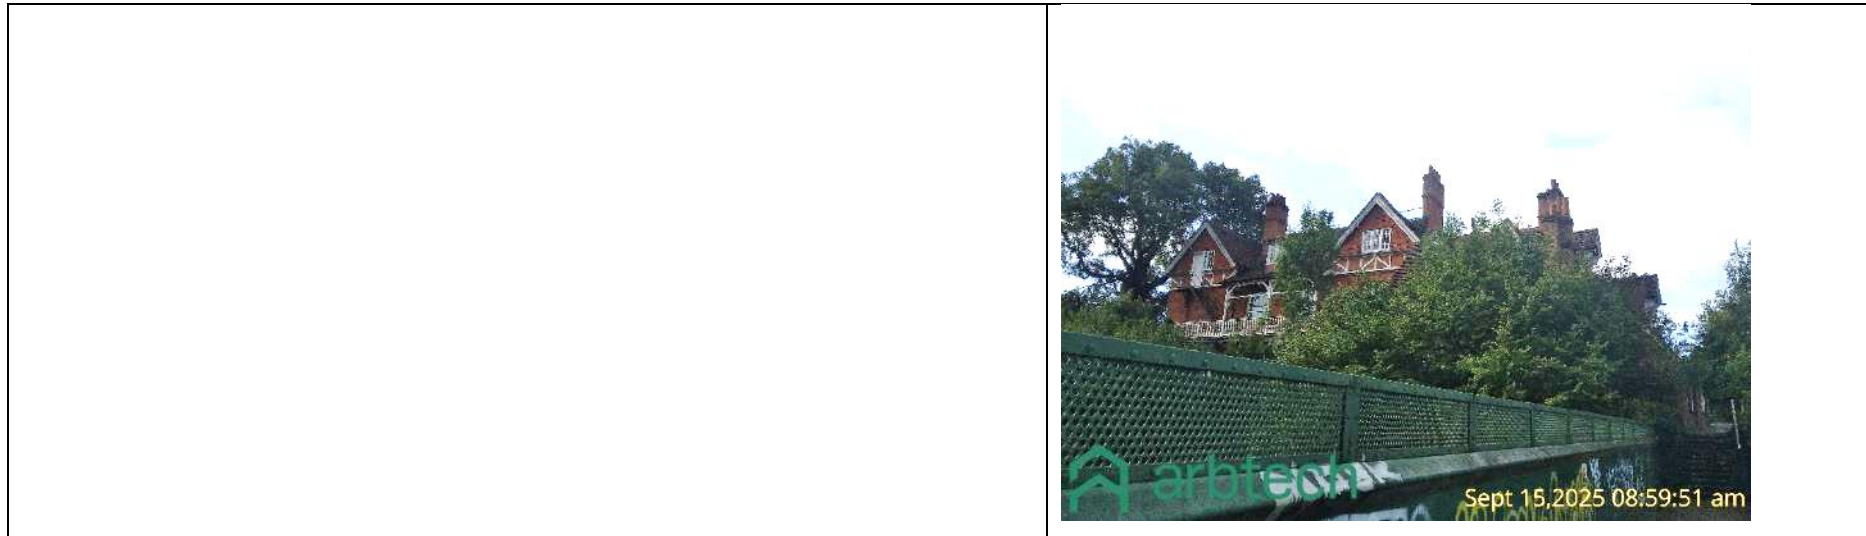
B1 is a large grade 2 listed building, which historically served as a hotel.

It is a three-storey building, constructed from red brick walls and a red clay-tiled roof. The roof structure is complex, featuring one-, two-, and three-story roof heights, as well as a combination of gable-ended, flat, cat-slide, and hipped roofs.

There are 7 red brick chimneys present.

Several gable-ended, upper-walls are decorated with red-clay hanging tiles, which are also present on the sides of all dormer windows.

There are gable-ended dormer windows present on every roof elevation.

Three gable-ended porches are present.

The northern elevation has several balconies as well as a single, flat-roof dormer window.

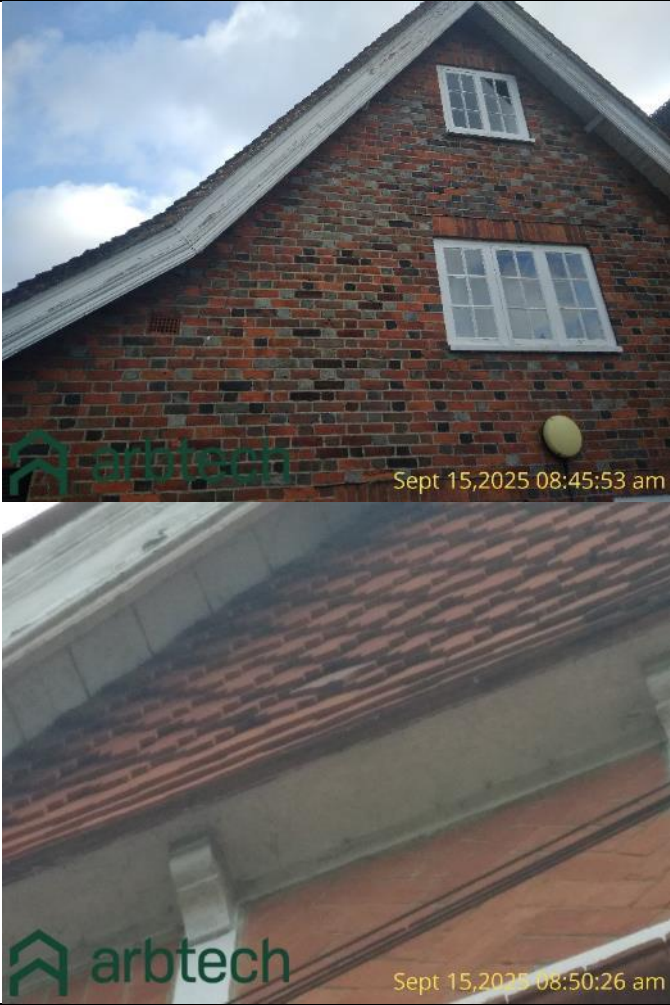
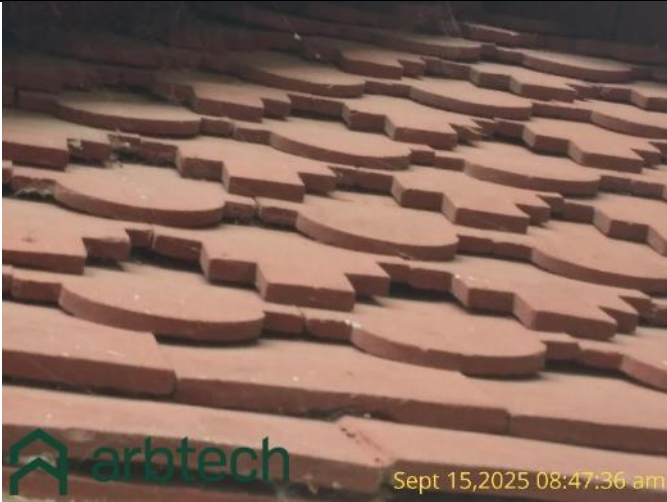
| Feature | Materials | Condition/description | Suitability/access/evidence of bats |
|---|---|---|---|
| Walls | Red brick walls, red clay hanging tiles | No features observed with the red-brick walls however, the hanging clay tile walls on the eastern porch, the upper gable walls and on the sides of the dormer windows have lifted tiles present.<br>Some dormer side elevations could not be observed due to limitations of the building shape, but features could be assumed to be present due to conditions on all walls that could be observed. | Raised hanging tiles provide ideal roosting habitat for crevice dwelling bats and could support maternity roosts. No evidence found but recent and current rain would wash this away externally. |

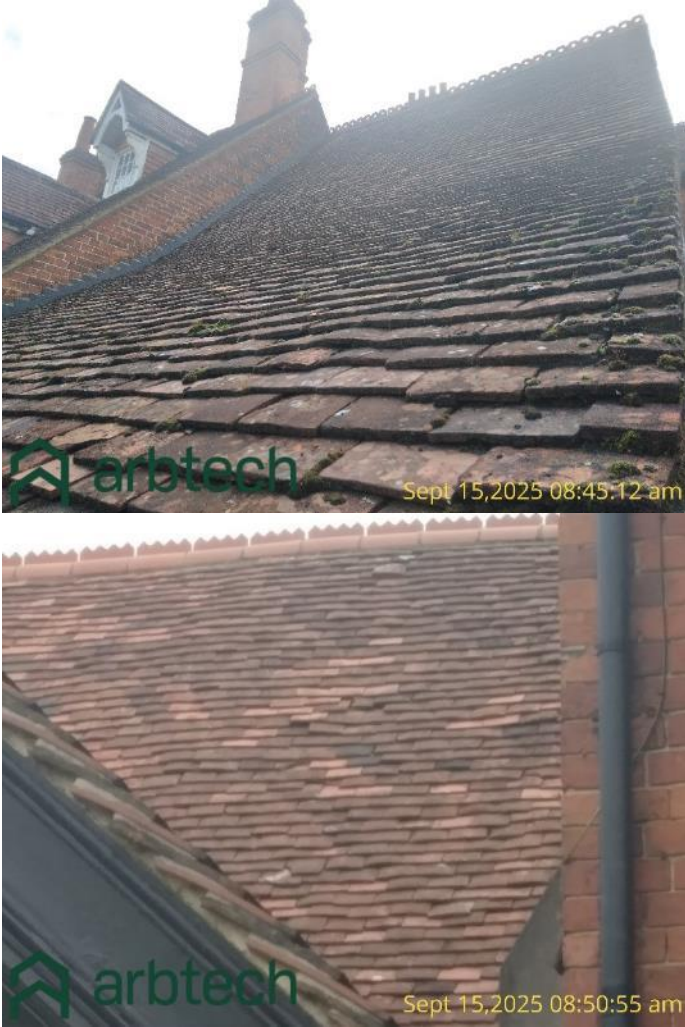
| Roof | Red Clay | Lifted tiles providing gaps of 8mm-2cm are present on every elevation of B1 and every section of the roof. Over 200 features are counted on the combined roof areas. No features were observed around the ridge tiles or around the chimneys, which are cemented in place. However, features that may be present in chimneys at blind spot locations and must not be discounted. | Space under tiles could accommodate crevice dwelling bats. due to the size of the roof and the sheer volume of available habitat, this is suitable to support maternity roosts of crevice dwelling bats. No evidence found but recent and current rain would wash this away externally |

| Section 4- Conclusions | |
|---|---|
| <i>Foreseen Impacts</i> | There are no plans to alter any exterior of the roof of B1, as such, there will be no direct impacts to any roosts that may be present under the roof tiles. However, there may be some disturbance through noise and vibrations, especially with work on the upper floors or in the rooms with vaulted ceilings as well as laying new insulation in the loft. |

| | <p>3 bat emergence/re-entry surveys are required on B1 during the active bat season (May – September) to confirm presence/likely-absence of bats roosting in or on the building. No works to the property that may block or remove potential roosting features should be carried out until the required surveys have been completed. Undertaking such work beforehand could unlawfully affect bats if present and may compromise the validity of the surveys and hinder the planning application process.</p> <p>These survey visits should be completed during the optimal survey period mid-May to August inclusive. The survey visits should be at least three weeks apart.</p> <p>Sub-optimal: early May and September. Would require greater justification of timing e.g., weather conditions, known local bat activity.</p> <p>One of the surveys could be a dawn re-entry survey, or all three can be at dusk if supported by night vision aids (NVA).</p> <p>Five surveyors are required to provide full coverage of the building's elevations to look for emerging/re-entering bats. An infrared camera should also be employed as part of the survey to see where any specific roost locations are located.</p> <p>If any bat roosts are confirmed from this survey schedule, a bat licence would be required to do works to the roof space of the buildings as it would involve the destruction or modification of roosts. This is applied for with the help of a suitably licenced bat ecologist after planning permission is granted but before commencement of works.</p> |

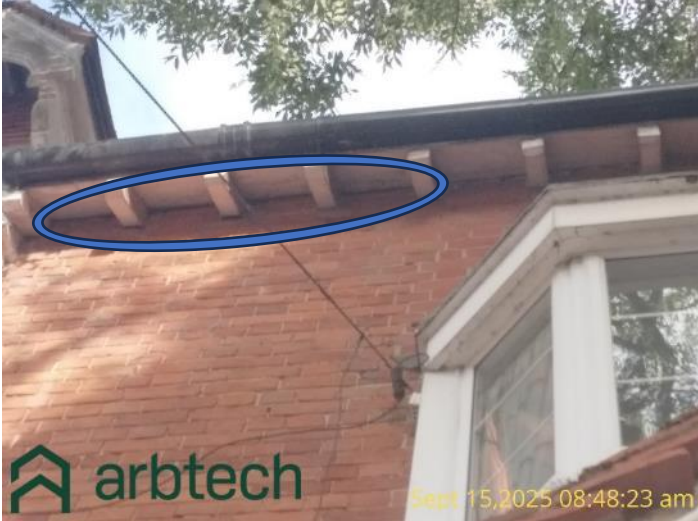
| Eaves | Overhanging , but no soffit | Gaps/crevices on wall tops. | Provides possible bat access into internal void and crevices on wall tops. |

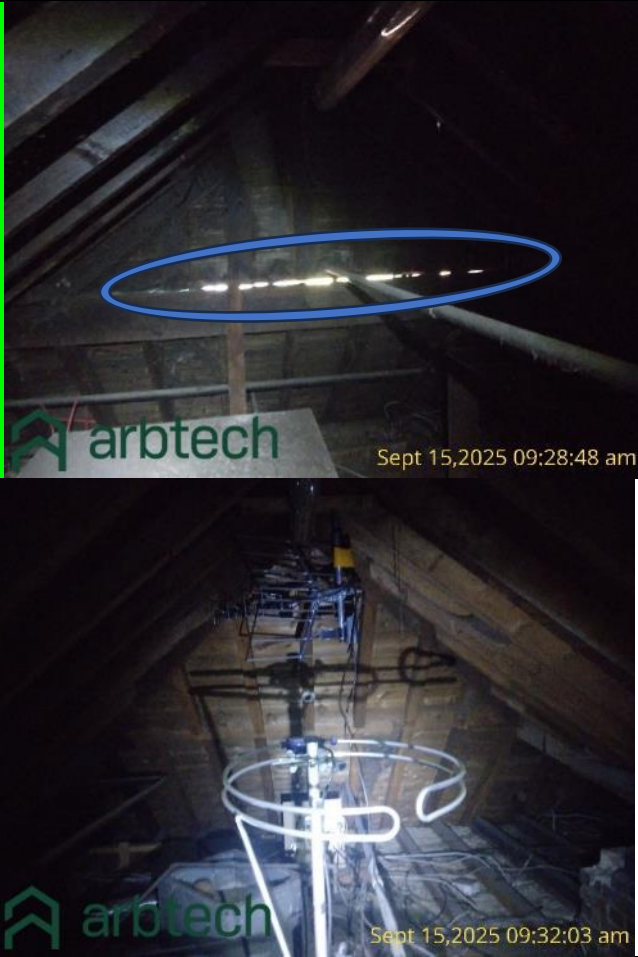
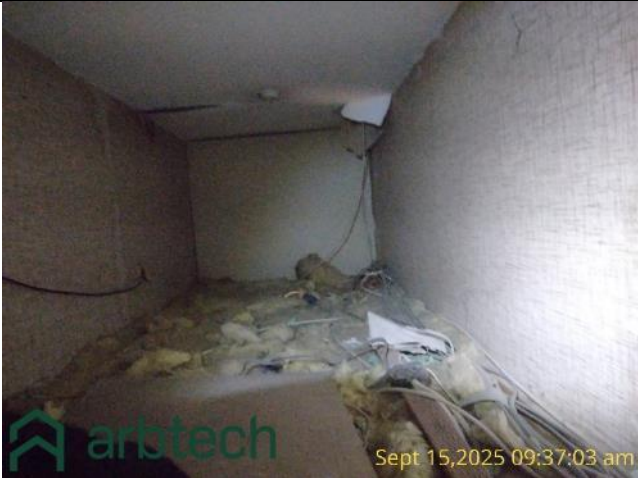
| Internal voids | <p>Timber rafters and ridge beam. Open floor to ridge. Water tanks present.</p> <p>No floor insulation.</p> <p>False ceiling secondary loft space below.</p> | <p>Internal space measures approximately. 13m long, 4.5m wide and 1.5m high.</p> <p>No crawl boards were present in the upper loft, and no floor insulation was in the loft. Straw remains were still present, suggesting the historical building had a straw floor as a means of insulation. No items are stored within the loft, but old water tanks are present in the central area, but not in use.</p> <p>Loft lining is wooden sarking boards, which appeared in good condition.</p> <p>It was noted that at the western end of the loft, there was a series of gaps present at the base of the ridge dormer. These gaps are large enough to allow bats direct access into the loft space.</p> | <p>No evidence of roosting bats was present; all droppings found within the loft were that of mice.</p> <p>Ridge line areas were lined in thick cobwebs as were the identified access point. Indicating no recent flying or passing of bats through the gaps into the loft.</p> <p>This indicates no void-dwelling bats have been using the loft space but does not rule out the possibility of crevice-dwelling bats between the roof tiles and sarking boards.</p> |

| | | <p>A secondary ceiling has been installed below the original, creating a secondary loft space less than 1m high. The void space below contains loose roll insulation. The loft hatches are lined up with each other, and this lower loft space has to be passed through to reach the upper loft.</p> <p>The loft space was only present in the upper ridge area of the three-storey roof. As shown on the map in Appendix 1. No other loft or crawl spaces could be identified within the building. Several of the rooms and corridors had a vaulted ceiling, which eliminated separate lofts being present.</p> | |

| Section 4- Conclusions | |
|---|---|
| <i>Recommendations</i> | <p>To mitigate the potential for disturbance, the following measures are recommended for the work to the room conversions.</p> <p>There were no droppings within the loft to indicate that void-dwelling bat species are present. The lack of void-dwelling species in any loft space will allow any new loft insulation to take place at any time. These works will not disturb any roosting bats. No removal of sarking boards or blocking up of the identified access point will take place if insulation occurs.</p> <p>However, of particular note is the need to avoid excessive noise or vibration disturbance e.g. from power tools or radios, within close proximity of the roost access features (locations shown in Appendix 1).</p> <p>Noise and vibration within the building must be kept to a minimum. Speaker systems must <i>not</i> be used in or around</p> |

| | <p>the building loft areas, and the use of heavy power tools on the site must be kept to a minimum. Where possible, non-powered hand tools only will be used within the loft. Sprayers in the loft must be avoided</p> <p>All person's present must ensure that noise levels are kept to a minimum in accordance with best practice as defined in the Control of Pollution Act 1974 to avoid unacceptable levels of noise and vibrations. Further guidance can be found in British Standard 5228-1:2009. Such measures applicable to the proposed development primarily include agreed working hours limiting night work, using the quietest equipment and plant available, shutting down equipment when not in use, and completing deliveries during working hours only. Most notably, prescriptions as to limit the noise of plant machinery as detailed within Table B.1 within the code of practice for noise control (British Standards Institution, 2014)</p> <p>Work to the upper floor conversion works and loft insulation installation are recommended to take place in the inactive season, October-March, as far as possible, when bats are less likely to be at the site and are not disturbed by vibrations and noise. Work to the lower floors is less impactful due to distance and therefore recommended to focus on the lower floors during the active season April-Oct</p> <p><u>If at any point bats, or evidence of bat roosting- such as bat droppings- is discovered during any work. Then all work must stop at once, and a qualified ecologist will be contacted.</u></p> <p><u><b>If work is to be on the roof or if future work is required, such as repairs, the following must take place.</b></u></p> |
