# THE KING'S MEADOW, READING

## HERITAGE NOTE

02 SEPTEMBER 2025

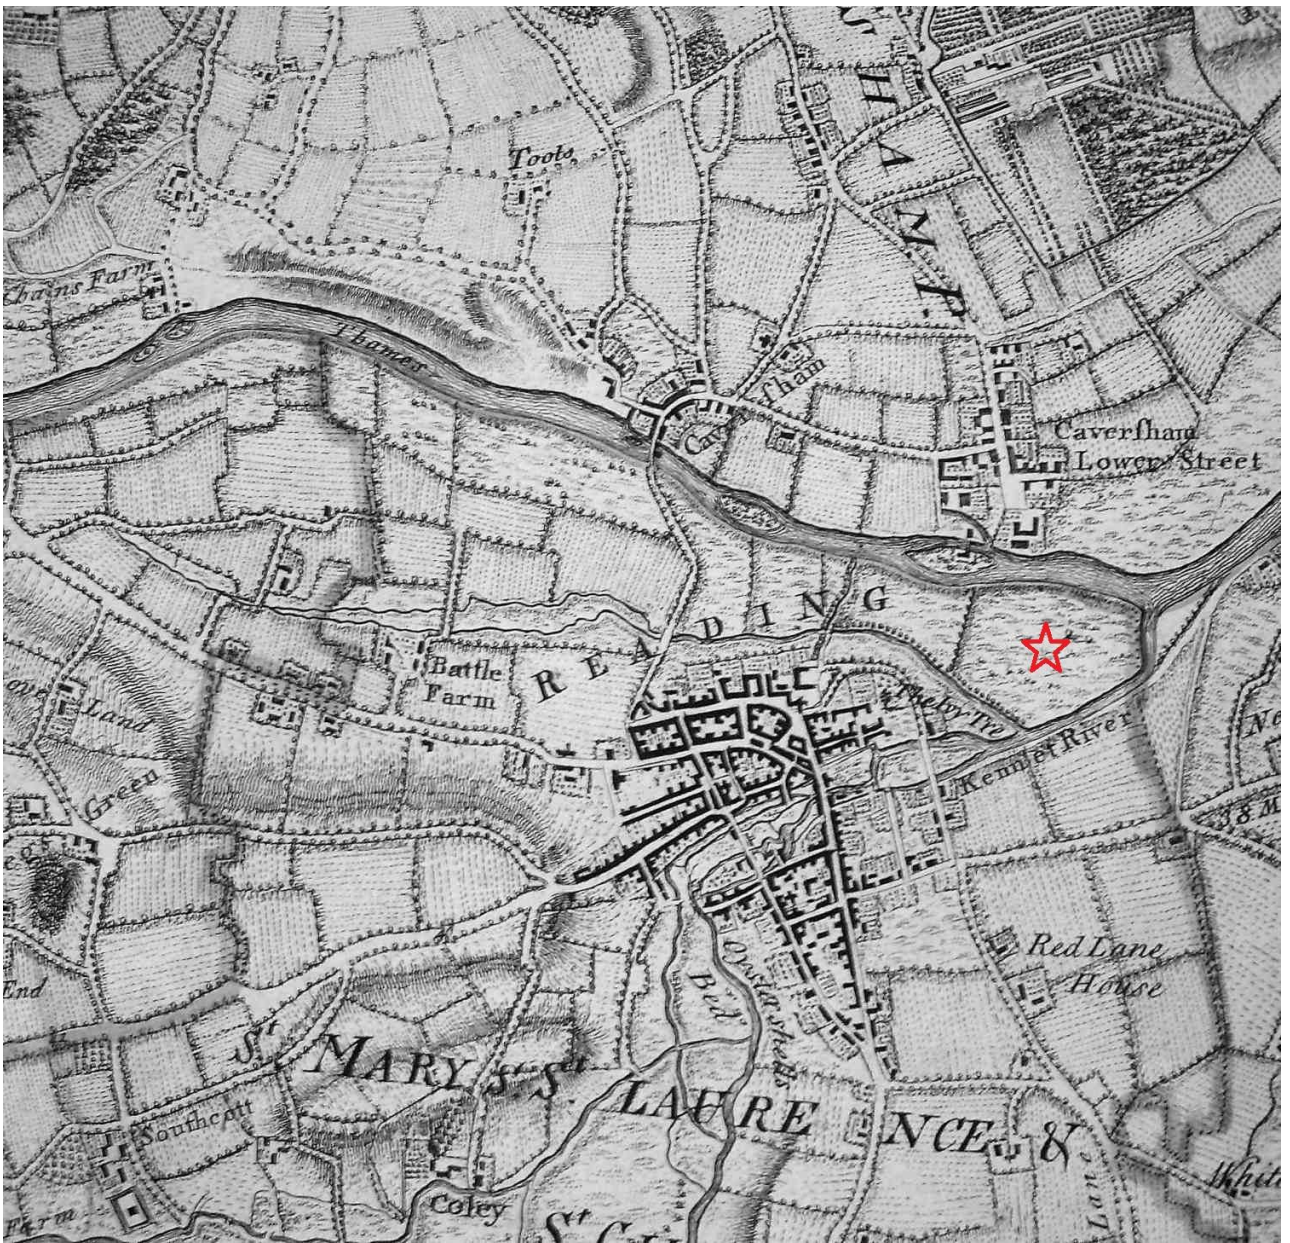
**Figure 2.3** Reading as shown in 1761 on John Rocque's county map of Berkshire. The King's Meadow is marked with a star. Source: [A place strongly fortified: Reading in the English Civil War | Reading Museum](#).

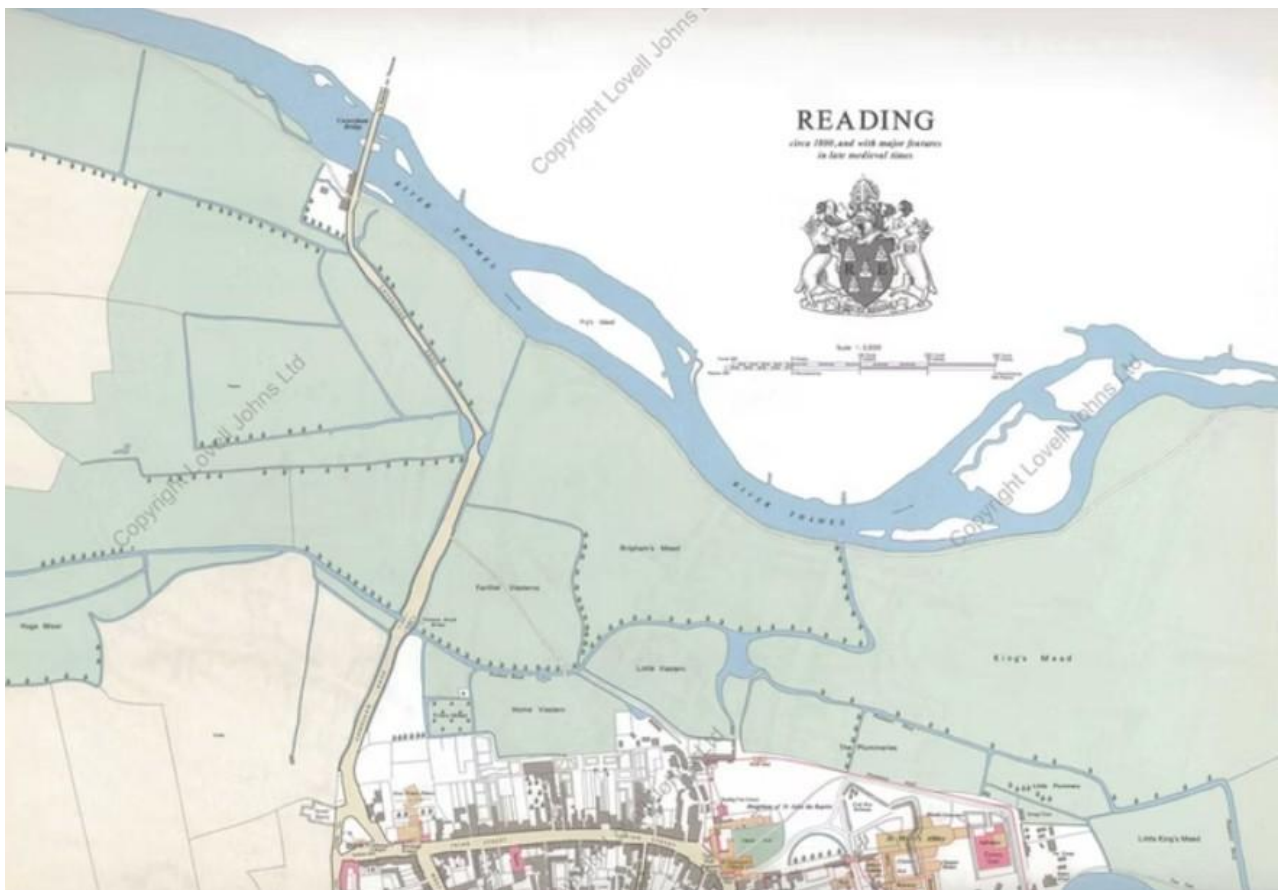
**Figure 2.4** Modern interpretative mapping of the landscape c.1800 showing extensive meadowland ('Kings Mead' to the right) with water channels (including the Civil War Plummery Ditch) towards the town. Source: <https://www.historictowntrust.uk/towns/reading>

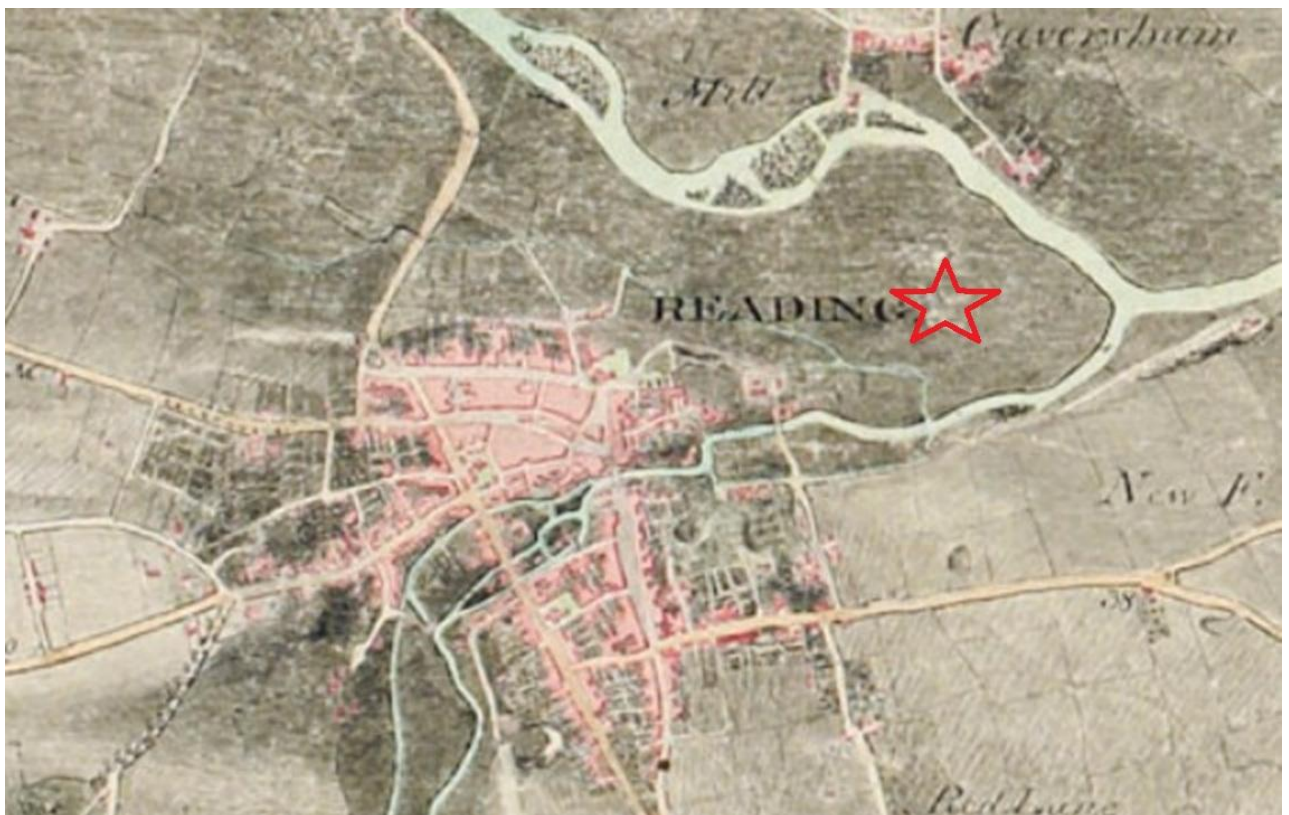
**Figure 2.5** Reading in 1809, with the expansive area of meadow and pasture north of the town between the Thames and Kennet. Source: British Library OSD 126.

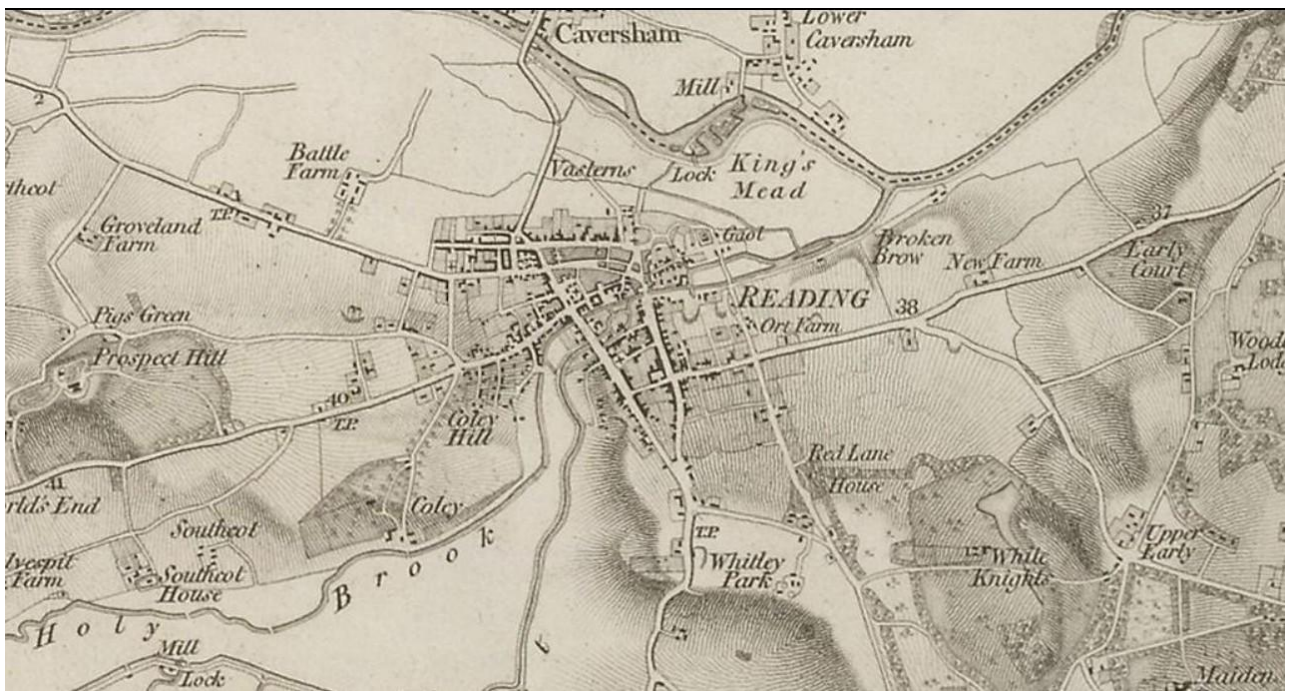
**Figure 2.6** OS 1 inch mapping of 1833, showing King's Mead. The Plummary Ditch is still marked.

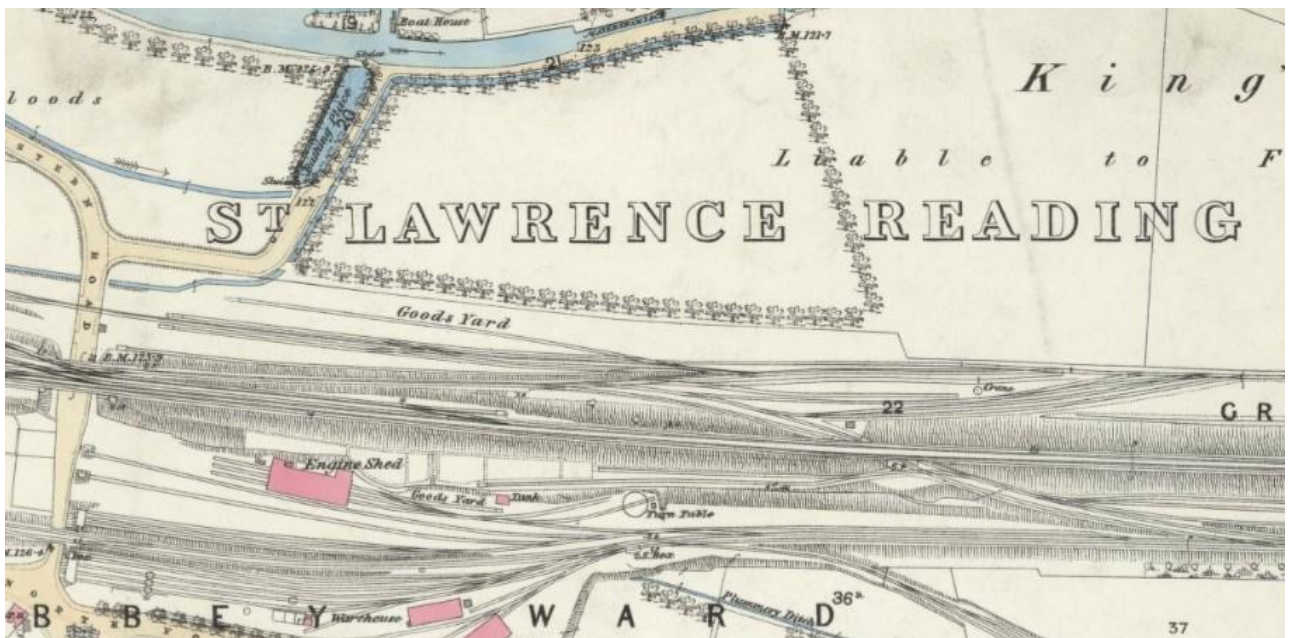
**Figure 2.8** Reading's first 25-inch mapping of the mid-1870s with the much-expanded railway zone.

The remaining part of King's Meadow was purchased by the town in 1869. It was subdivided, and the westernmost section lined with trees. Immediately to the west a bathing pool was created, fed from the Thames. It stands alongside the road leading to Caversham Lock, which had been opened 1778. Source: Berks sheet XXXVII.3 (surveyed 1875-7, published 1879). All historic OS mapping courtesy of National Library of Scotland.

Immediately off the centre of the map to the south is Huntley & Palmer's massive biscuit factory, opened in 1846. It closed in 1976 and was subsequently demolished.

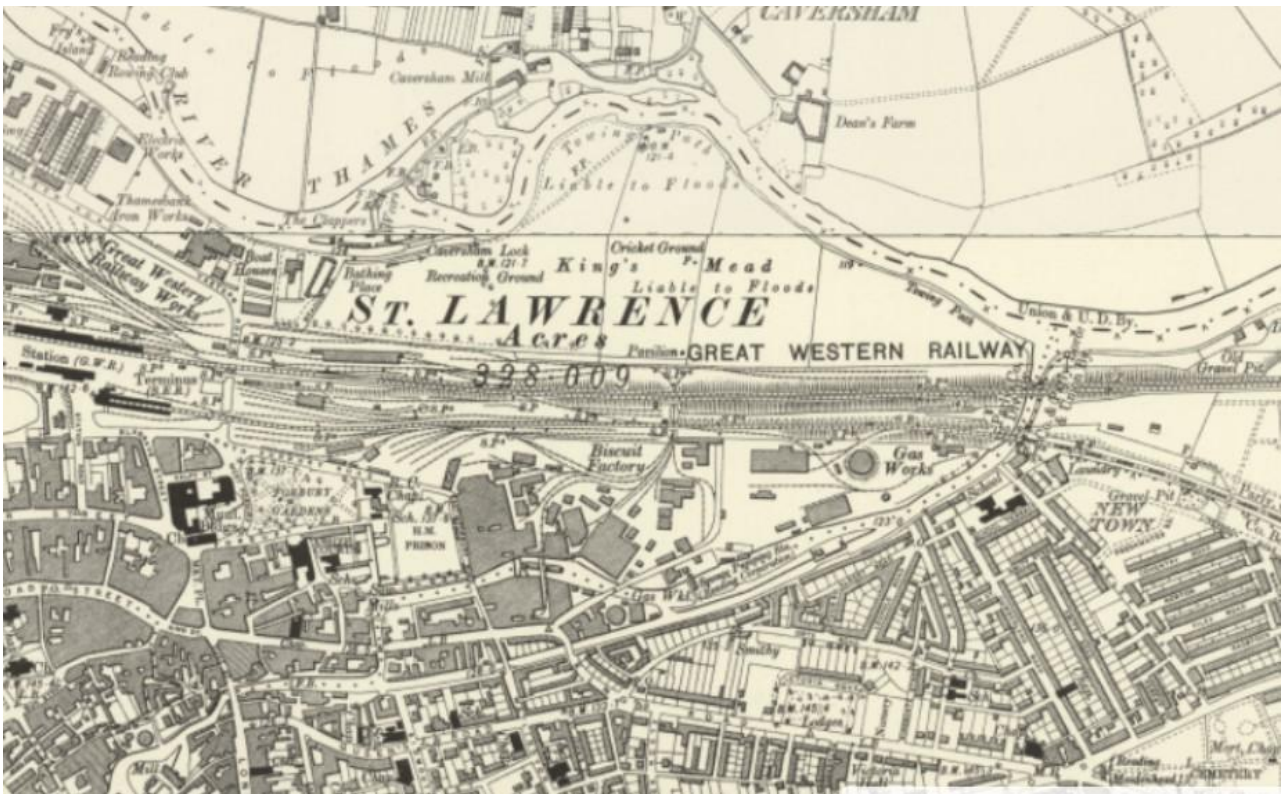
**Figure 2.10** OS composite 6 inch mapping of c.1900 showing how the railway was a hard divide between the town and the riverside meadows.

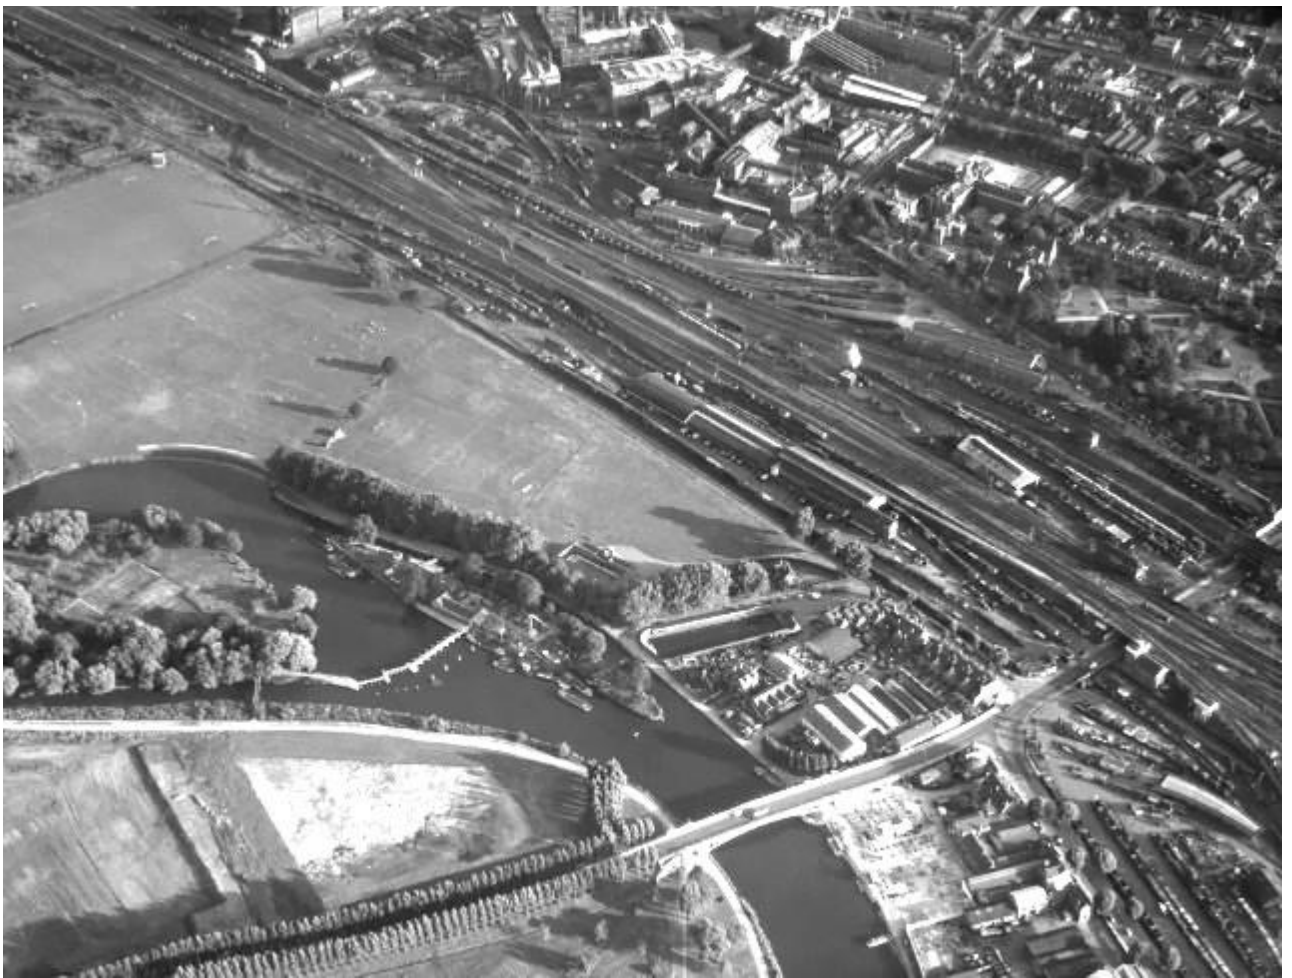
**Figure 2.14** View south-east across the largely featureless King's meadow in 1955. The rectangular 'Men's bathing place' pool is prominent below centre. Source: HE EAW061619.

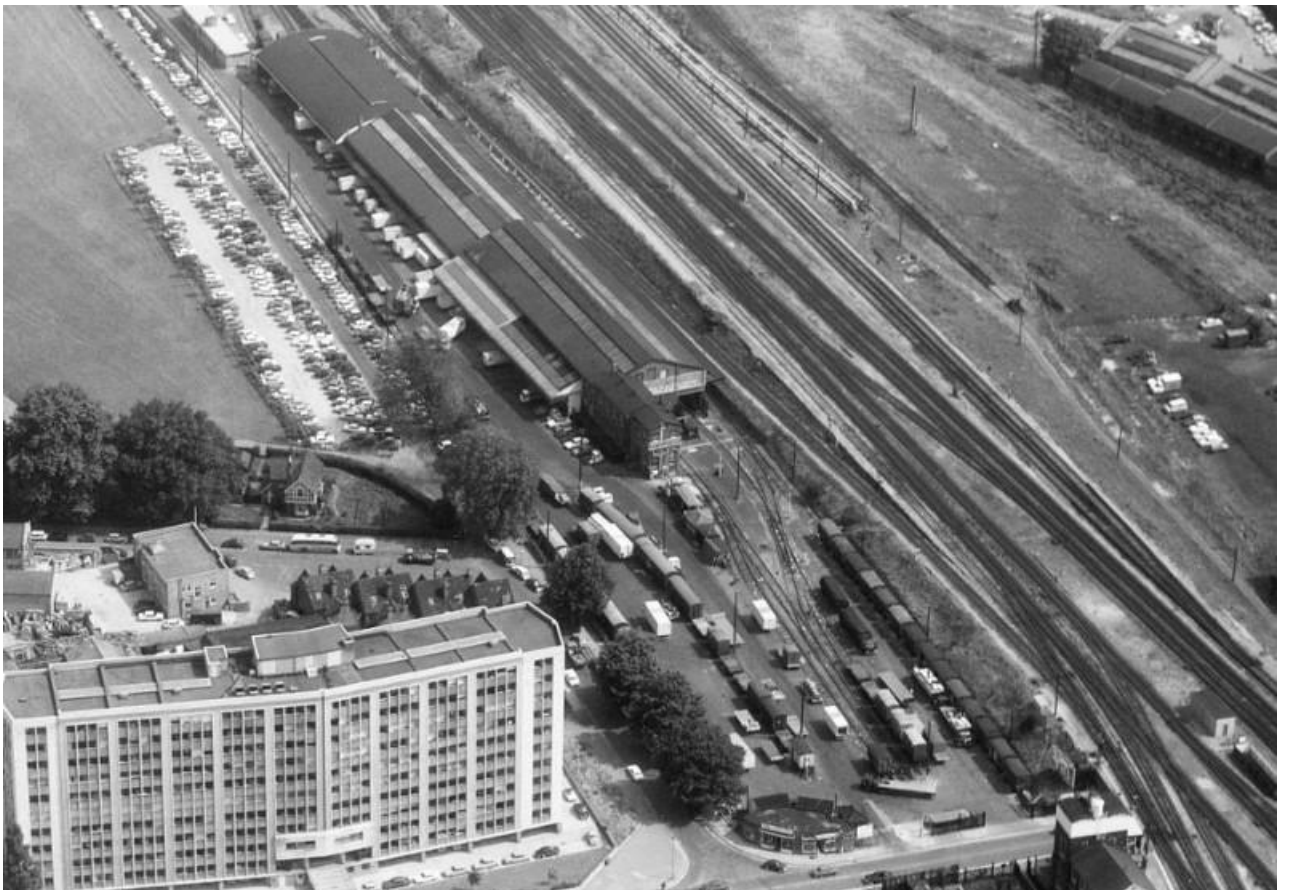
**Figure 2.15** 1962 air photo with car park along southern edge of The King's Meadow in front of the goods shed. Reading Bridge House in foreground. Source: Aerofilms EAW098027.

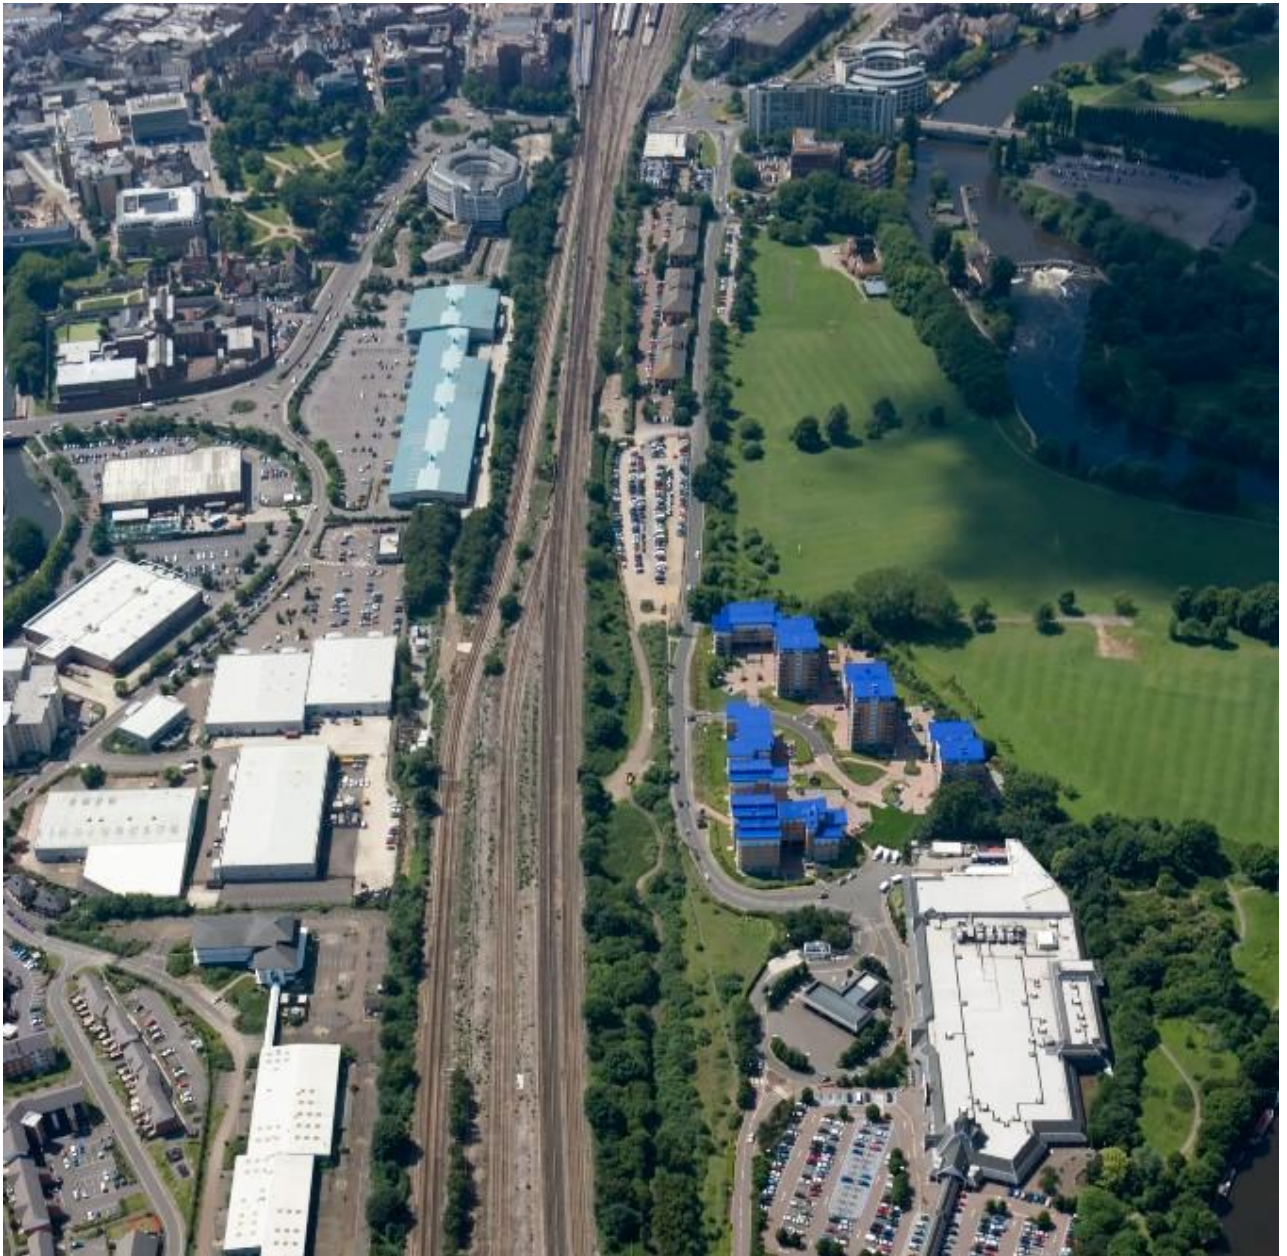
**Figure 2.17** 2007 view looking west with new blue-roofed development at the east end of The King's Meadow which has replaced the earlier warehouse shown on Figure 15. Source: HE 24624\_014 (2007). The present line of trees post-date the 1962 aerial photograph and probably also the 1979 OS survey plan. They may have been planted in association with the construction of the car park, and to provide screening and amenity to users of the open space.
