## **Preliminary Risk Assessment**

Kings Meadow View, Reading

17 November 2025

**Client Name:** Waterman Structures on behalf of Abrdn Property Income Trust  
**Document Reference:** 21990100-WAT-XX-XX-RP-N-770001\_C02\_A0  
**Project Number:** WIE21990

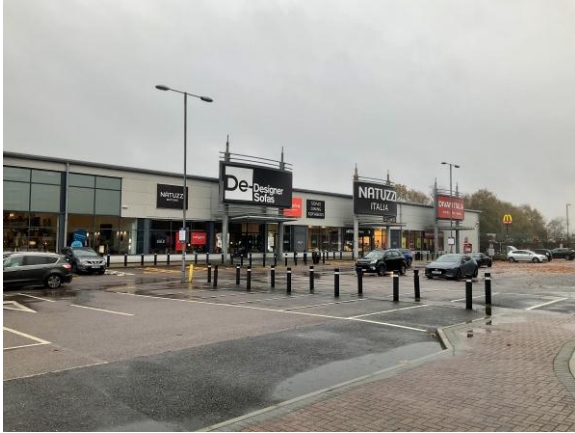
B1: General view of property looking towards north-east.

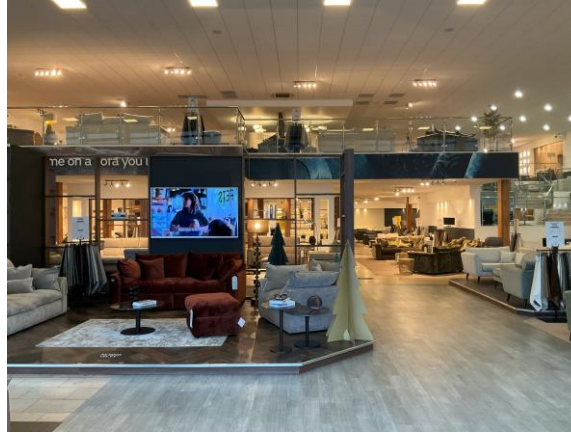
The eight retail units are generally occupied by soft furnishings and home fitting suppliers, with the majority of floorspace in use as a showroom at each unit. Each unit is double-height, with a floating second storey level to increase floorspace.

B2: Typical interior to main building retail unit

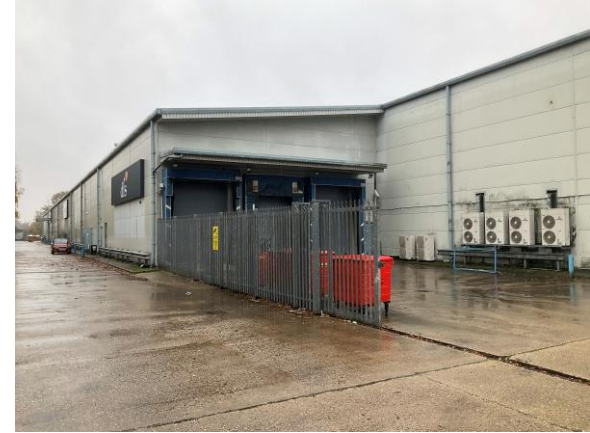
To the north of these units, a hardstanding yard is present in use as a loading/unloading area with loading docks, and for waste/recycling storage. Two electrical substations are present here, with one in the north-east corner and a second in the north against the site boundary. A vehicle access ramp leading to the adjacent railway lines is also present in the north-east corner.

B3: Service yard and bin storage to rear of main unit

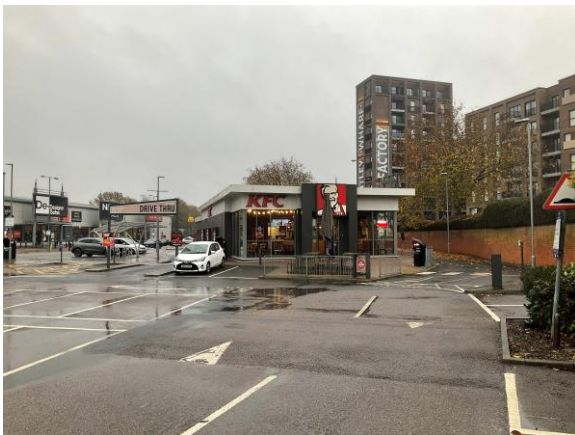
The drive-thru building in the south of the site is a single-storey structure operated by KFC. It comprises a restaurant with seating area, food prep area and customer toilets. A drive-thru circuit surrounds the building, with barriers to direct vehicles. The eastern corner of the building is in use for storage, with bins for waste and recycling.

B4: KFC drive-thru

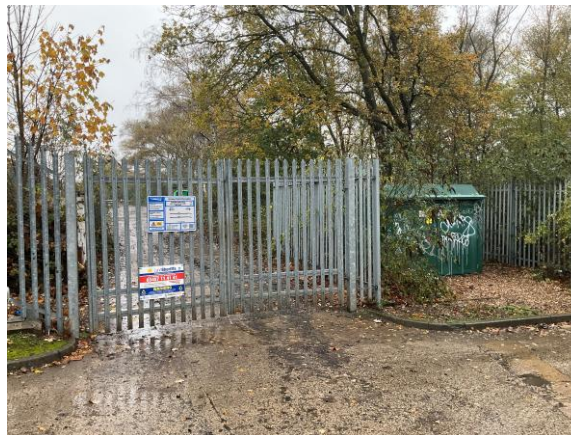
Current potentially contaminative Site uses identified during the property inspection were limited to two electrical substations in the north and north-east.

B5: Electrical substation and rail access in the north-east corner of the site.

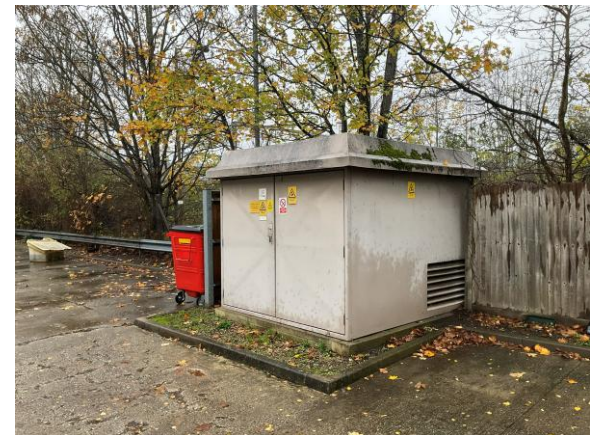
B6: Second electrical substation in north of the Site
