# Assessment of Decommissioned Tank, Circle Reading Hospital, Reading RG2 0NE

## Prepared for Circle Health Group

**10/2628 Rev. 00**

# Assessment of Decommissioned Tank

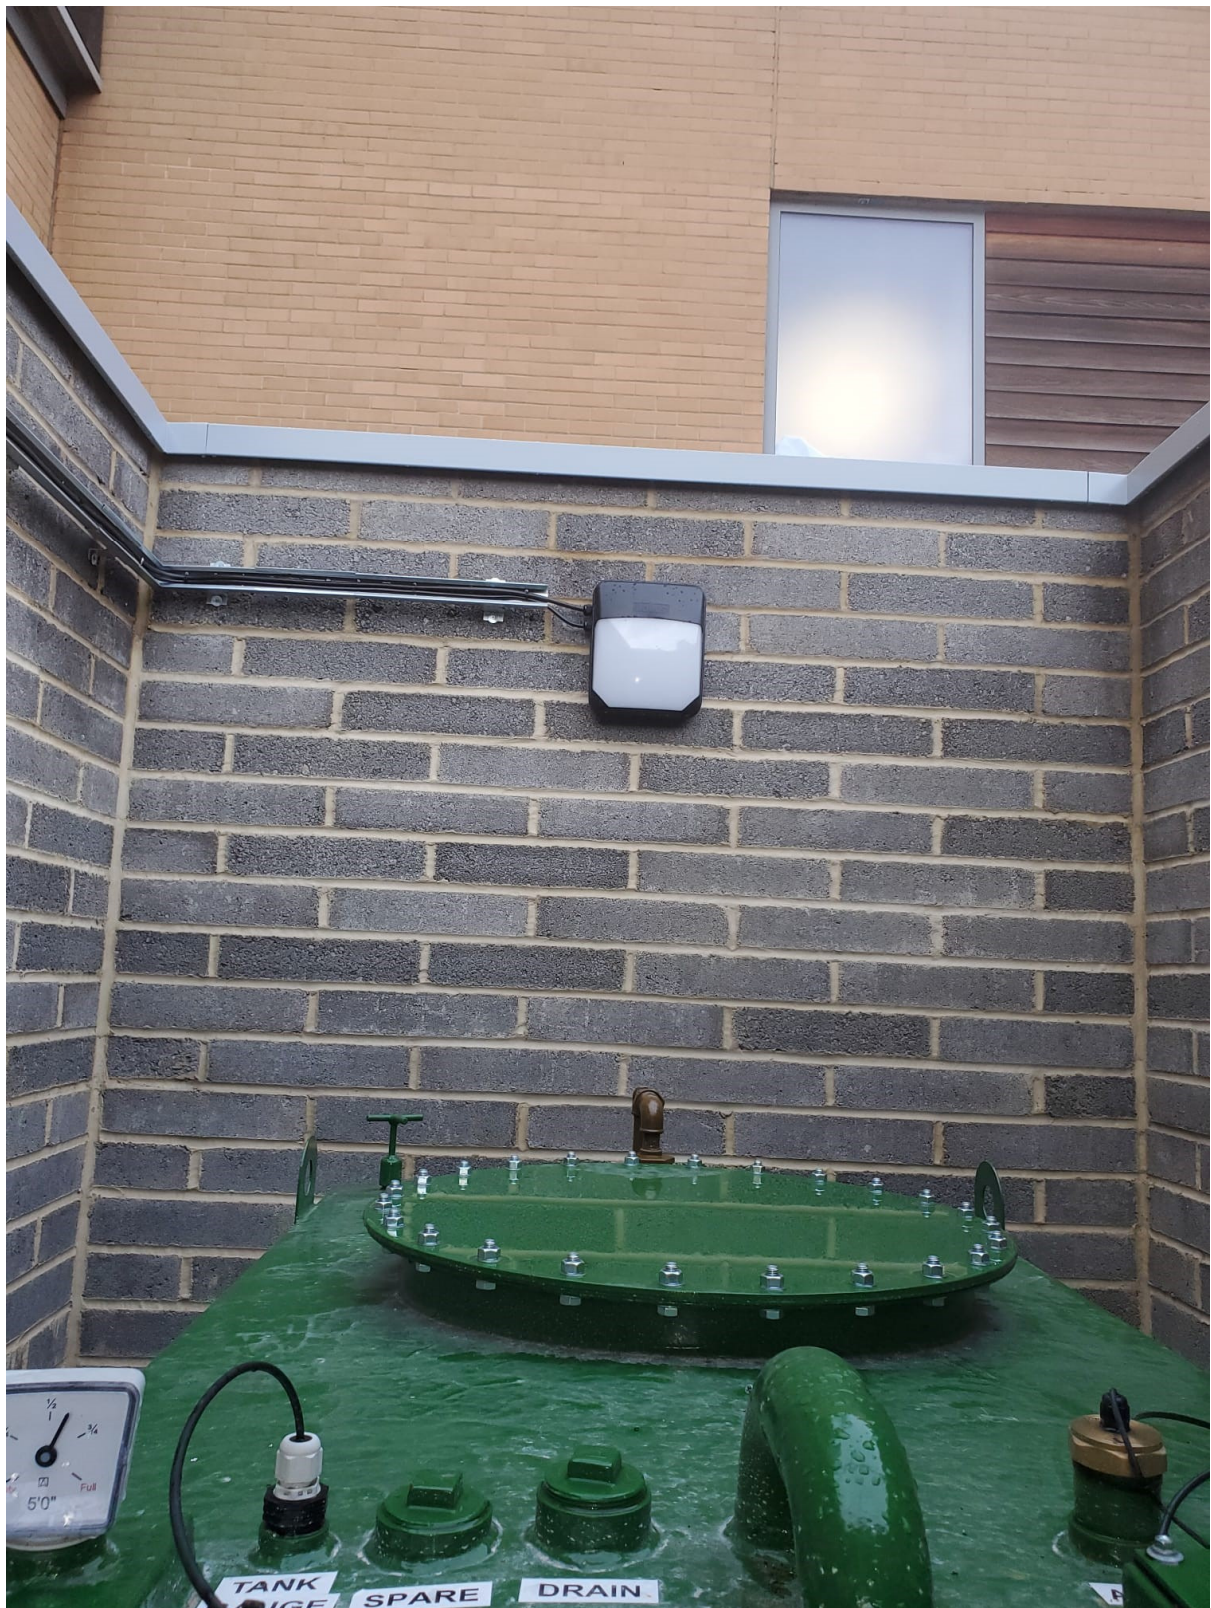
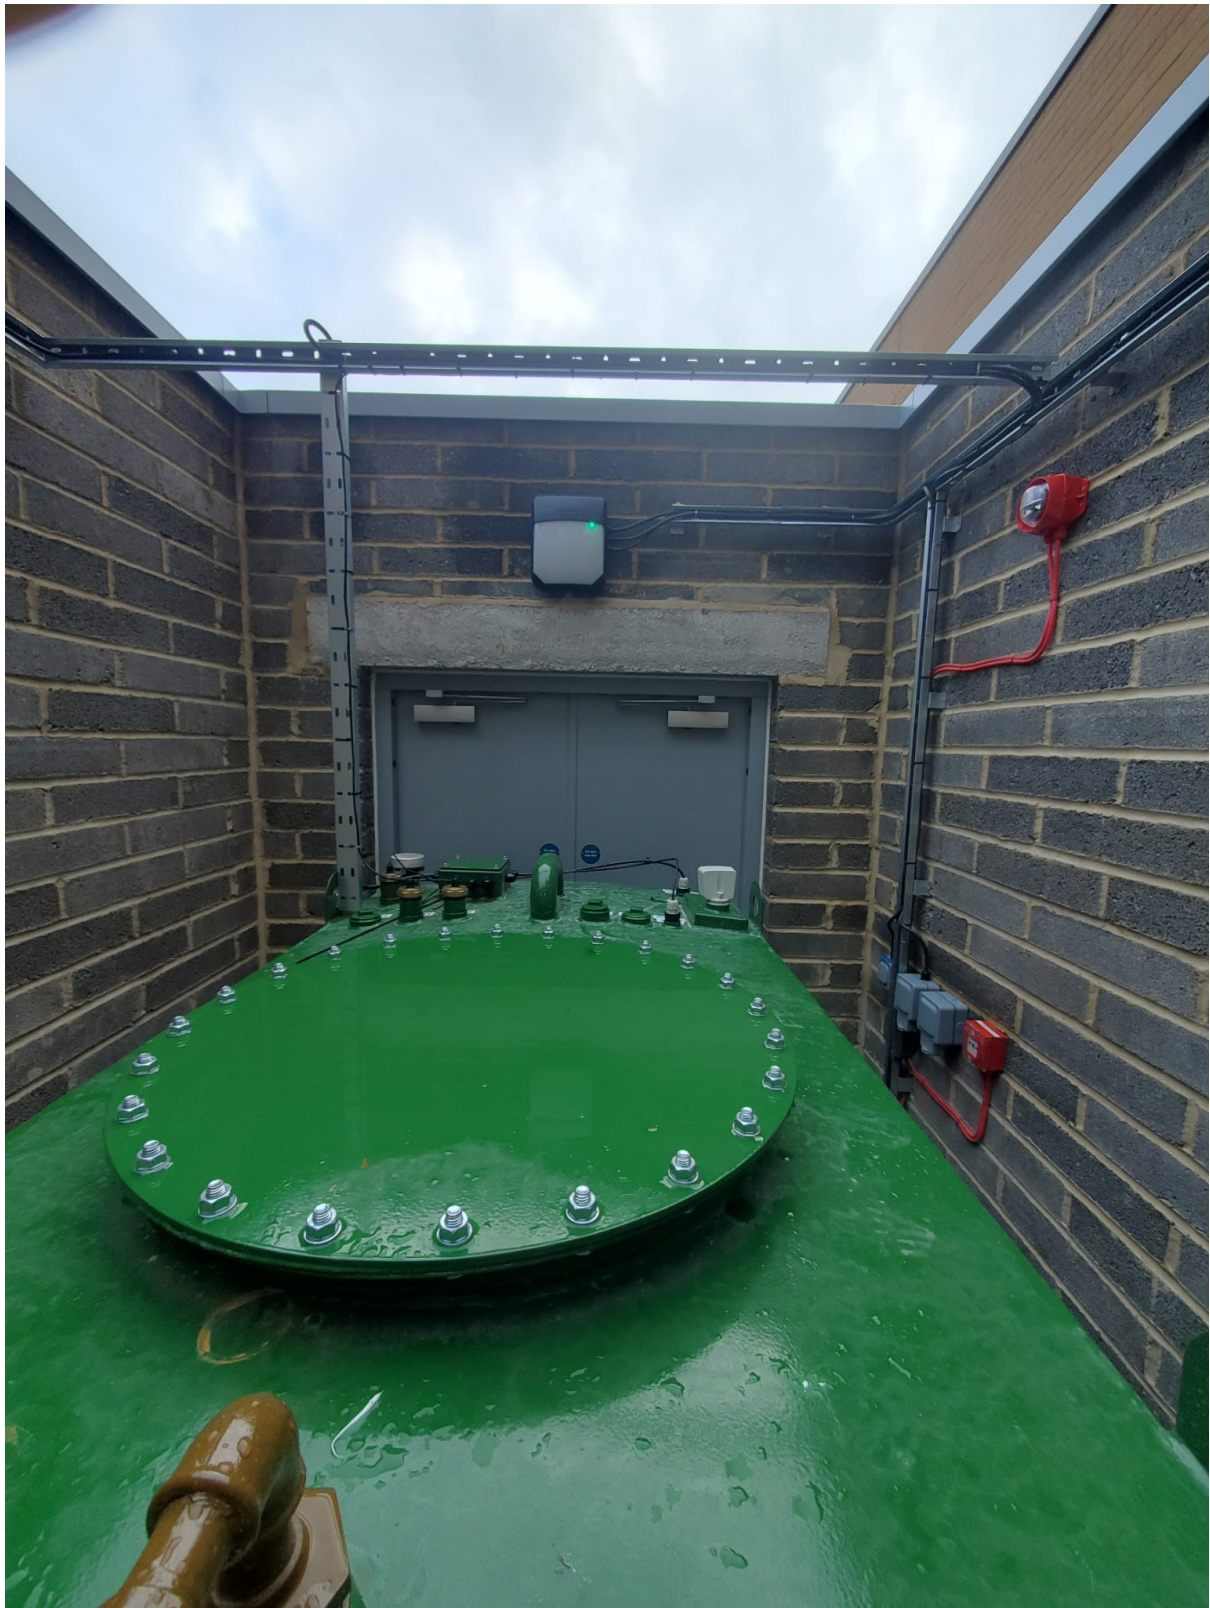
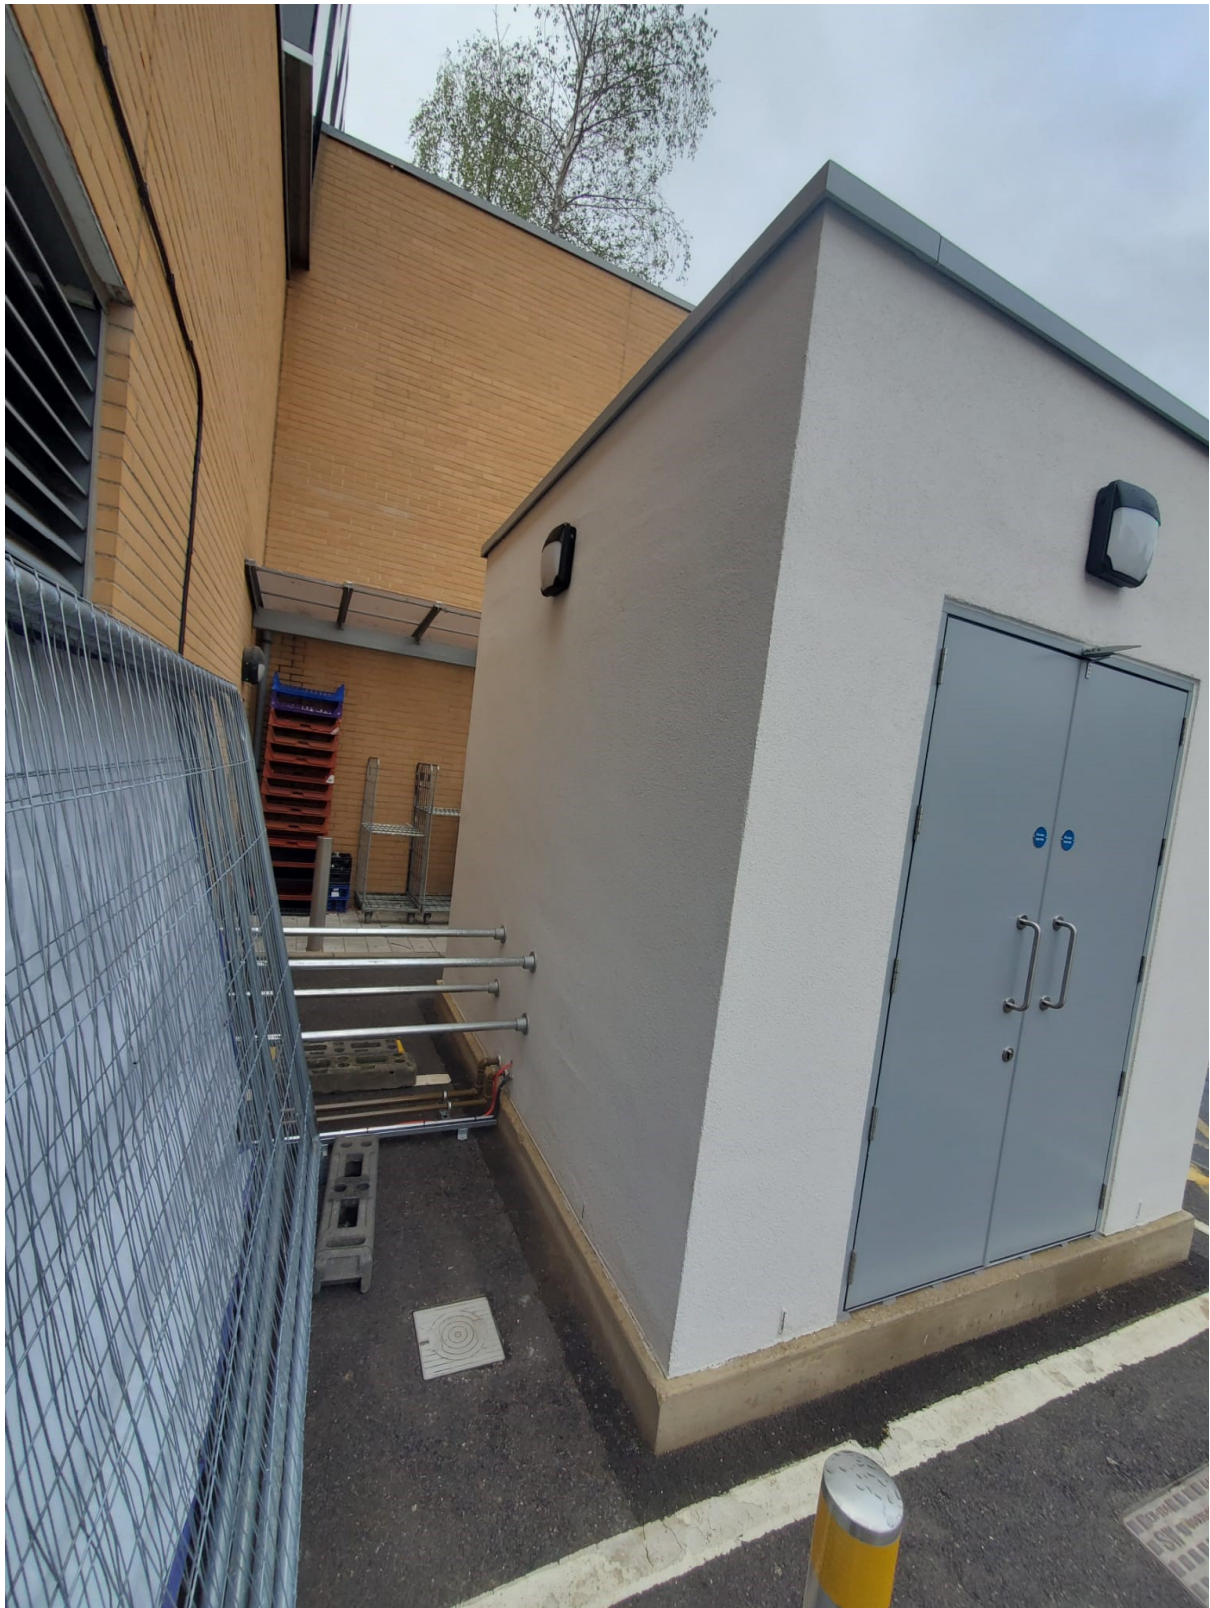
**APPENDIX IV**  
**PHOTOS OF ABOVE GROUND TANK**

The new above ground tank has been installed and the old tank emptied. There are no current plans to remove the old tank.
