# Preliminary Ecological Appraisal and Roost Assessment

3 Briar Close, Caversham, Reading, RG4 7QH

This report is prepared to inform a planning application with the Reading Borough Council. The proposal is described as:  
Conversion of garage and conservatory. Addition of bedroom above garage conversion.

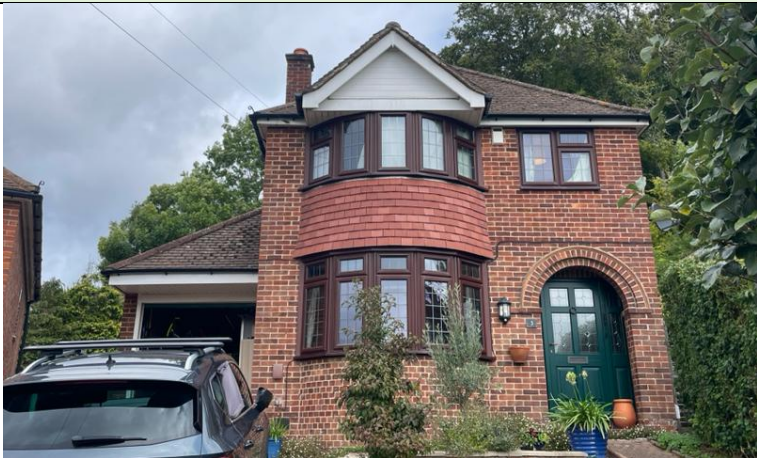
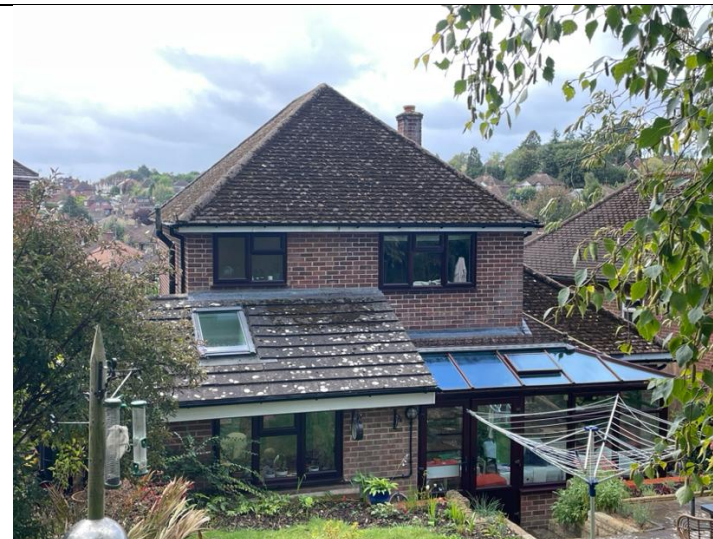
| | <p><b>Foraging and commuting habitat</b></p> <p>Habitats recorded on site are assessed to provide foraging and commuting opportunities for bats in the form of grassland, native hedgerows, introduced shrub and scattered trees. Additionally, the adjacent woodland provides foraging and commuting opportunities for bats. These habitats are likely to provide micro-climatic conditions that support invertebrates that will in turn provide foraging opportunities for local bat populations.</p> <p><b>Roosting habitat</b></p> <p>Buildings and trees to be impacted by the proposed development are assessed for their suitability to support roosting bats below. There are a total of 2 buildings on site: the main dwelling (B1), and one outbuilding (B2). Only B1 was surveyed as this will be impacted by the proposed development. No evidence of roosting bats was identified on or within B1 or any of the surveyed trees on-site.</p> |
|---|---|
| <p><i>Summary</i></p> <p>B1 is a main house. The roof is tiled with concrete roof tiles. B1 has a hipped roof and hanging tiles on the gable end dormer, all structures are in good condition. The roof tiles are in a very good condition with no raised tiles under which bats could roost. The doors and windows are UPVC and appear in excellent condition with no suitable bat roosting sites. There is plastic cladding on the gable dormer which is well sealed and in very good condition with no raised or missing boards under which bats could roost. The rear single-story extension is well sealed and in very good condition with no gaps under which bats could roost. The rear conservatory is well sealed and in good condition. There is a single chimney, with led flashing that is well sealed and in very good condition with no gaps under which bats could roost. No evidence of bats was found.</p> | |

There is one loft space within the main roof void of B1. The roof structure is built from modern timber beams. The interior of the roof is insulated with Celotex and polystyrene and is well-sealed with bitumen and horsehair and brown paper and is in very good condition with no gaps or tears. There is no ridge beam, and no cobwebs present, and no daylight enters the loft space which indicated that it is well sealed. No evidence of bats was found.

A garage is attached to B1, with no loft space. The roof of the garage is well-sealed with horsehair and brown paper. There is a window and door at the rear of the garage with a constant display of natural light. No evidence of bats was found.

The building has **negligible value**.

| <i>Recommendations</i> | <p><b>Roosting habitat [Buildings]</b></p> <p>In the unlikely event that a bat or evidence of bats is discovered during the development all work must stop and a bat licensed ecologist contacted for further advice.</p> <p><b>Foraging and commuting habitat</b></p> <p>No further surveys are required.</p> <p><b>Artificial lighting</b></p> <p>None required.</p> <p><b>Suggested biodiversity enhancements</b></p> <p>The installation of one bat box at the site will provide additional roosting habitat for bats. The bat boxes will be incorporated into the fabric of the new extension. They will be suitable for pipistrelles (which have been identified locally through EPSL data). Bat boxes should be positioned 3-5m above ground level facing in a south or south-westerly direction with a clear flight path to and from the entrance, away from artificial light.</p> |

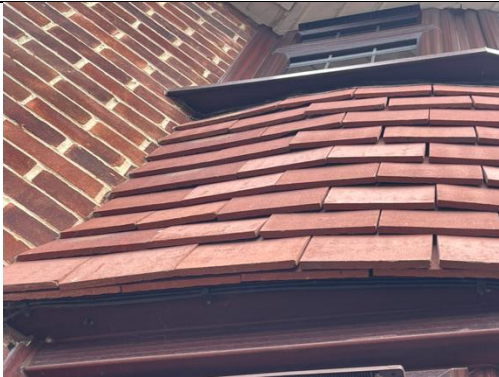
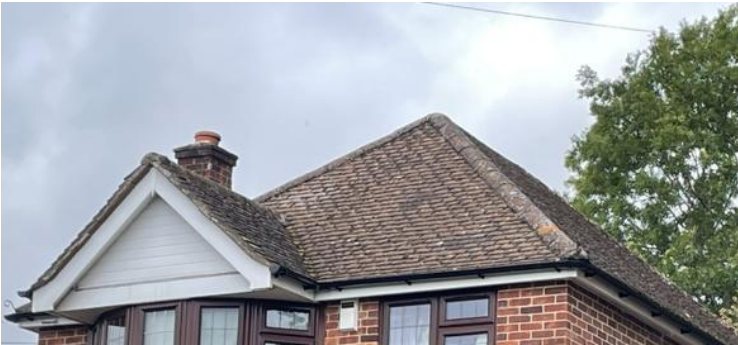
| Roof | Concrete | <p><b>Condition/description</b></p> <p>Hipped roof and hanging tiles on the gable end dormer, all structures are in good condition. The roof tiles are in a very good condition with no raised tiles under which bats could roost.</p> <p><b>Suitability/access/evidence of bats</b></p> <p>No suitability or access for bats. No evidence found but recent and current rain would wash this away externally.</p> | |

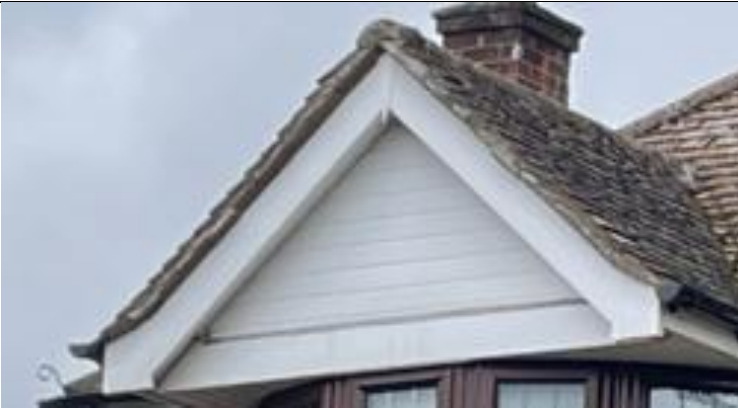
| Eaves | Overhanging | <p><b>Condition/description</b></p> <p>Good condition, no gaps present.</p> <p><b>Suitability/access/evidence of bats</b></p> <p>No evidence found but recent and current rain would wash this away externally.</p> | |

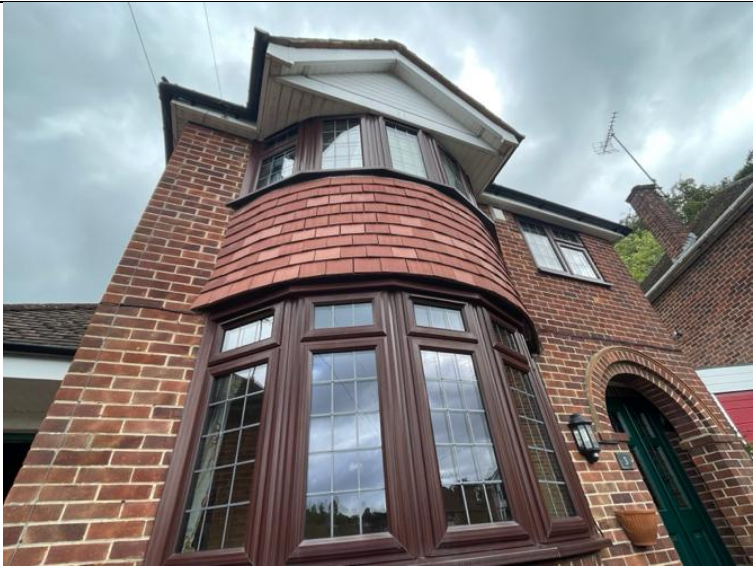
| Window/doors frames and lintels | UPVC | Tight fitting | |

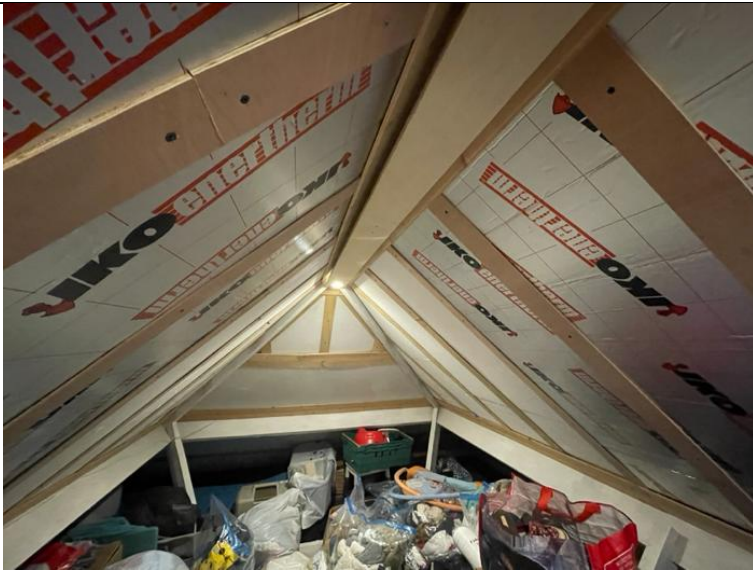
| Internal voids | Timber rafters.<br>Insulated with Celotex and polystyrene. | <p><b>Condition/description</b></p> <p>The internal void is used for storage, no daylight enters the loft space which indicated that it is well sealed.</p> <p><b>Suitability/access/evidence of bats</b></p> <p>Well-sealed and no access or evidence of bats.</p> | |

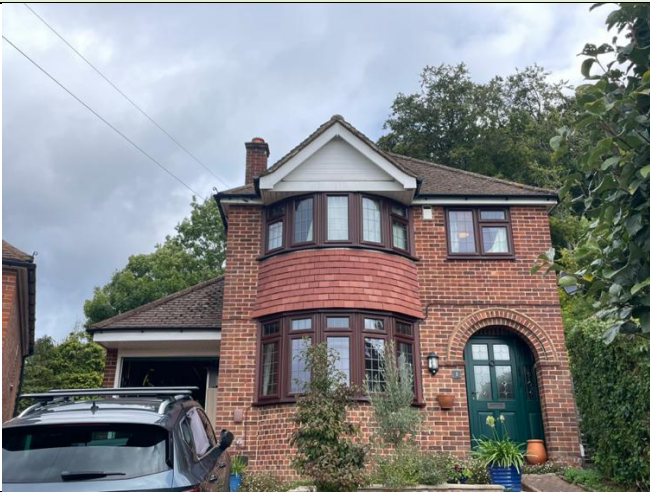
| Buildings | |
|---|---|
| | Figure 1: Main dwelling (B1) on site |

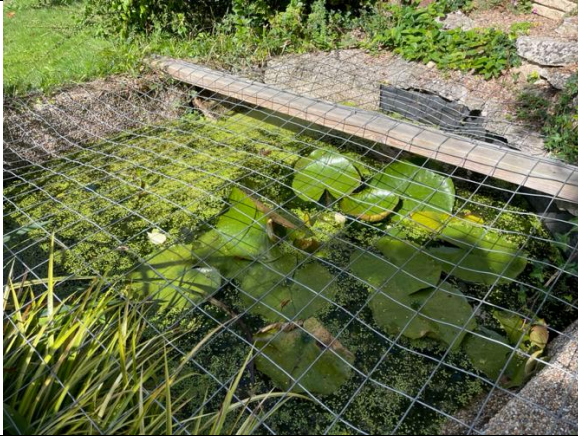
There is one pond present on site (P1). Pond P1 is a man-made pond that measures 3m x 1.5m. The banks are vertical with concrete sides with a liner, some submerged vegetation including lily pads and sedges. The pond is not connected to streams or other waterbodies and is densely vegetated with duckweed. The water was poor quality but clear at the time of the survey, indicating the potential presence of fish. No waterfowl were viewed using the pond during the survey. The pond water quantity fluctuates year-round.

Figure 10: Pond along the eastern boundary consisting of lily pads and duckweed
