# Amethyst Ecology

89 Westwood Road, Tilehurst, RG31 5PY

## **Bat Report** **(Preliminary Roost Assessment & Emergence** **Survey)**

January 2026

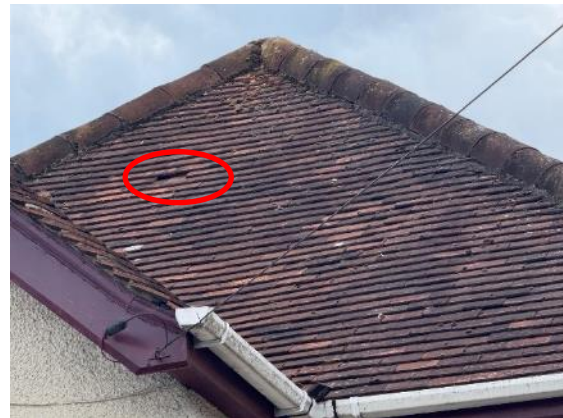
Photograph 2. Roof tiles with gaps between tiles

- 4.9 The roof tiles across the main roof pitch contain a few gaps due to lifted or missing tiles (Photo 2) that offer as suitable Potential Roosting Features (PRFs) for crevice dwelling bats to utilise, such as a common pipistrelle *Pipistrellus pipistrellus*. It was noted from the internal search that the roof does not have any internal lining, with the tiles laid directly onto battens. This reduces the suitability of the tile features as the PRF between the tiles is very exposed and is suitable for individual bats as transitional/opportunistic roost.

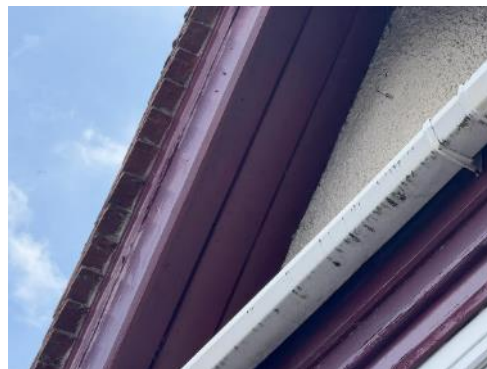
Photograph 3. Soffit gap

- 4.10 The timber boards forming the roof overhang on the gable end have small gaps between them which form suitable PRFs for bats (Photo 3). The void behind the boards typically creates a more stable environment for bats.

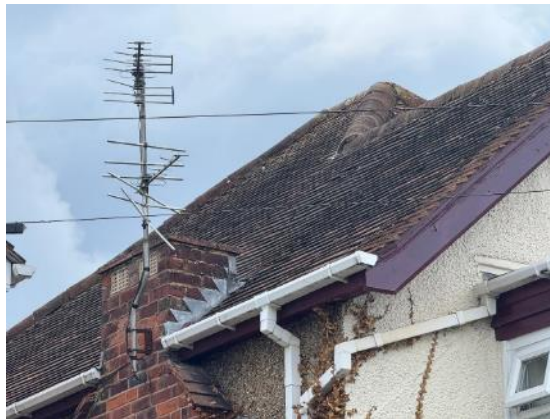
Photograph 4. Southeast elevation roof

- 4.12 The southeast elevations' main pitch tiles exhibited minor lifts that provide suitable access to the space between the tiles that crevice dwelling bats could utilise. As noted above, the lack of internal lining greatly reduces the suitability of the roof tile features for bats due to the exposed nature of them.
- 4.13 The timber soffits and fascia across do not contain and PRFs and are well sealed. The brickwork is also in reasonable order, with no PRFs present (no PRFs identified across brickwork on any elevation). The lead flashing around the chimney is flush and no PRFs are present.

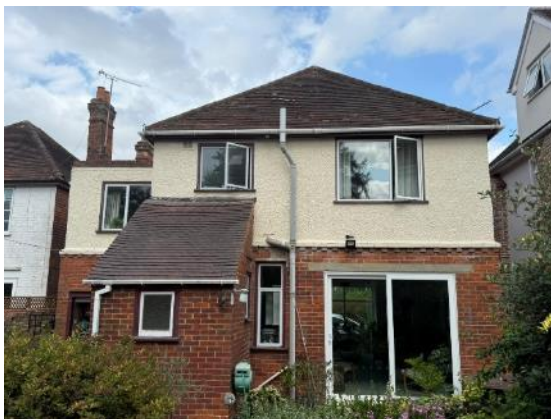
Photograph 5. Southwest elevation of B1

- 4.14 The west elevations roof tiles contain small gaps that provide as suitable PRFs for crevice dwelling bats, but under the same rationale as above, are of low potential due to the lack of internal lining. There is also spalled mortar along the right-hand hip tiles of this elevation, which provide as suitable PRFs.
- 4.15 The tiles across the lean-to roof are flush and do not exhibit any PRFs.
- 4.16 The soffits, brickwork and window/door frames are all well sealed, with no suitable PRFs present.

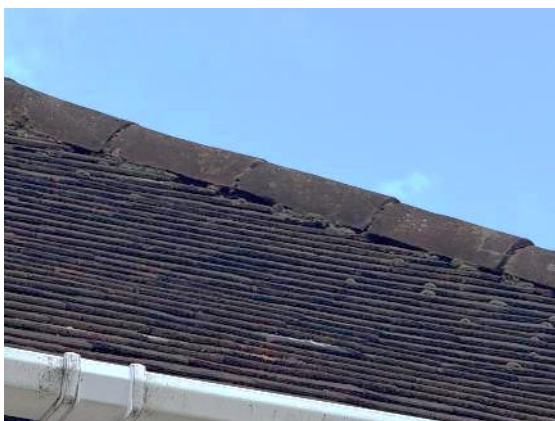
Photograph 7. Hip tiles with spalled mortar

- 5.2 The majority of features across B1 and B2 are in association with the roof coverings, including lifted tiles and missing tiles, as well as some spalled mortar at the hip of B1. The lack of an internal roof lining greatly reduces the suitability of the tile features for roosting bats, as they are restricted to the immediate exposed gap at the front of the tile. There is also a gap in the timber boards of the soffit of the roof overhand that provide potentially suitable roosting opportunity for bats. The cladding on B2 does not provide sufficient PRFs for crevice dwelling bats, due to the overlap of the boards being relatively small, and there being no lining behind. The gaps could be inspected via torchlight, and no bats or bat evidence was recorded.

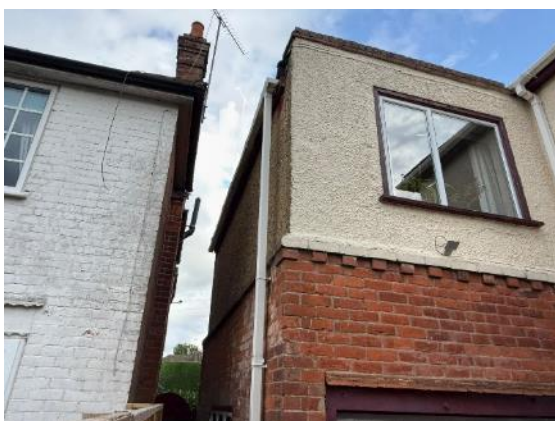
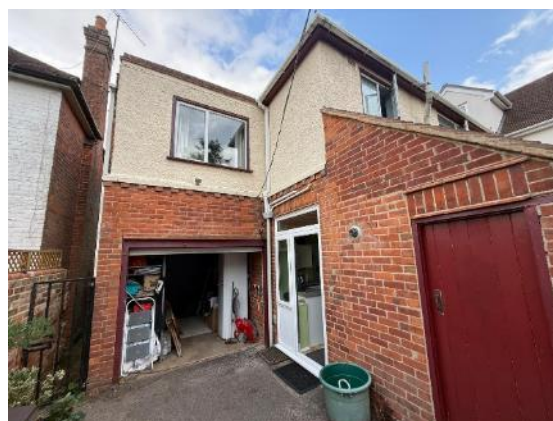
- 4.17 The flat roof of the northwest elevation could not be accessed, nor could the hip roof of this elevation be viewed.
- 4.18 The soffits, fascia, brickwork and window/door frames are all well sealed, with no suitable PRFs present.

Photograph 9. Northwest elevation

Photograph 10. Northwest elevation (wide angle)

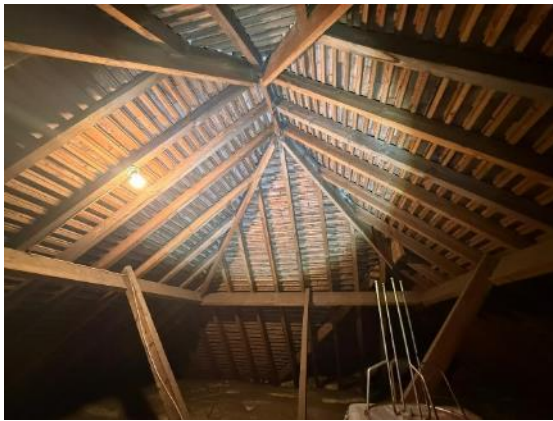
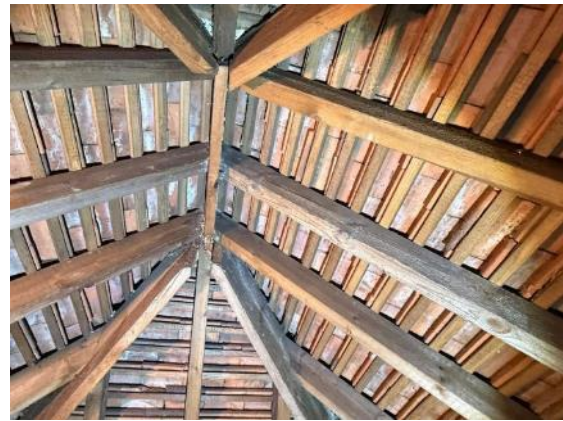
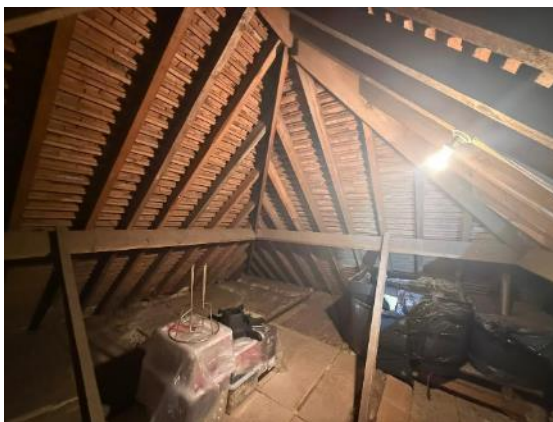
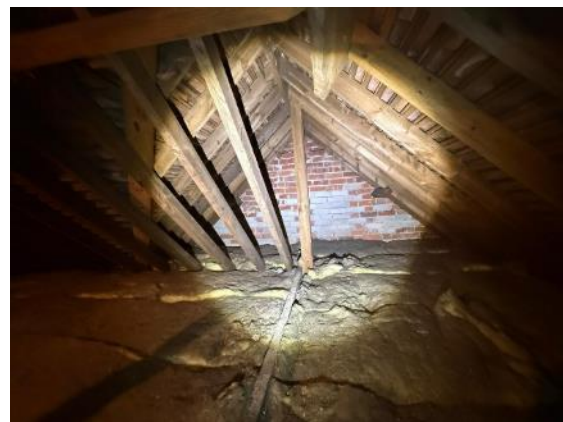
- 4.19 The loft space is constructed of modern timber frame, including rafters, purlins struts and a ridge board. The roof has no lining, with the underside of the roof tiles exposed. The floor is lined with mineral wool insulation, which is laid between the floor joists, which is partially boarded.
- 4.20 Where tiles were noted to be missing or lifted from the exterior, these were inspected internally for bat evidence. No evidence was recorded, and the gaps were vacant. The underside of the hip tiles could also be partially seen, which were also vacant with an absence of bat evidence e.g. droppings.
- 4.21 All surfaces and internal brick/block work were inspected for any bat evidence, as items such as bat droppings can typically collect across these areas. No internal evidence of bats was recorded.

- 4.22 The insulation was lifted to check for historic bat evidence; none was recorded.

Photograph 11. Roof void of B1

Photograph 12. Close up of B1 roof coverings

Photograph 13. B1 roof void with water tanks

Photograph 14. Internal face of northeast gable

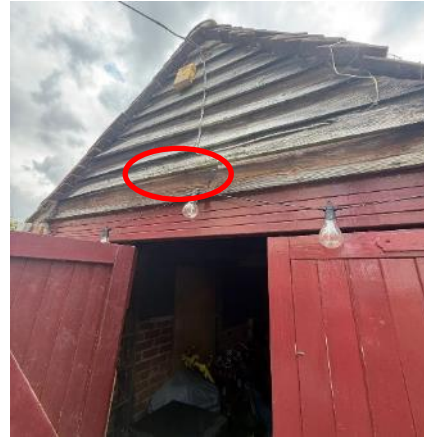
Photograph 16. Close-up of lifted and exposed cladding

- 4.25 The verge tiles across the shed have spalled mortar, which creates suitable PRFs for bats. The gaps could be inspected with a torch and were vacant, with the gap only extending to the width of the tile.
- 4.26 The timber boards at the apex of the gable contain gaps and lifts. There is no lining behind the boards, with the overlap being very small. The gaps are unlikely to be utilised by crevice dwellers due to the exposure but do provide

as a suitable access point to the internal space of the shed for void dwelling bats such as a brown long eared.

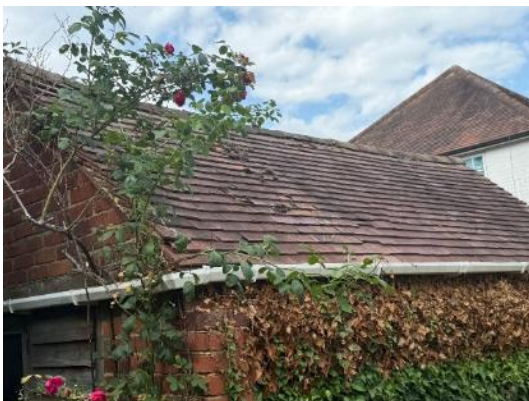
Photograph 17. Southeast elevation of B2

- 4.28 The main roof tiles across B1 have numerous lifted and gaps that could serve as a potential access point for void dwelling bats. The gaps themselves are of low value to crevice dwellers such as a pipistrelle sp. due to the exposure of the feature and lack of internal lining.

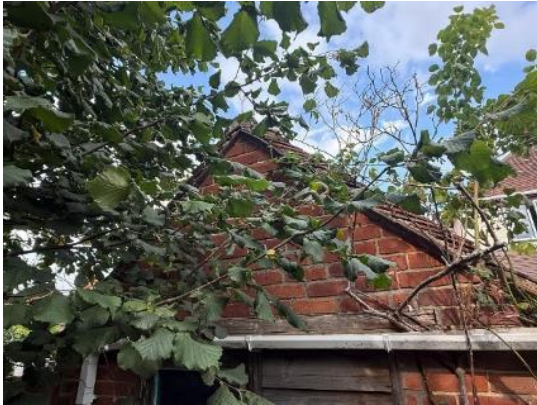
Photograph 19. Southwest elevation of B2

- 4.29 The southwest elevation has timber cladding from ground level up to c. 1.5m of the gable elevation. The overlaps of the cladding are only c. 2-3cm and do not have any lining behind. Considering this and the low positioning of the feature, bats are unlikely to utilise the cladding.
- 4.30 The verge mortar has spalled on this elevation leaving small, exposed gaps along the roof. The back of the gaps can be seen, and no bats or bat evidence was recorded. There are gaps between the tiles themselves, but

these were also vacant of bats or bat evidence; also, the lack of lining behind reduces the suitability of the features as only this leaves only the space between the tiles to be occupied.

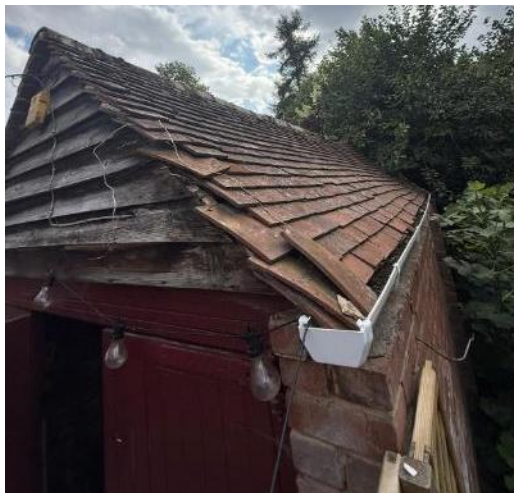
Photograph 22. Southwest elevation of B2

- 4.31 The northwest elevations roof contains lifted and slipped roof tiles at the northwest end of the building. The gaps provide suitable access to the interior of the building, as well as low value roosting potential for crevice dwelling bats.

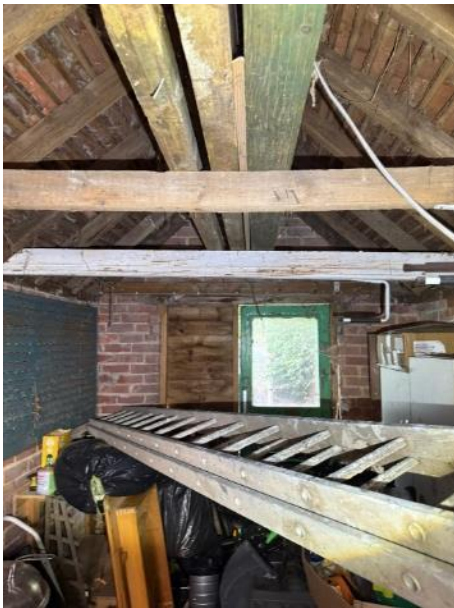
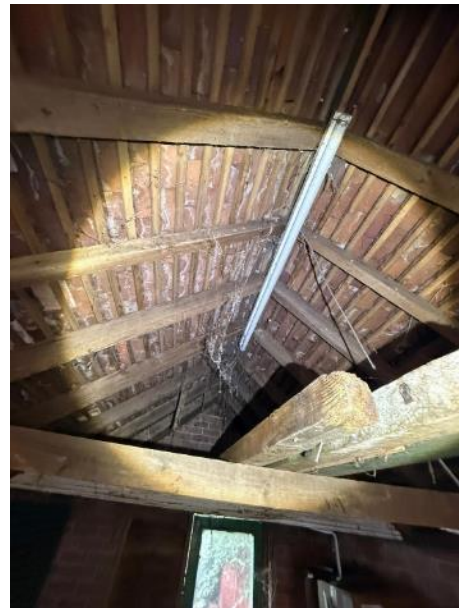
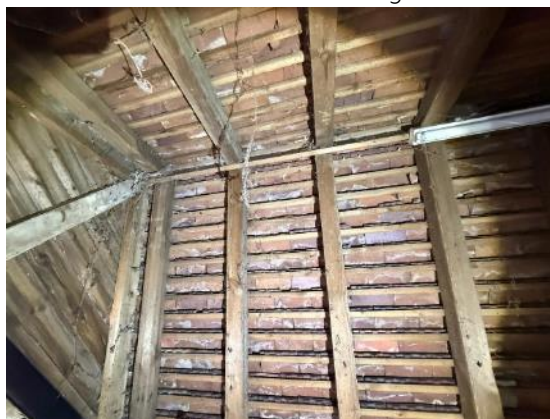
- 4.33 Where tiles were noted to be missing or lifted from the exterior, these were inspected internally for bat evidence. No evidence was recorded, and the gaps were vacant.

- 4.34 All surfaces and internal brick work were inspected for any bat evidence, as items such as bat droppings can typically accumulate across these areas. No internal evidence of bats was recorded.

- 4.35 The interior space of the shed had thick and old cobwebs spanning the roof structure, which indicates no recent internal activity. Furthermore, there is a window on the southwest elevation that allows daylight to penetrate, which is typically unsuitable conditions for roosting bats.

Photograph 23. Internal space of B2

Photograph 24. Roof structure and underside of coverings

Photograph 25. Underside of coverings and internal face of exposed timber cladding.

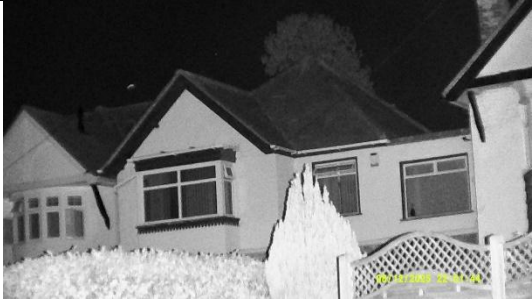
| | Camera position 01 |

| Survey Date | Sunset Time | Start Time | End Time | Temp. (°C) | | Cloud Cover (oktas 0-8) | | Wind (Beaufort Scale 0-12) | | Precipitation |
|---|---|---|---|---|---|---|---|---|---|---|
| B1 | 01 | The first bat activity recorded from this position was at 21:11, where a soprano pipistrelle was observed passing past the site on the eastern boundary. The bat was following the ornamental hedgerows down the street line heading south (see plan in Appendix C). At 21:21, the same activity by a soprano pipistrelle was observed. Activity then ceased beyond this point from this position. No emergences were recorded by the surveyor or through post-survey analysis of the IR footage. | | | | | | | | |

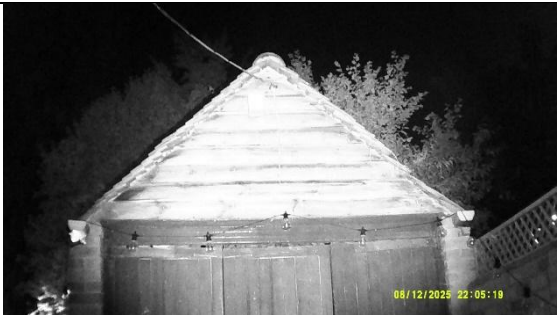
| | <p>Camera position 04</p> |

| Survey Date | Sunset Time | Start Time | End Time | Temp. (°C) | | Cloud Cover (oktas 0-8) | | Wind (Beaufort Scale 0-12) | | Precipitation |
|---|---|---|---|---|---|---|---|---|---|---|
| | 04 | No emergences were recorded through post-survey analysis of the IR footage. | | | | | | | | |

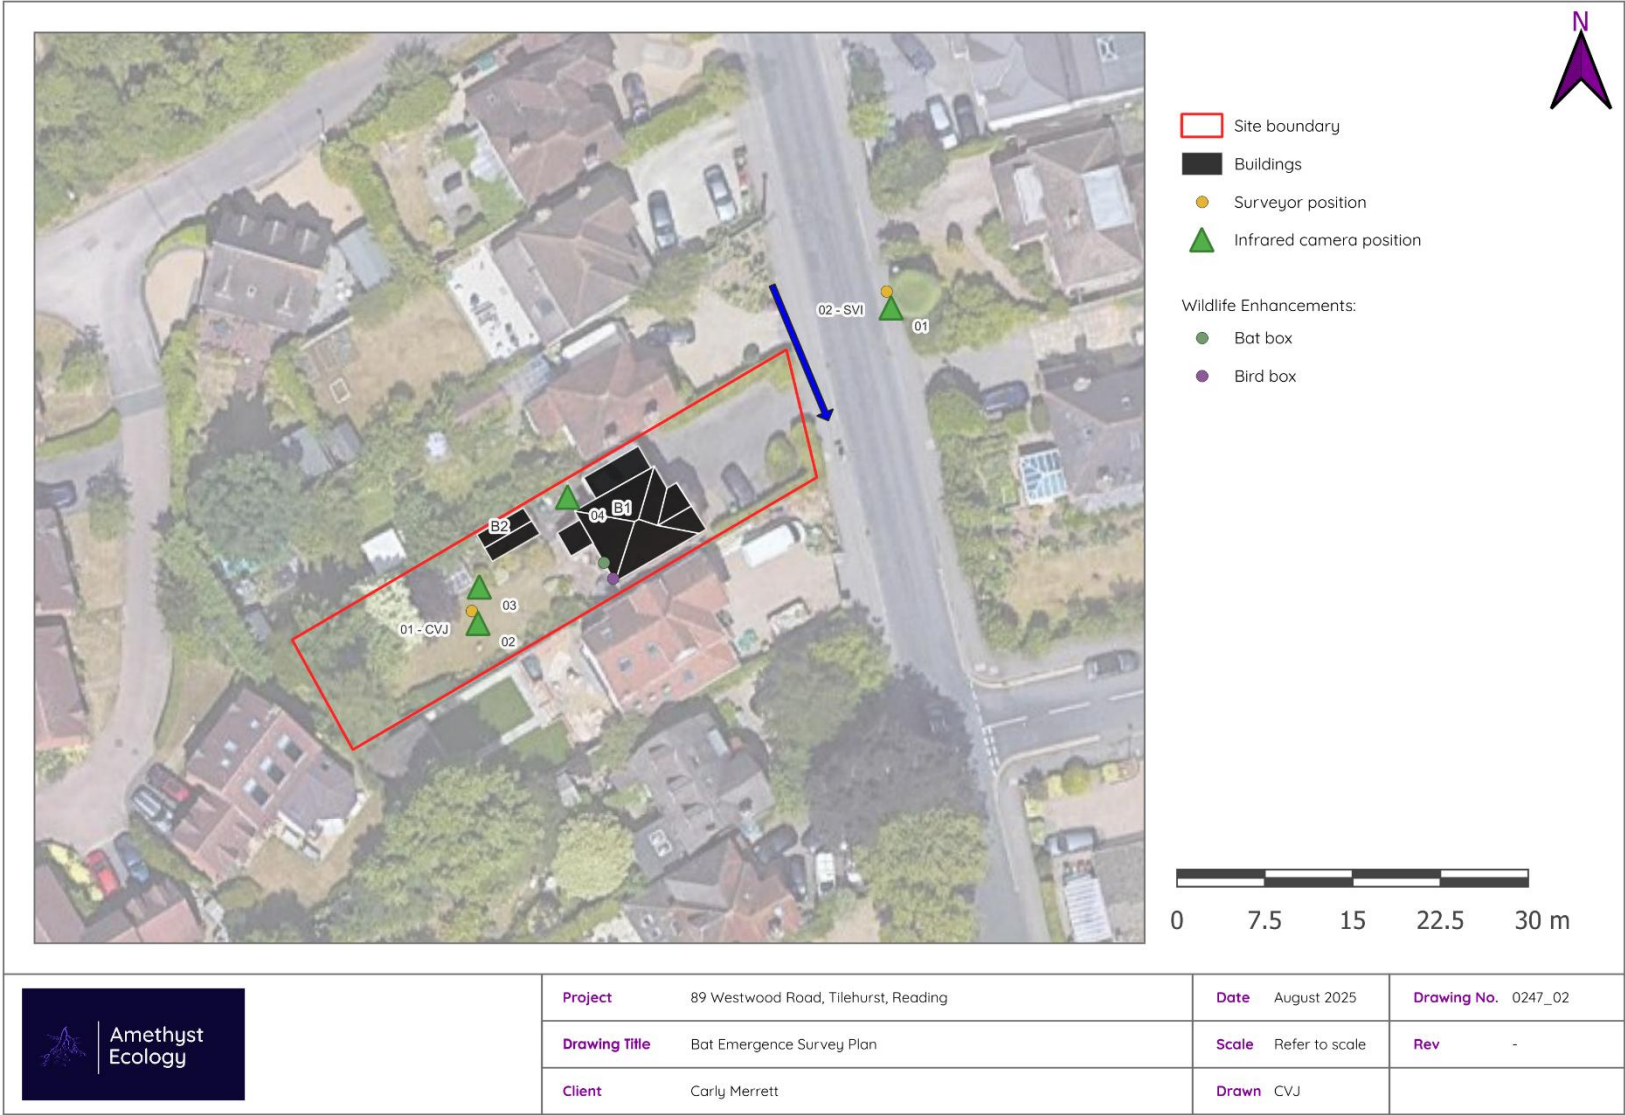
- 3.17 The positions of the surveyors and the infrared camera rigs around the building during the survey are illustrated on the Bat Emergence Survey Plan in Appendix C.
