Proposed redevelopment  
Eaton Court  
104-112 Oxford Road  
Reading

## Ground Investigation Report

**Proposed redevelopment  
Eaton Court  
104-112 Oxford Road  
Reading  
RG1 7LL**

**GROUND INVESTIGATION REPORT**

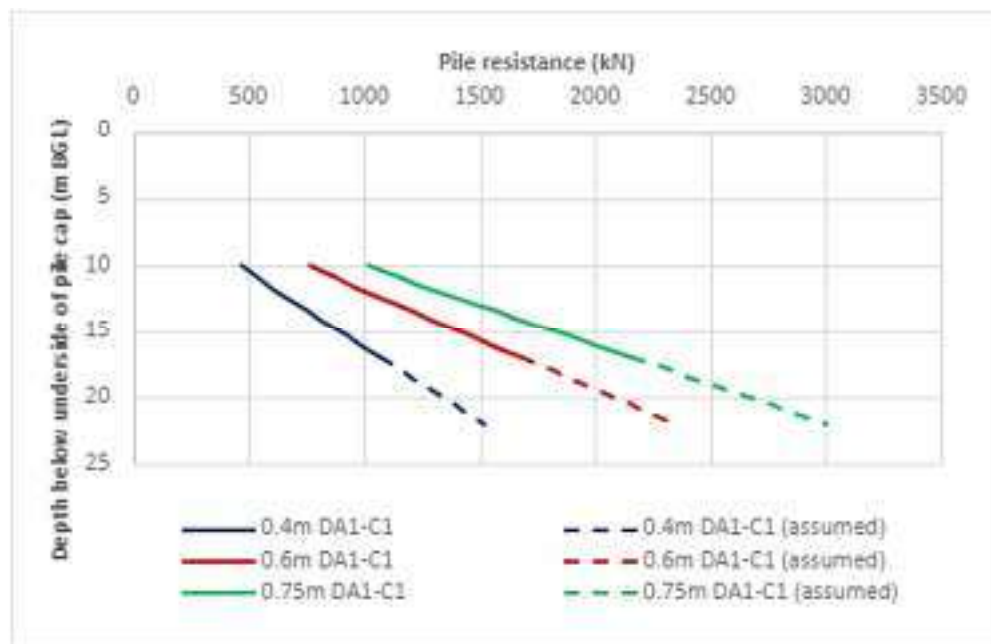
Figure 2 – Variation of pile resistances against depth – Combination 1

- 7.6.8 The variation of single pile resistance in relation to pile toe level is presented below for three different pile diameters. It should be noted that the resistance of a single pile is reduced in the vicinity of other piles. Accordingly, detailed design of the piled foundation arrangement should take into account spacing between piles and pile group effects.

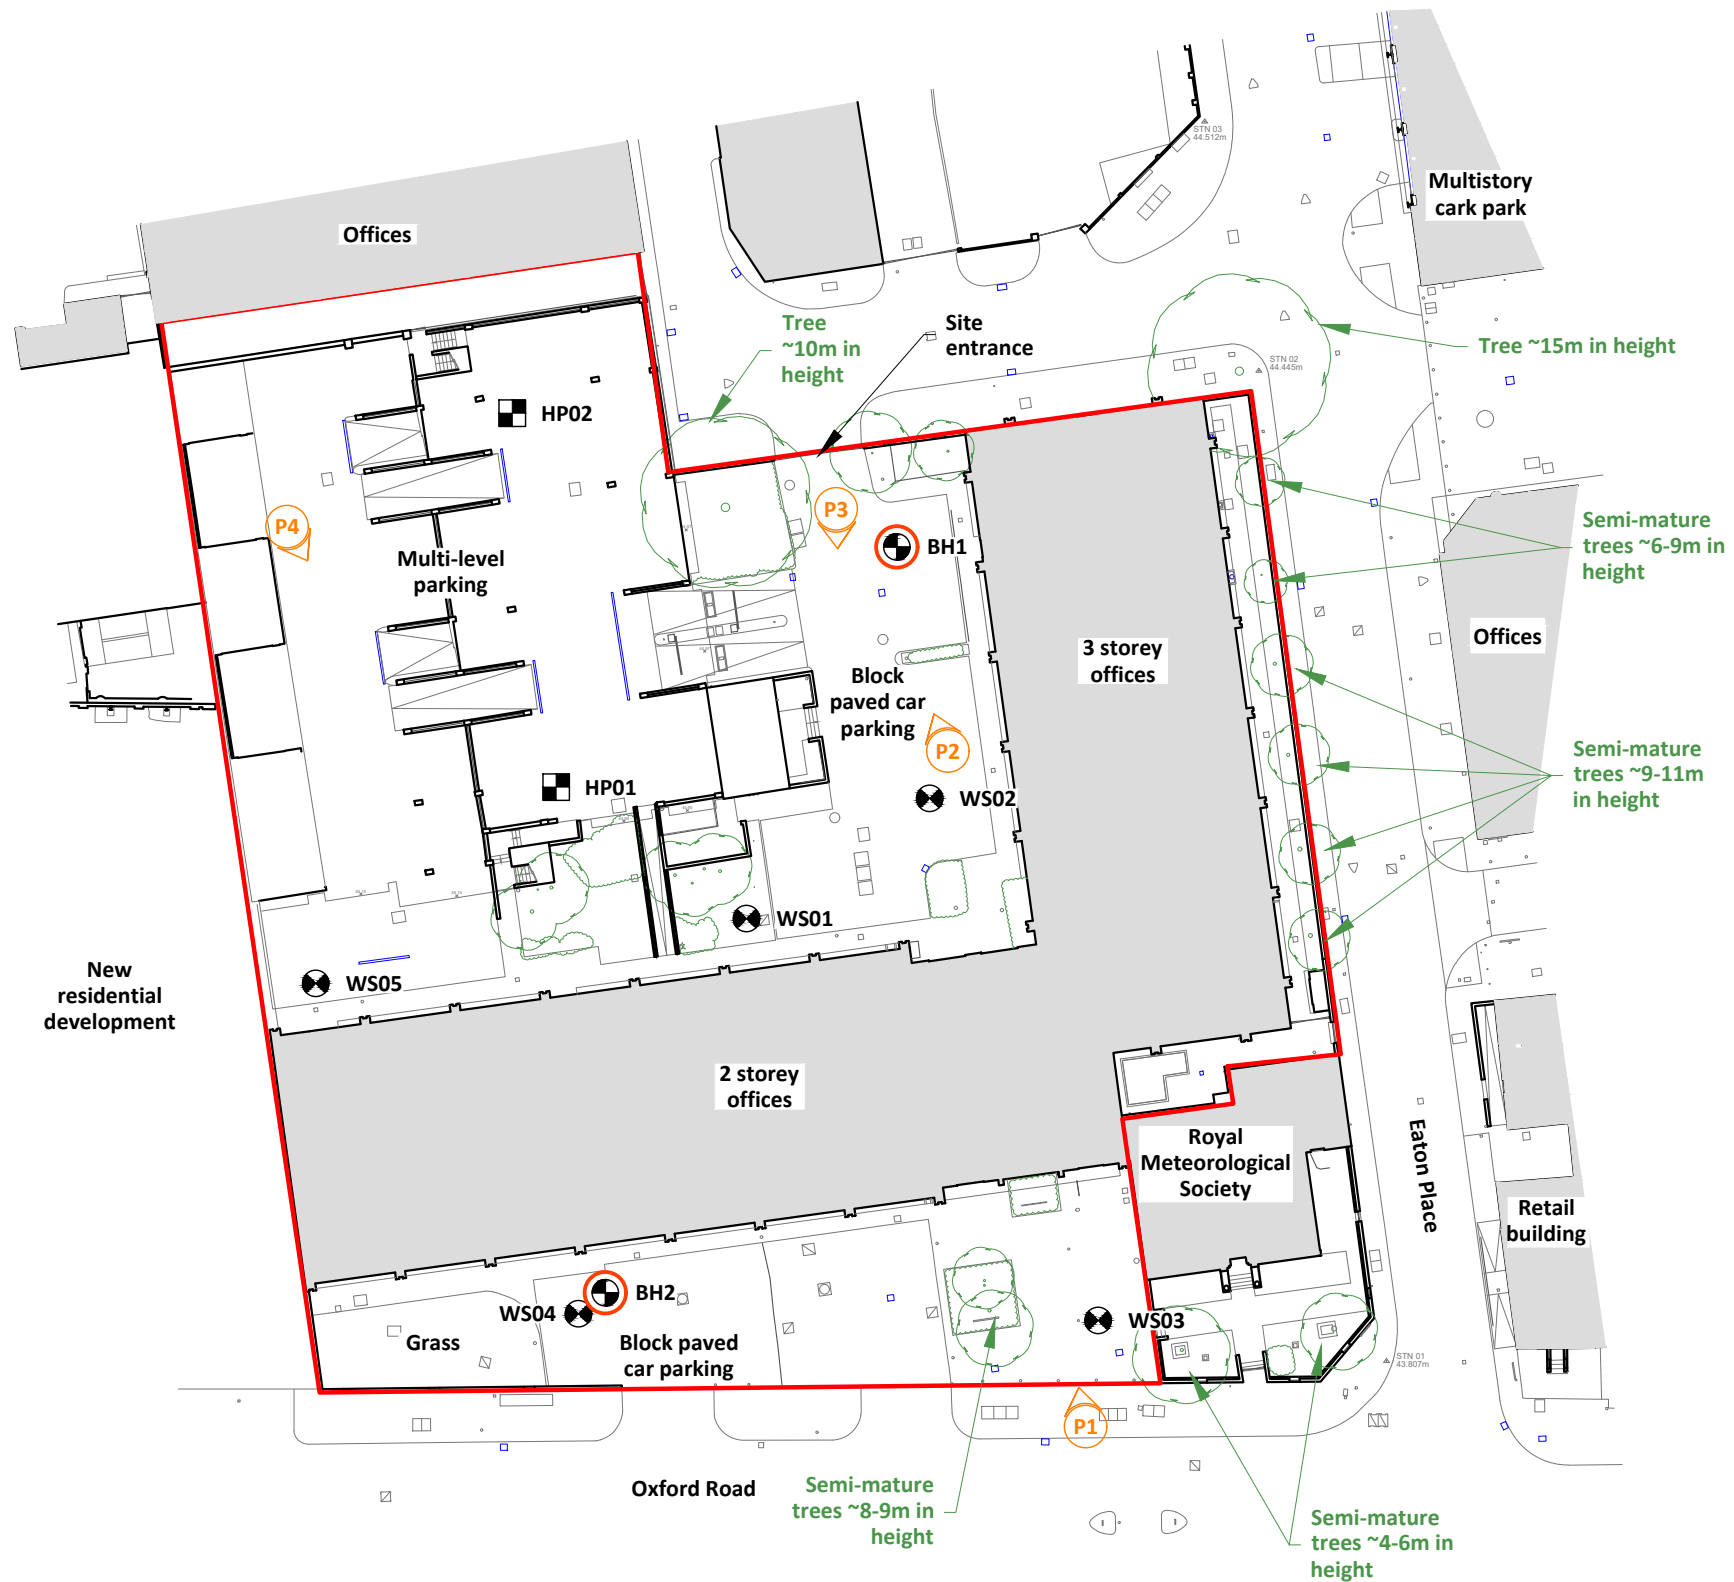
| PROJECT NO.<br>STR4832 | SCALE AT A3<br>1:500 | DRAWING NO.<br>02 |

- Key**
- BH** Cable percussive borehole
  - WS** Dynamic windowless sampling borehole
  - HP** Hand dug trial pit
  - Standpipe installed
  - Photographic record
  - Site boundary

- 3.2.4 A plan showing observed site features and location of exploratory points is presented on Drawing 02.

4.1.2 A plan of the site showing observed/existing site features and approximate position of exploratory points is presented on Drawing 02.
