# Whitley Villa

1 Christchurch Road, Reading RG2 7AB

## HERITAGE STATEMENT

Document No: 1341-HR-A-HS-XX-01  
Rev 07

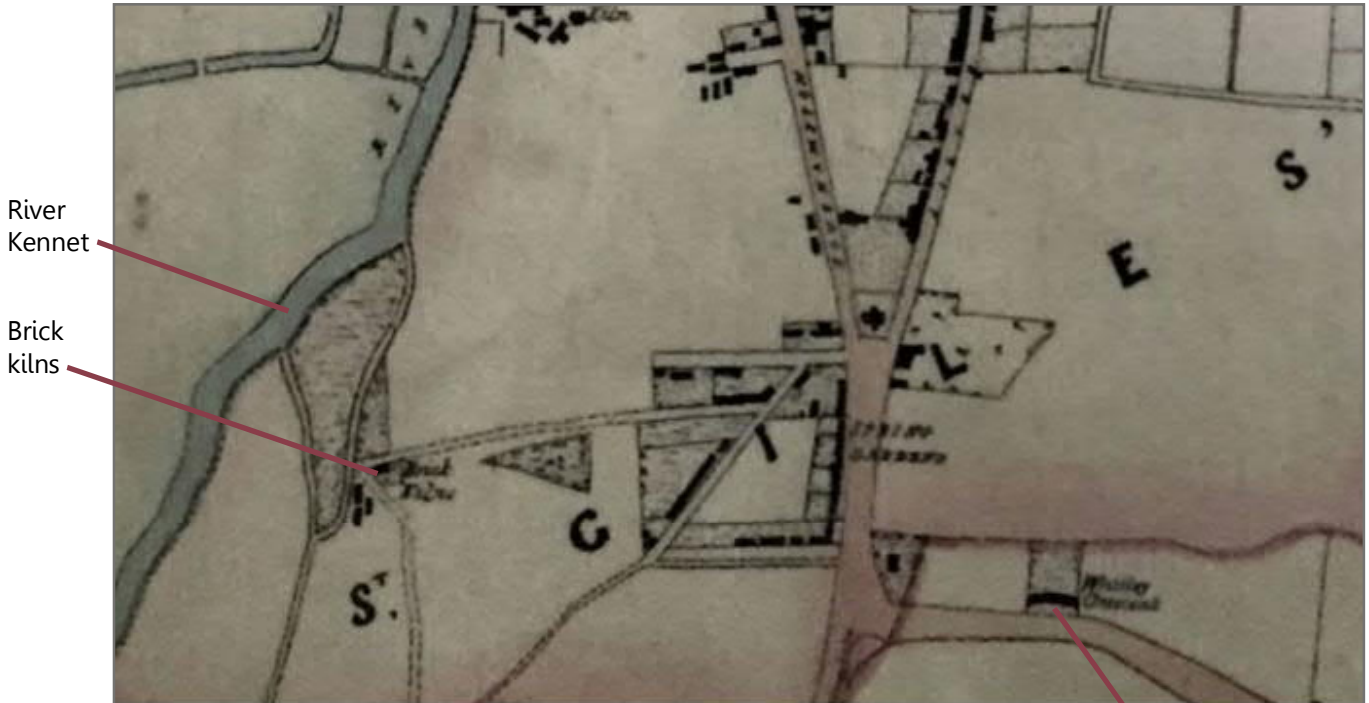
Image 5: Extract of the 1834 Commissioner's Map of Reading (RBC, 2024)

Central block of Whitley Crescent

- 2.1.2 The first buildings constructed along what was referred to as the 'Road to Farnham' or 'From Shinfield' appear to have been the Grade II listed brick-built terrace of houses, now the central 'block' of Whitley Crescent - numbers 11-25 Christchurch Road, (Historic England List Entry Number 1321966). Refer to the map extract from 1834. Brick kilns are located at this time by the River Kennet, to the west of The Site.

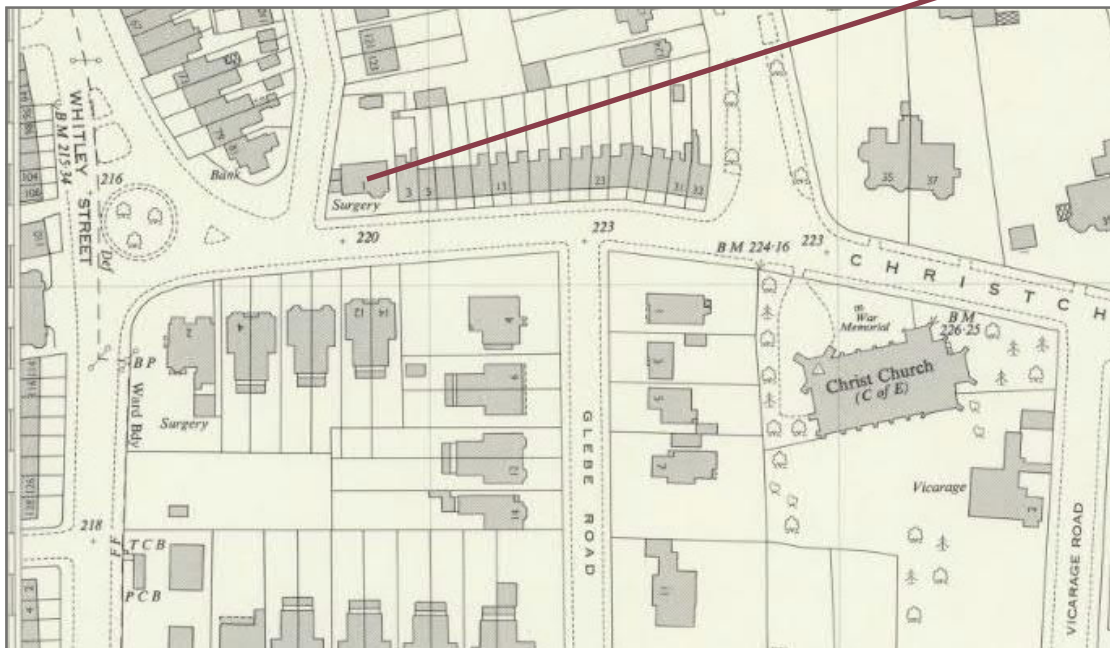
Image 12: Extract of the Berkshire XXXVII.7 map from 1957, published 1958 (National Library of Scotland, 2025).

2.1.8 The 1957 map identifies the property as a surgery (Image 12), and incorporates an outbuilding to the north of the previous boundary (refer to the 1932/33 map, Image 11) into the curtilage. The 1939 register of occupants for the address identifies a Mr and Mrs Simmons, aged 28 and 27 respectively, who are recorded as being married in the District of Bangor (Wales) between October-December of 1938 (The National Archives). Mr Simmons is registered as a medical practitioner, and Mrs Simmons as a 'Retired State Registered Nurse'. It is possible part of the property became a doctor's surgery under the occupation of Mr Simmons. The later map from 1971 shows little change to the property, other than a rear access from Highgrove Street appears to have been created, denoted by a break in the boundary (Image 13).

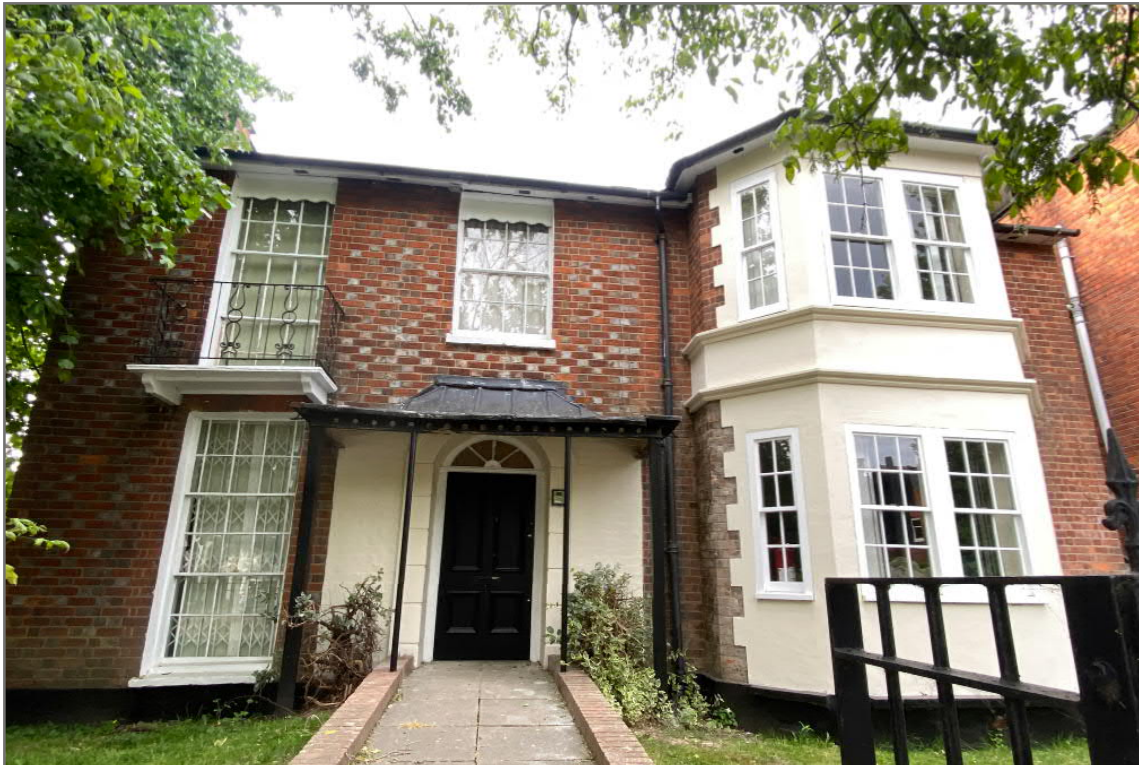
Image 16: View of the south elevation of Whitley Villa

- 2.5.5 The first floor central window does not feature consistent queen closers which may suggest a later re-working of the opening over the entrance door. Both the first floor sash windows feature pelmets that would have hidden shading devices, reflecting the southern aspect of the elevation. The central sash is a replacement; the triple sashes are original: the small panes of glass, 10 over 10 over 10 inclusive of narrow margin lights, whoses delicate sashes do not feature horns.

- 2.5.6 Regency features include the delicate 'pagoda' style ironwork canopy over the entrance door and balcony feature at the first floor. The two outer entrance canopy posts appear to be less elegant in proportion and are likely to be later replacements.

- 2.5.7 Both the bay window and the masonry surrounding the front entrance door have been over-clad in stucco concealing the brickwork, with 'stone' coursing created by incised lines around the entrance door, and quoin-like stucco features added to the bay window. The fanlight over the entrance door is a particularly plain example and may be a replacement as it seems at odds stylistically with the relative ostentation of the triple sashes, brickwork and ironwork.

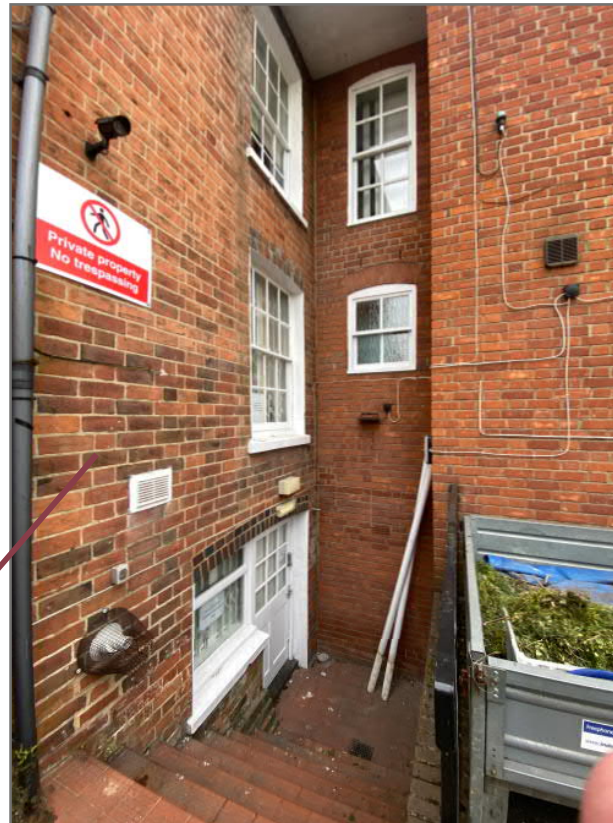
Image 25: View of east return of 1980's extension

Note grey header bricks not used to the rear elevation - demonstrating a greater outlay of investment to the public street side rather than the private rear elevation

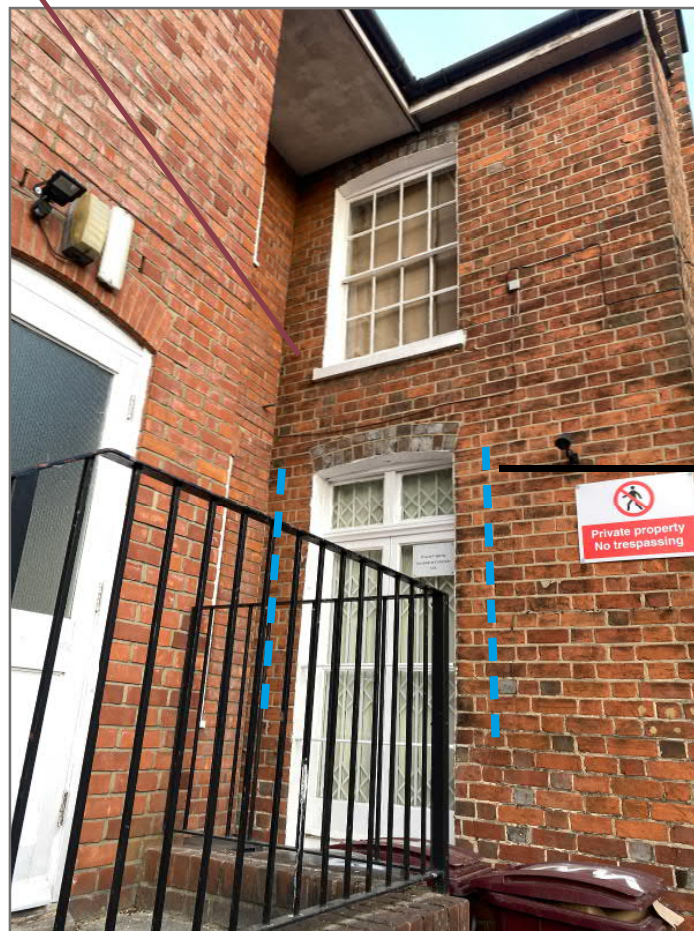
Image 26: View of north elevation and 1980s extension

Queen closers stop suggesting this was originally a window of height to match that above, rather than a full height window

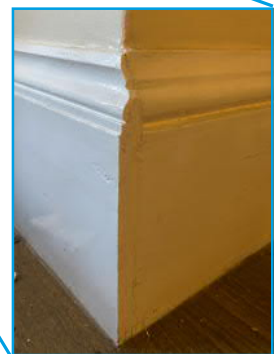
Mis-matching skirting  
profiles  
- 310mm high  
Chimney breast

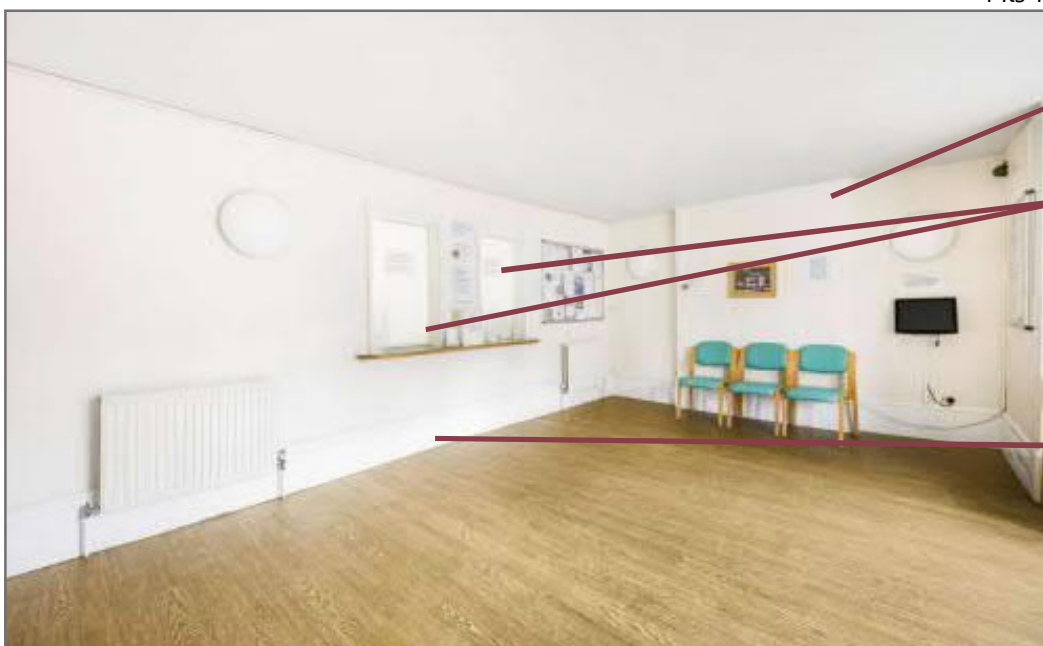
Image 30: Ground Floor East Reception Room (latterly the surgery waiting room)

Two hatch  
openings within  
the wall

Skirting  
330mm high

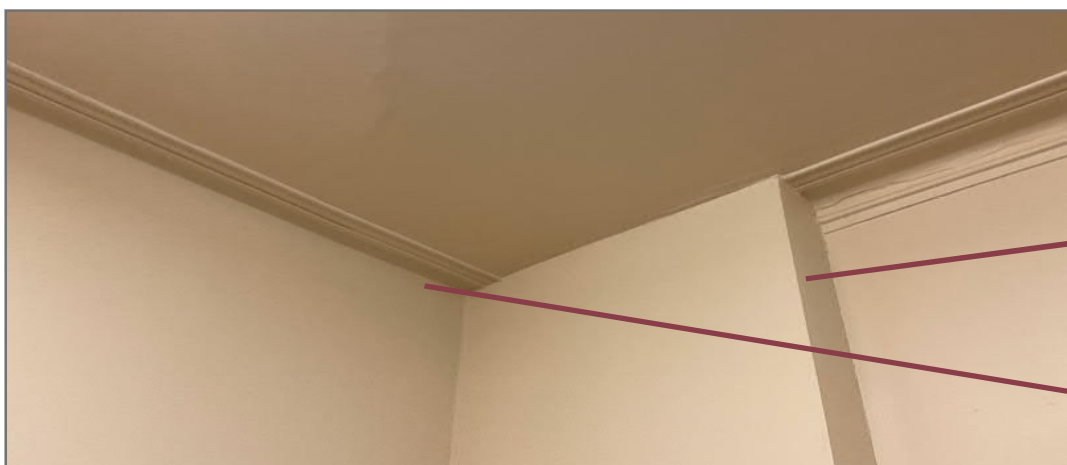
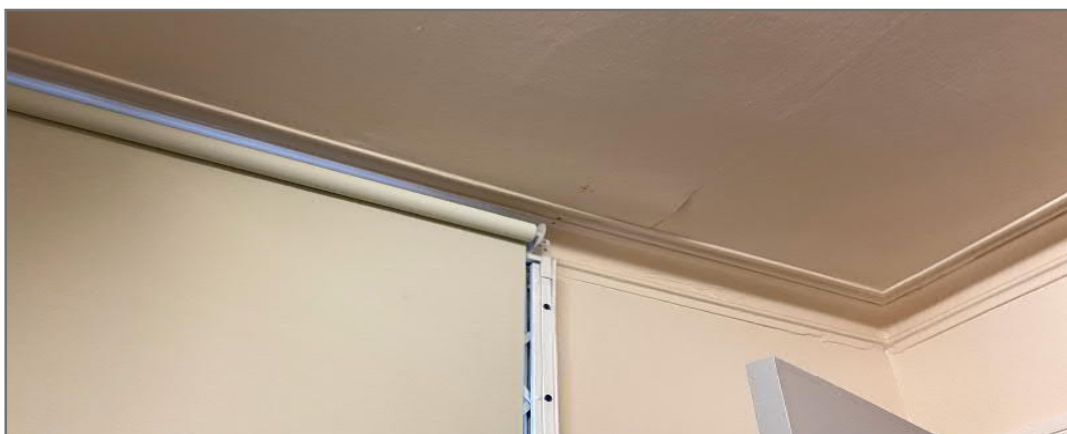
Images 34a and b: Full cornicing to three walls to west rear room

Boxing-in for  
services from  
First Floor

Cornicing cut  
when separat-  
ing wall was  
removed in  
the past, now  
reinstated

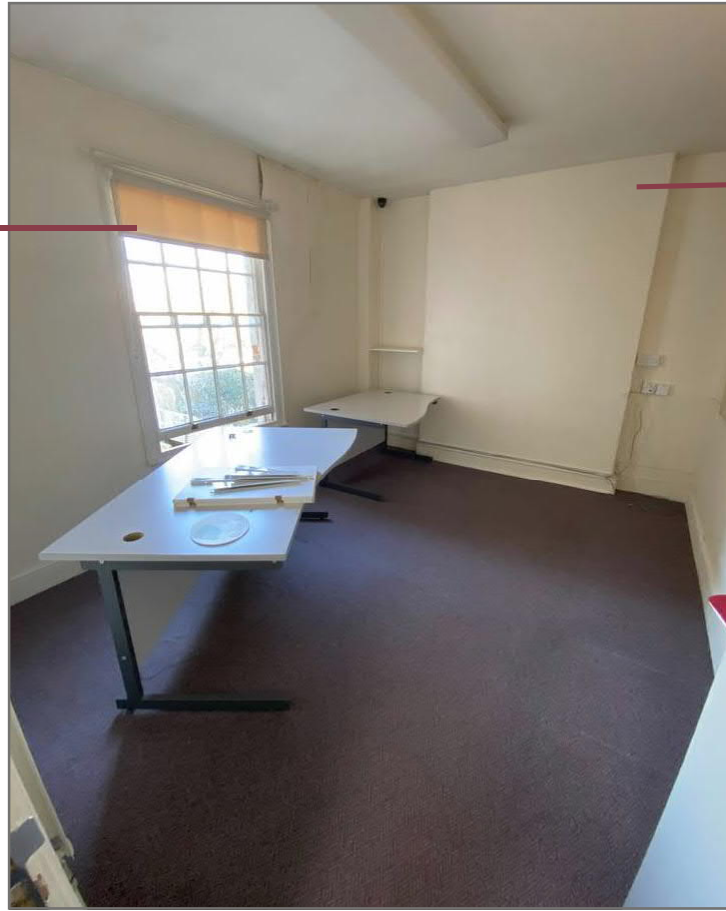
Image 39: First Floor east rear room (latterly Waiting Room)

Original sash window

Chimney breast

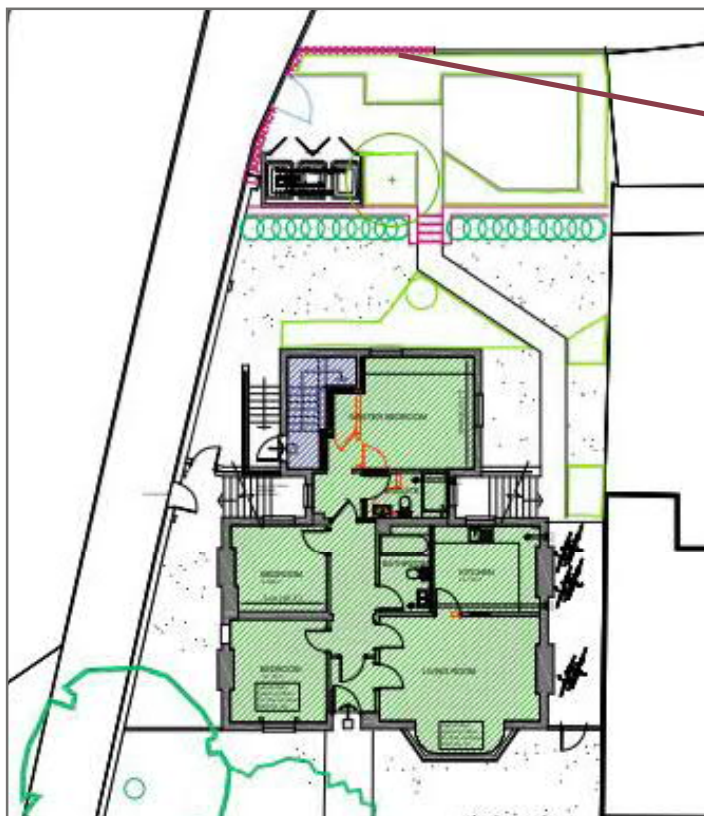
The proposal seeks to reinstate a plot boundary evident in the 1877 OS map (refer to Image 8a) which is considered an improvement to both the boundary within the conservation area, and to the setting of the property, and that of No.3 Christchurch Road as viewed from Highgrove Street.

Site boundary reinstated as per the 1877 plot

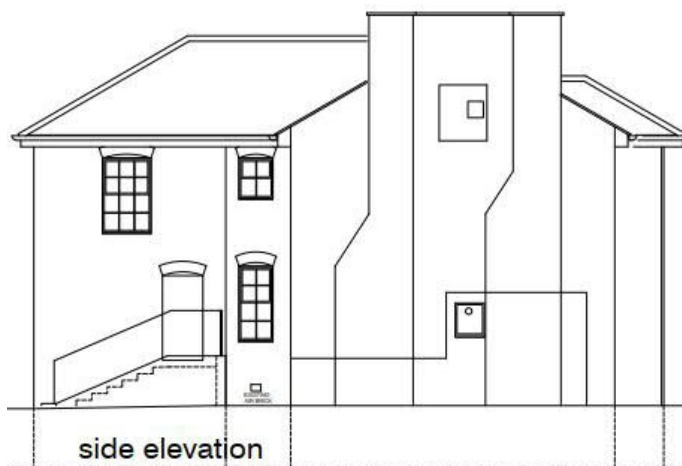
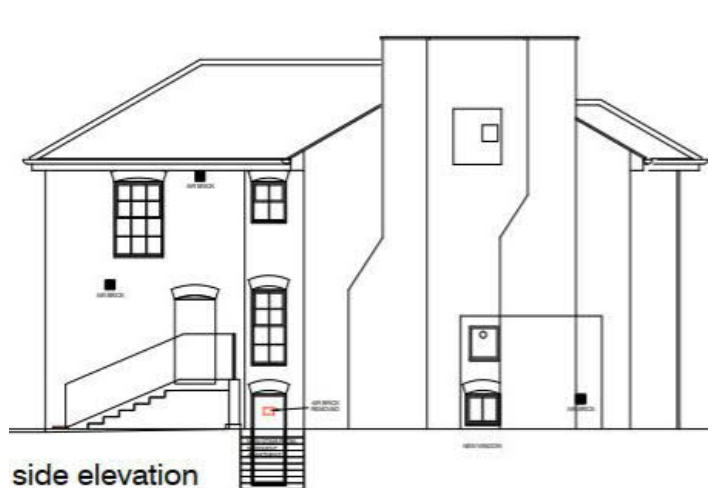
Image 49b: Proposed Side (West) Elevation

The proposed windows to the west side elevation (refer to Images 49a and b) and the east side elevation (Images 50a and b), similarly as per the rear elevation, take their architectural detail design cues from the existing windows, and are located discretely.
