McLaren (Broad Street Mall) Ltd and UREF III LP

# Broad Street Mall, Broad Street, Reading, RG1 7QE

Phase 1 Desk Study

1922703 R01 (03)

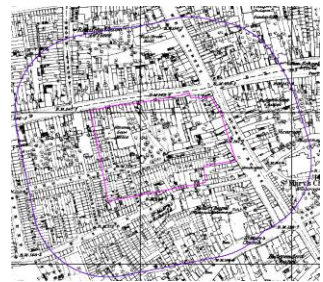
| Date from | Date to | Historical Land Use (on-site) | Area of site |
|---|---|---|---|
| 1879 | 1898 | The site is already heavily developed by 1879, with buildings covering approximately 90% of the area. The buildings appear to be residential housing, however there is a building named Steam Saw Mill located in the north west of the site. In the centre of the site there is an outside area containing trees which may be a courtyard. Hope Street enters the site in the south west. | |

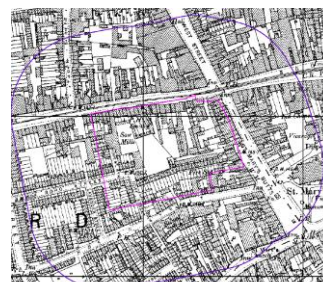
| Date from | Date to | Historical Land Use (on-site) | Area of site |
|---|---|---|---|
| 1899 | 1912 | There is a smithy and a public house located in the north of the site, and there is a Fire Station in the southeast of the site. | |

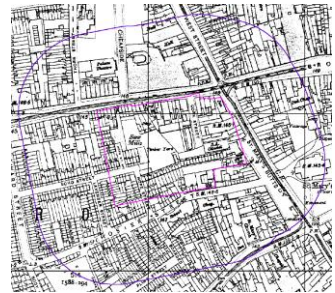
| Date from | Date to | Historical Land Use (on-site) | Area of site |
|---|---|---|---|
| 1912 | | Saw Mills still remain in the north west corner of the site, but there is now a timber yard labelled in what was previously the courtyard area. A road named Cork Street now exists in the north east of the site. In the west of the site there is a building labelled as a Salvation Army Citadel. | |

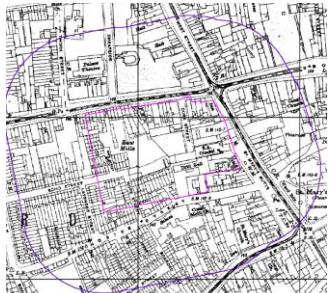
| Date from | Date to | Historical Land Use (on-site) | Area of site |
|---|---|---|---|
| 1931 | | The Timber Yard no longer appears on the site. Drill Hall is labelled in the southeast of the site, although it is unclear whether this is an industrial building, it may be a shooting hall. There is an Inn in the northeast corner of the site. | |

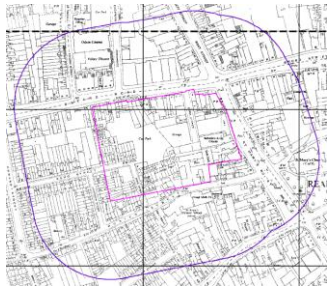
| Date from | Date to | Historical Land Use (on-site) | Area of site |
|---|---|---|---|
| 1957 | | Over time the site has become less occupied with housing and more occupied with commercial and amenity space. Saw Mills is no longer labelled on the site, and a large space in the centre-west of the site is now a car park. There is a garage in the east of the site, and there is a ruin in the southeast. | |

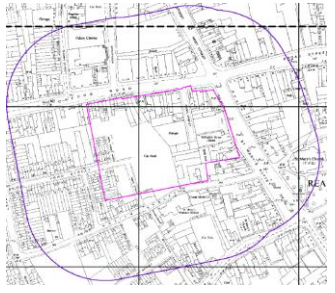
| Date from | Date to | Historical Land Use (on-site) | Area of site |
|---|---|---|---|
| 1962 | | Buildings in the south of the site have been demolished and the car park has been extended. | |

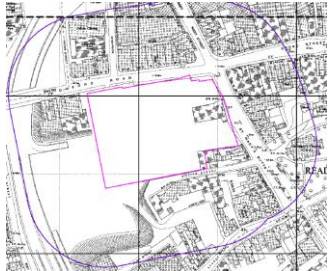
| Date from | Date to | Historical Land Use (on-site) | Area of site |
|---|---|---|---|
| 1970 | | By 1970 all of the pre-existing buildings on the site (bar one) had been demolished and the site appears almost entirely unoccupied. | |

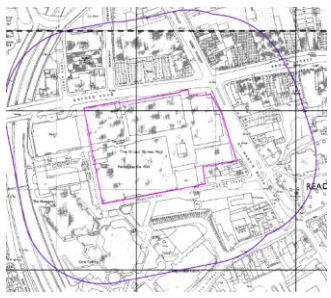
| Date from | Date to | Historical Land Use (on-site) | Area of site |
|---|---|---|---|
| 1980 | | There is now a labelled multistorey car park on the site, and the building located in the south of the site is labelled as a public house. Fountain House has been constructed in the west of the site. | |
