Project:  
**15 Castle Street  
RG1 7SB**  
Drawing:  
**Site Location Plan As  
Proposed**

Project:  
15 Castle Street  
RG1 7SB

Drawing:  
Floor Plans As Proposed

Drawing:  
**Front Elevation As  
Proposed**

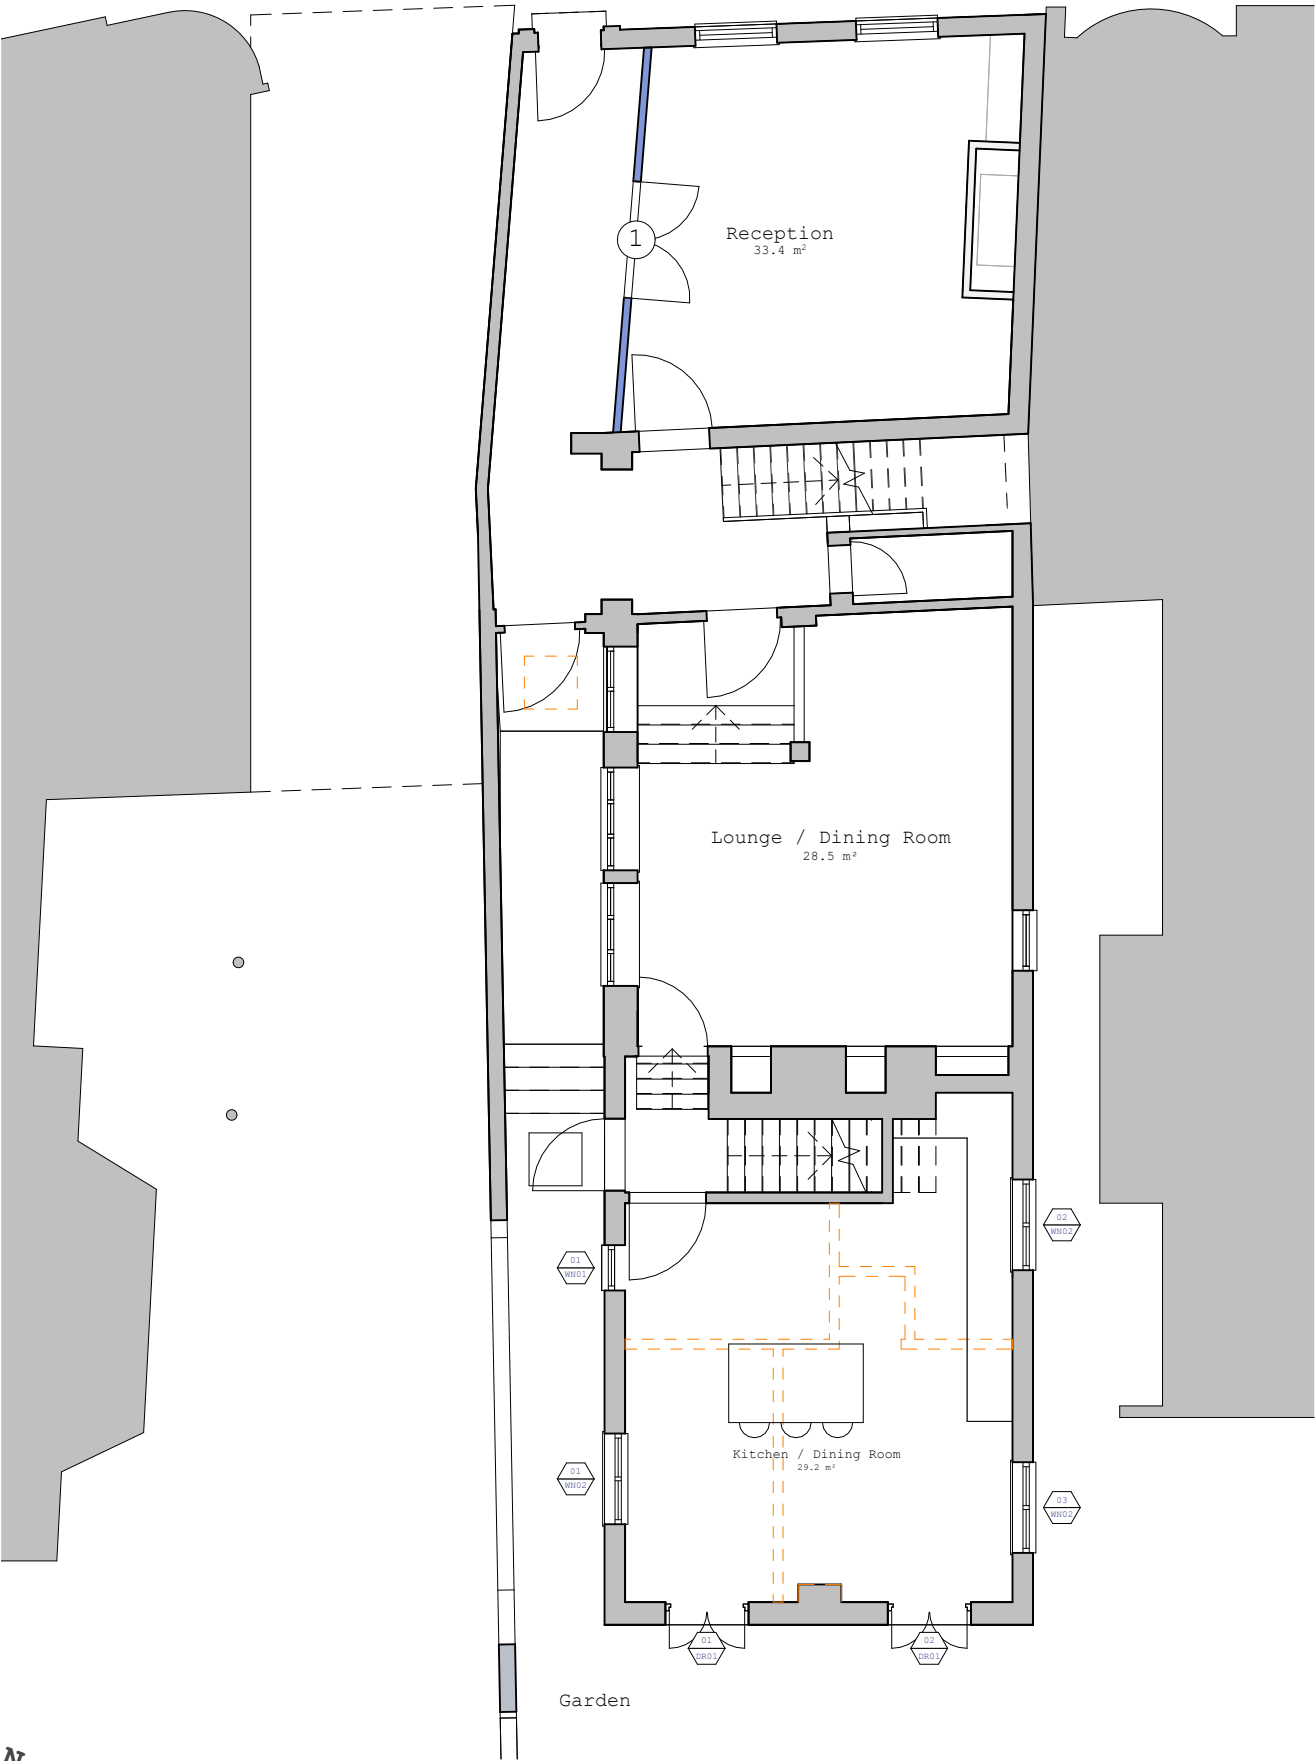
Ground Floor Plan

Front portion of existing building is a fine double-fronted Tudor building fronting Castle Street: HIGH SIGNIFICANCE

Central portion of existing building was renovated extensively in the 1980s with modern fabric and unsympathetic connections to the oldest parts: LIMITED / NO SIGNIFICANCE

Rear portion of existing building is an extension built in 1982: NO SIGNIFICANCE

- Consent given under PL/24/0061 application for internal alterations to create new hallway and floor repairs. Not yet constructed. Expiry date for this application is 06/08/27
- The installation of the stud wall and tiled bathroom wall finish is to be made with preservation of historic fabric as a priority. The current space where the bathroom is to be created has a modern wall and the proposals do not affect the historic fabric behind it

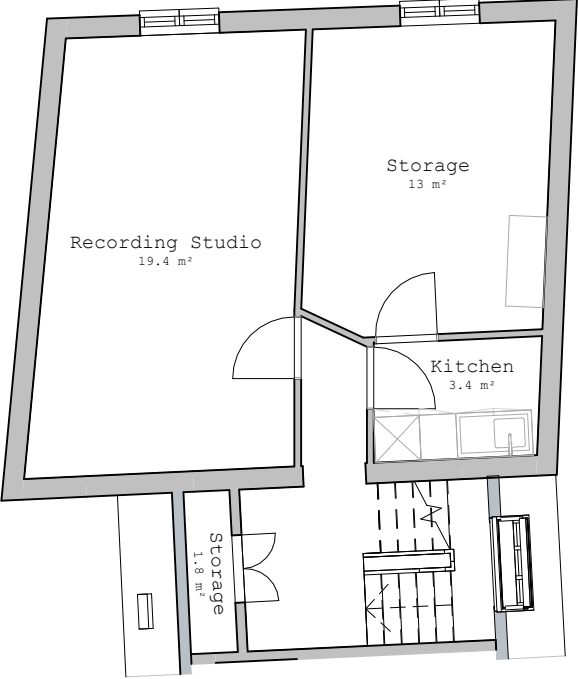
Second Floor Plan

Replacement doors and windows to be timber frame fenestration and the latter to be double glazed

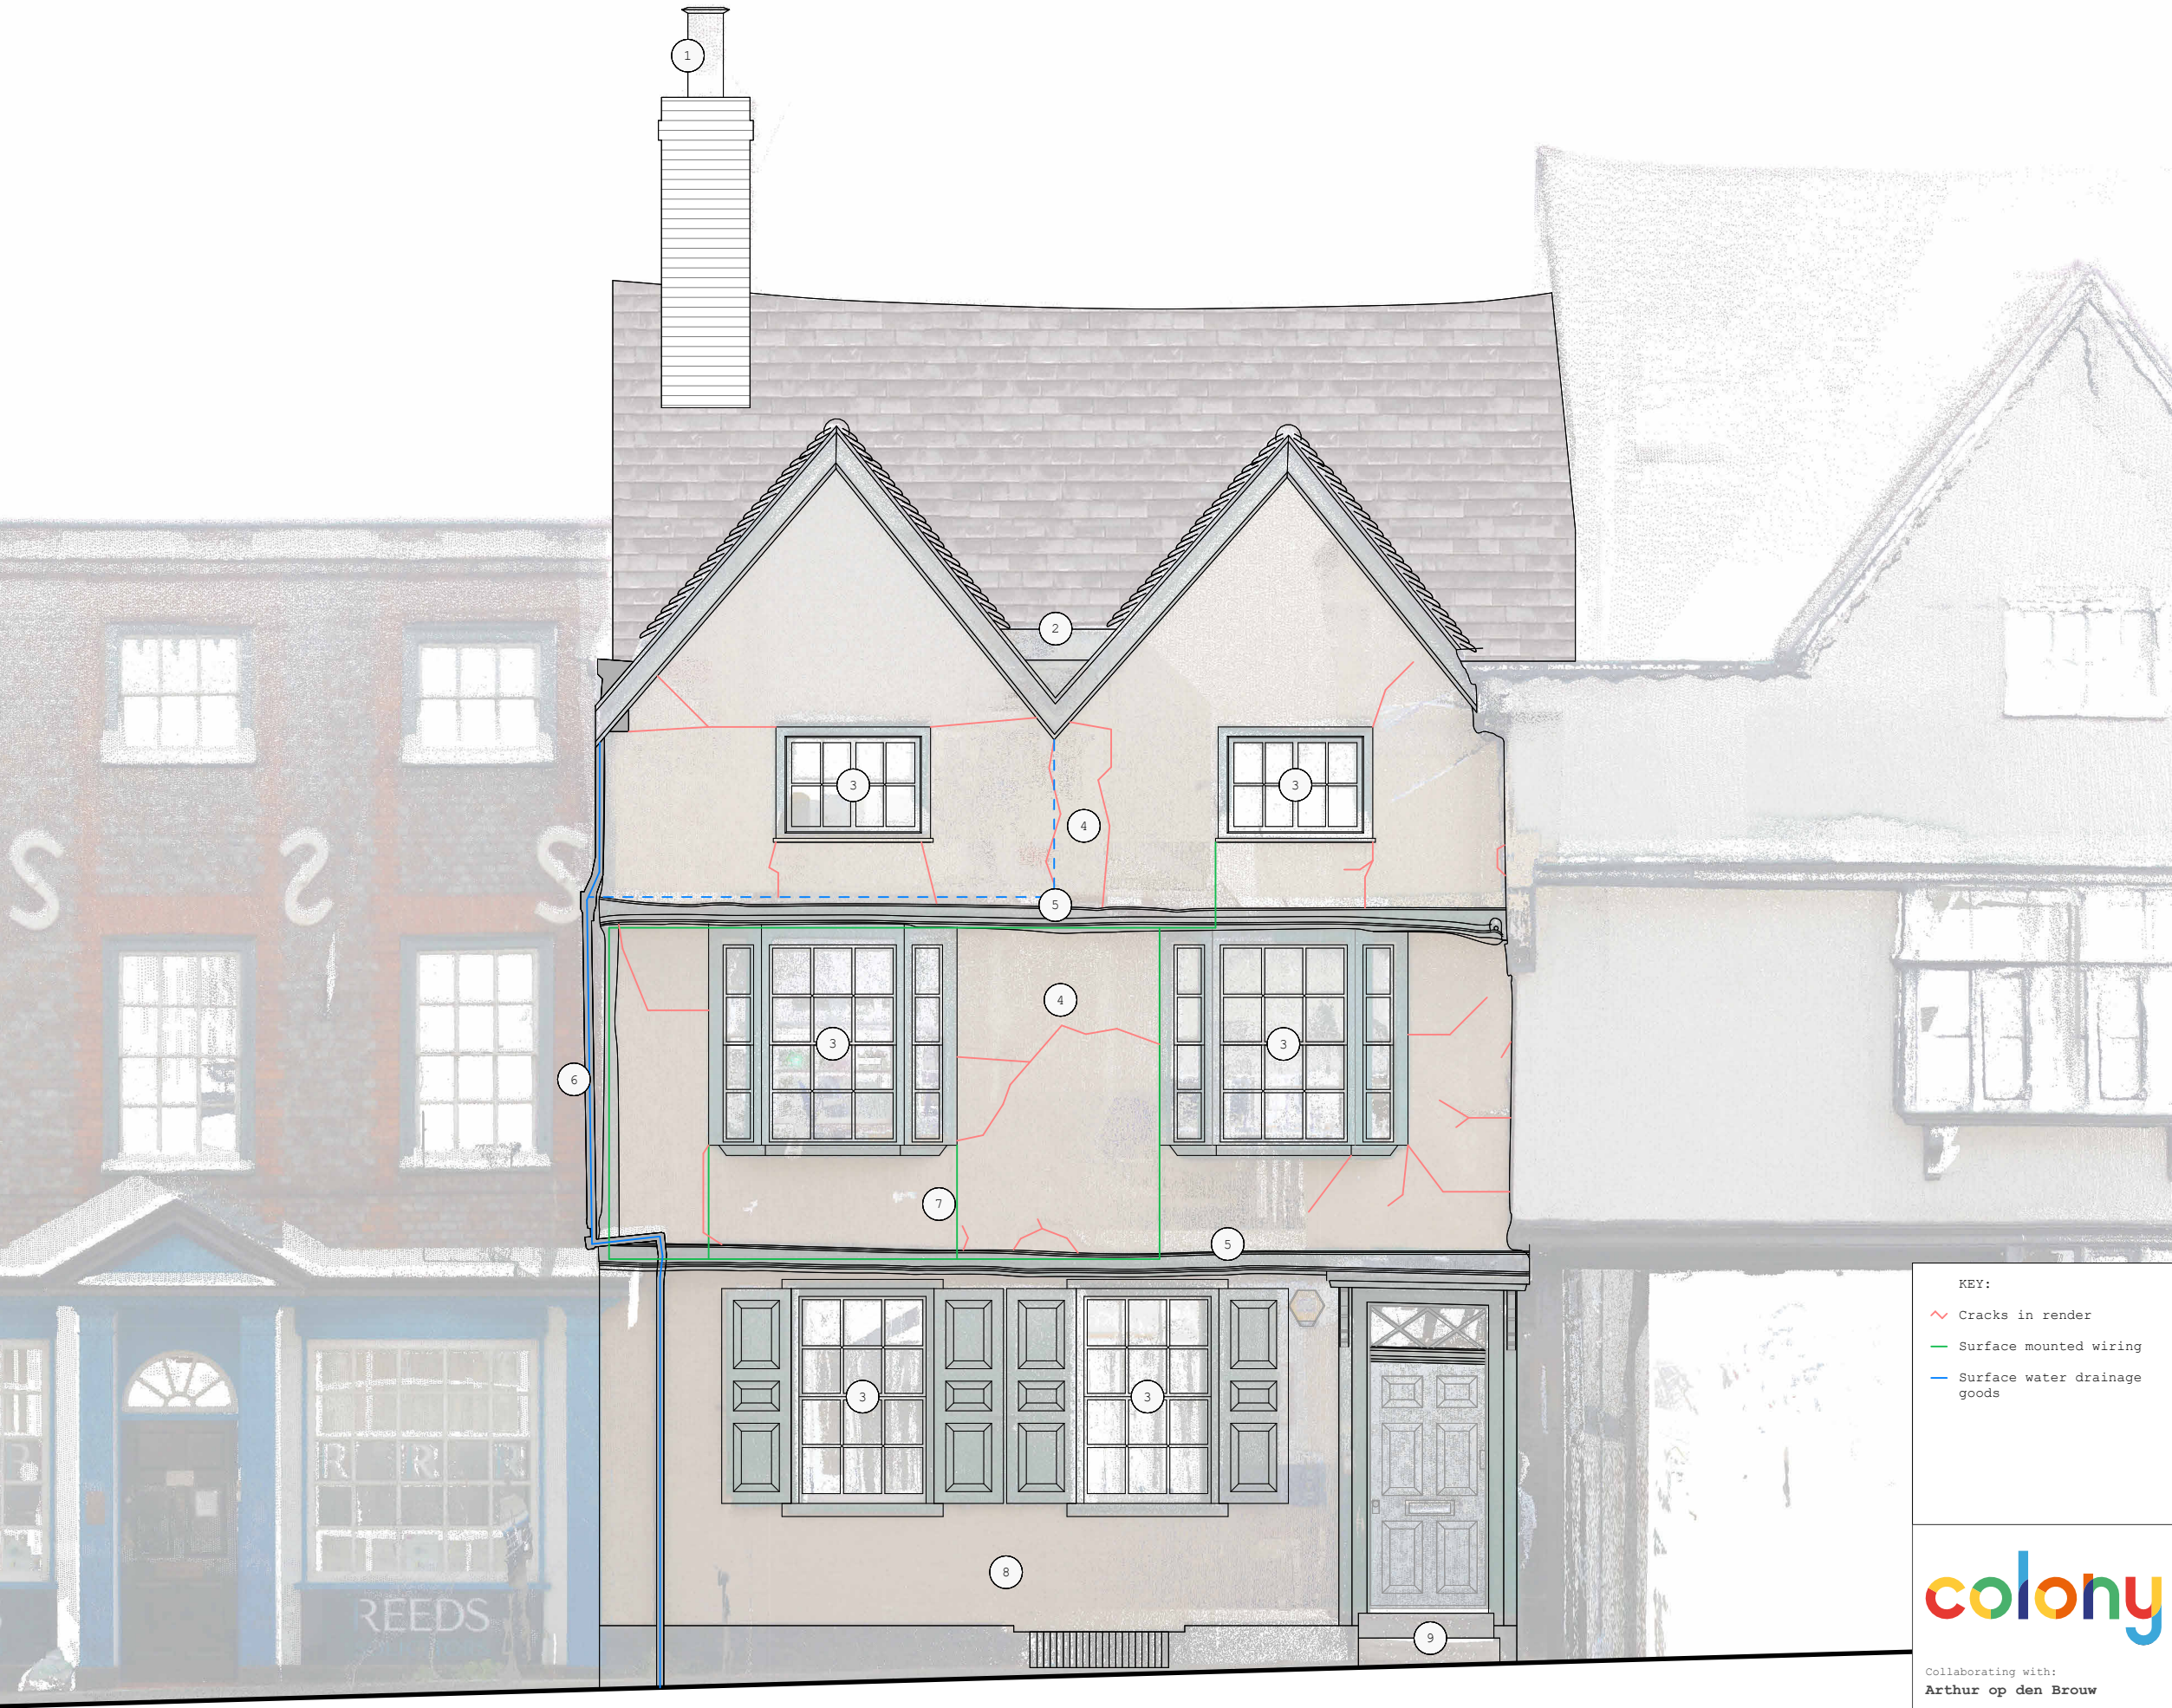
- 1 REMOVE VEGETATION**  
Check chimney and roof for any vegetation taking hold and remove and check for damage. Make good any repairs.
- 2 ROOF REPAIRS**  
Existing leadwork has been historically repaired and this repair may have failed. Area to be inspected for broken tiles and leadwork inspected for cause of water ingress. If necessary, leadwork to be replaced. Underlying substrate to be inspected for signs of damp and rot and replaced if necessary. Breathable construction/good ventilation to be maintained throughout.

- 3 REPAINTING OF TIMBERWORK**  
Window and door frames and shutters, as well as roof verges and horizontal timber beam cornices to be carefully stripped with heat gun and inspected for the need for repairs. Repainted in similar colour

- 4 REPAIR OF LIME RENDERED WALLS**  
Significant cracking and some delamination can be seen in the existing render from street level. Full extent of existing plaster to be tested for soundness and removed if at risk of coming away from substrate. Areas that are in good condition but have started to come away to be pinned back to lathes with stainless steel screws, 40mm mesh squares and 25mm washers. Patch repairs to be undertaken with lime render in a mix with additives to match that found in the existing render being removed. If condition of whole rendered surface is found to be poor (this is not expected), all render to be removed and lathes/substrate checked for soundness and replaced like-for-like as necessary. It is not anticipated that structural timbers will be affected.

- 5 REPAIRS TO TIMBERWORK**  
Evidence of historic deterioration of timber elements can be seen from street level. Areas to be inspected and tested for soundness of timber. Timber in poor condition to be cut away to expose good wood and appropriate hardwood fillets fitted as patch repairs. Should any timber elements show significant rot and a patch repair would not suffice, said element should be replaced in full, using same-species material and respecting existing joints and techniques.

- 6 SURFACE WATER DRAINAGE**  
All rainwater goods assessed for continuity and effectiveness. If condition of overall system is insufficient, it should be replaced wholesale with metal rainwater goods in a 'cast-iron appearance' style. Rainwater goods to be painted black at ground floor and cream at first and second floor. It is understood the central valley drains along a pipe enclosed in the external wall as shown dotted. This should be inspected and recorded during the replastering work (if possible without material damage) with repairs made at junctions if there are any signs of leaks. Internal pipe to be lagged if space permits with breathable material.

- 7 SURFACE MOUNTING WIRING**  
Redundant wiring removed and nail holes made good.
- 8 REPAINTING OF BRICKWORK WALLS**  
Existing brickwork walls have been painted in a non-breathable paint. It is likely that the removal of this paint may cause some damage to the substrate. A small inconspicuous patch should be tested and if the paint can be removed without damage to the brickwork beneath it should be stripped back carefully with chemical and/or low pressure water. Whether stripped or cleaned, the wall should be repainted in a colour to match render over. If paint is stripped, lime-based breathable paint must be used.

- 9 STONE STEP RE-LAID**  
Existing stone step has shifted due to poor foundation. Existing stone to be taken up and re-laid on solid footing so it sits level to ground.

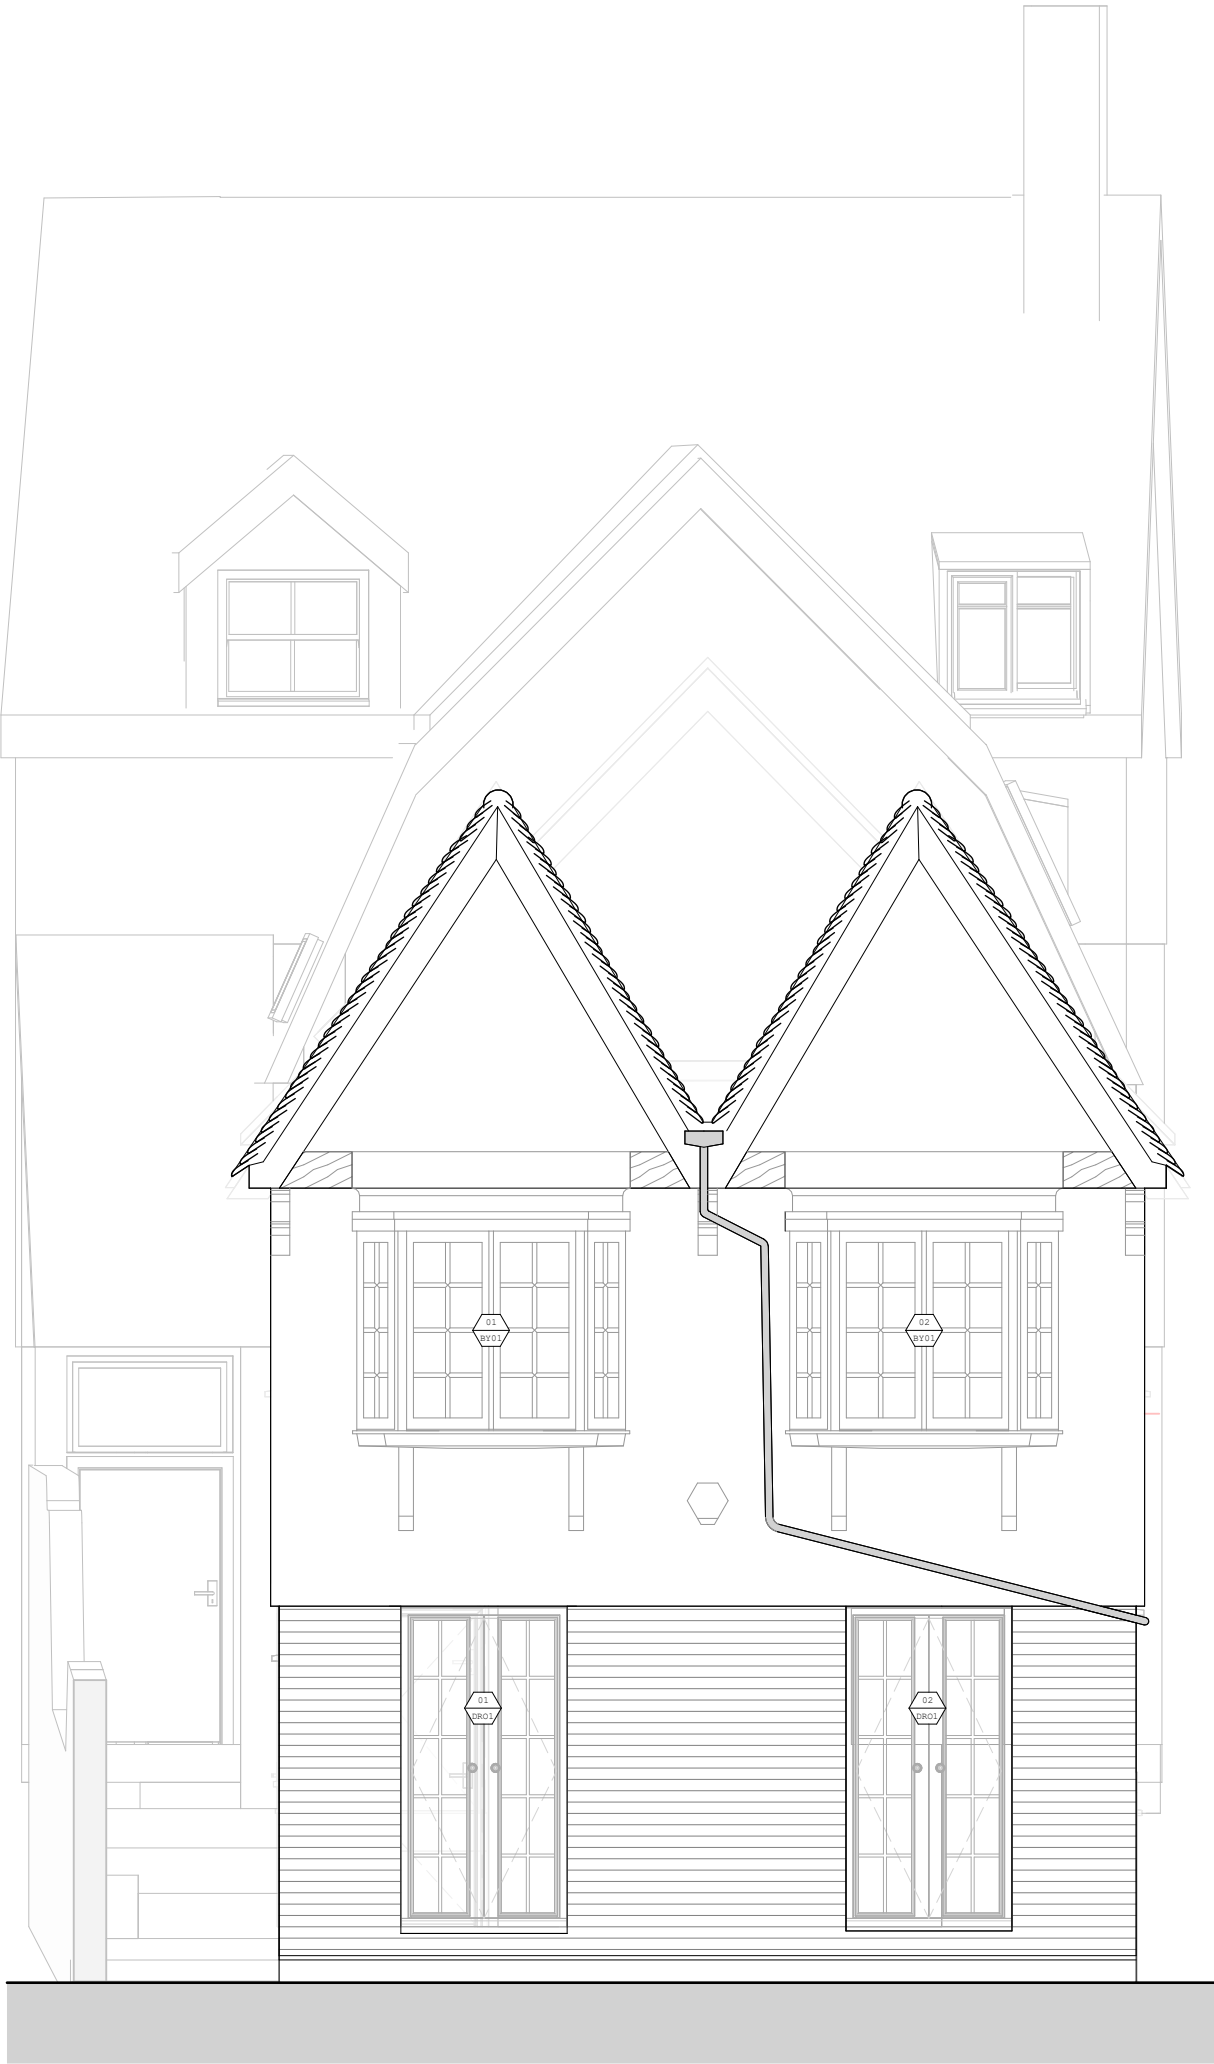
Replacement doors and windows to be timber frame fenestration and the latter to be double glazed

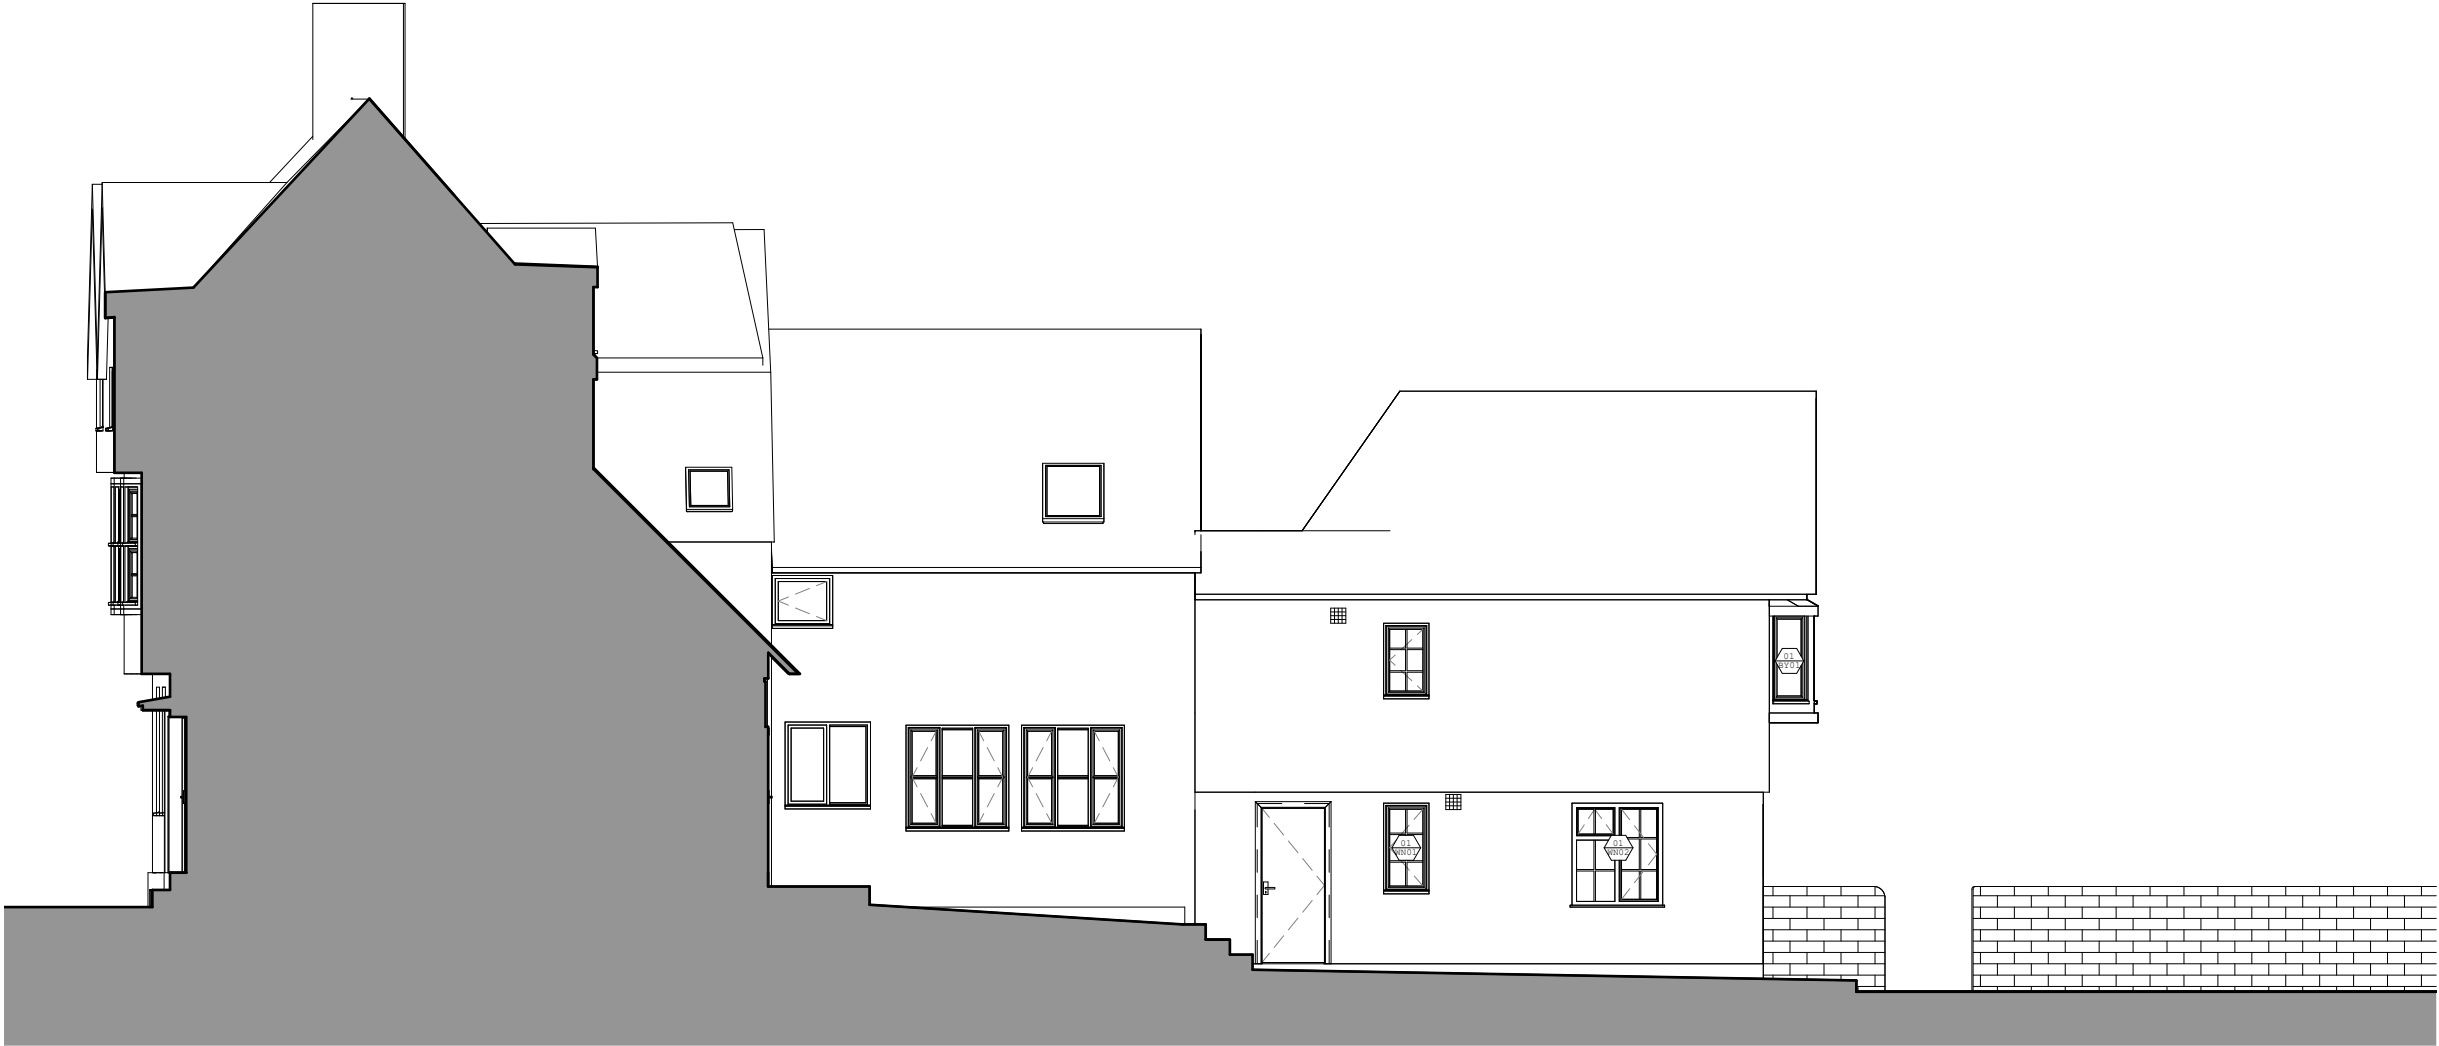
Extract fan grilles to be white coloured and are located in modern fabric, therefore having no impact on historic construction

Replacement doors and windows to be timber frame fenestration and the latter to be double glazed

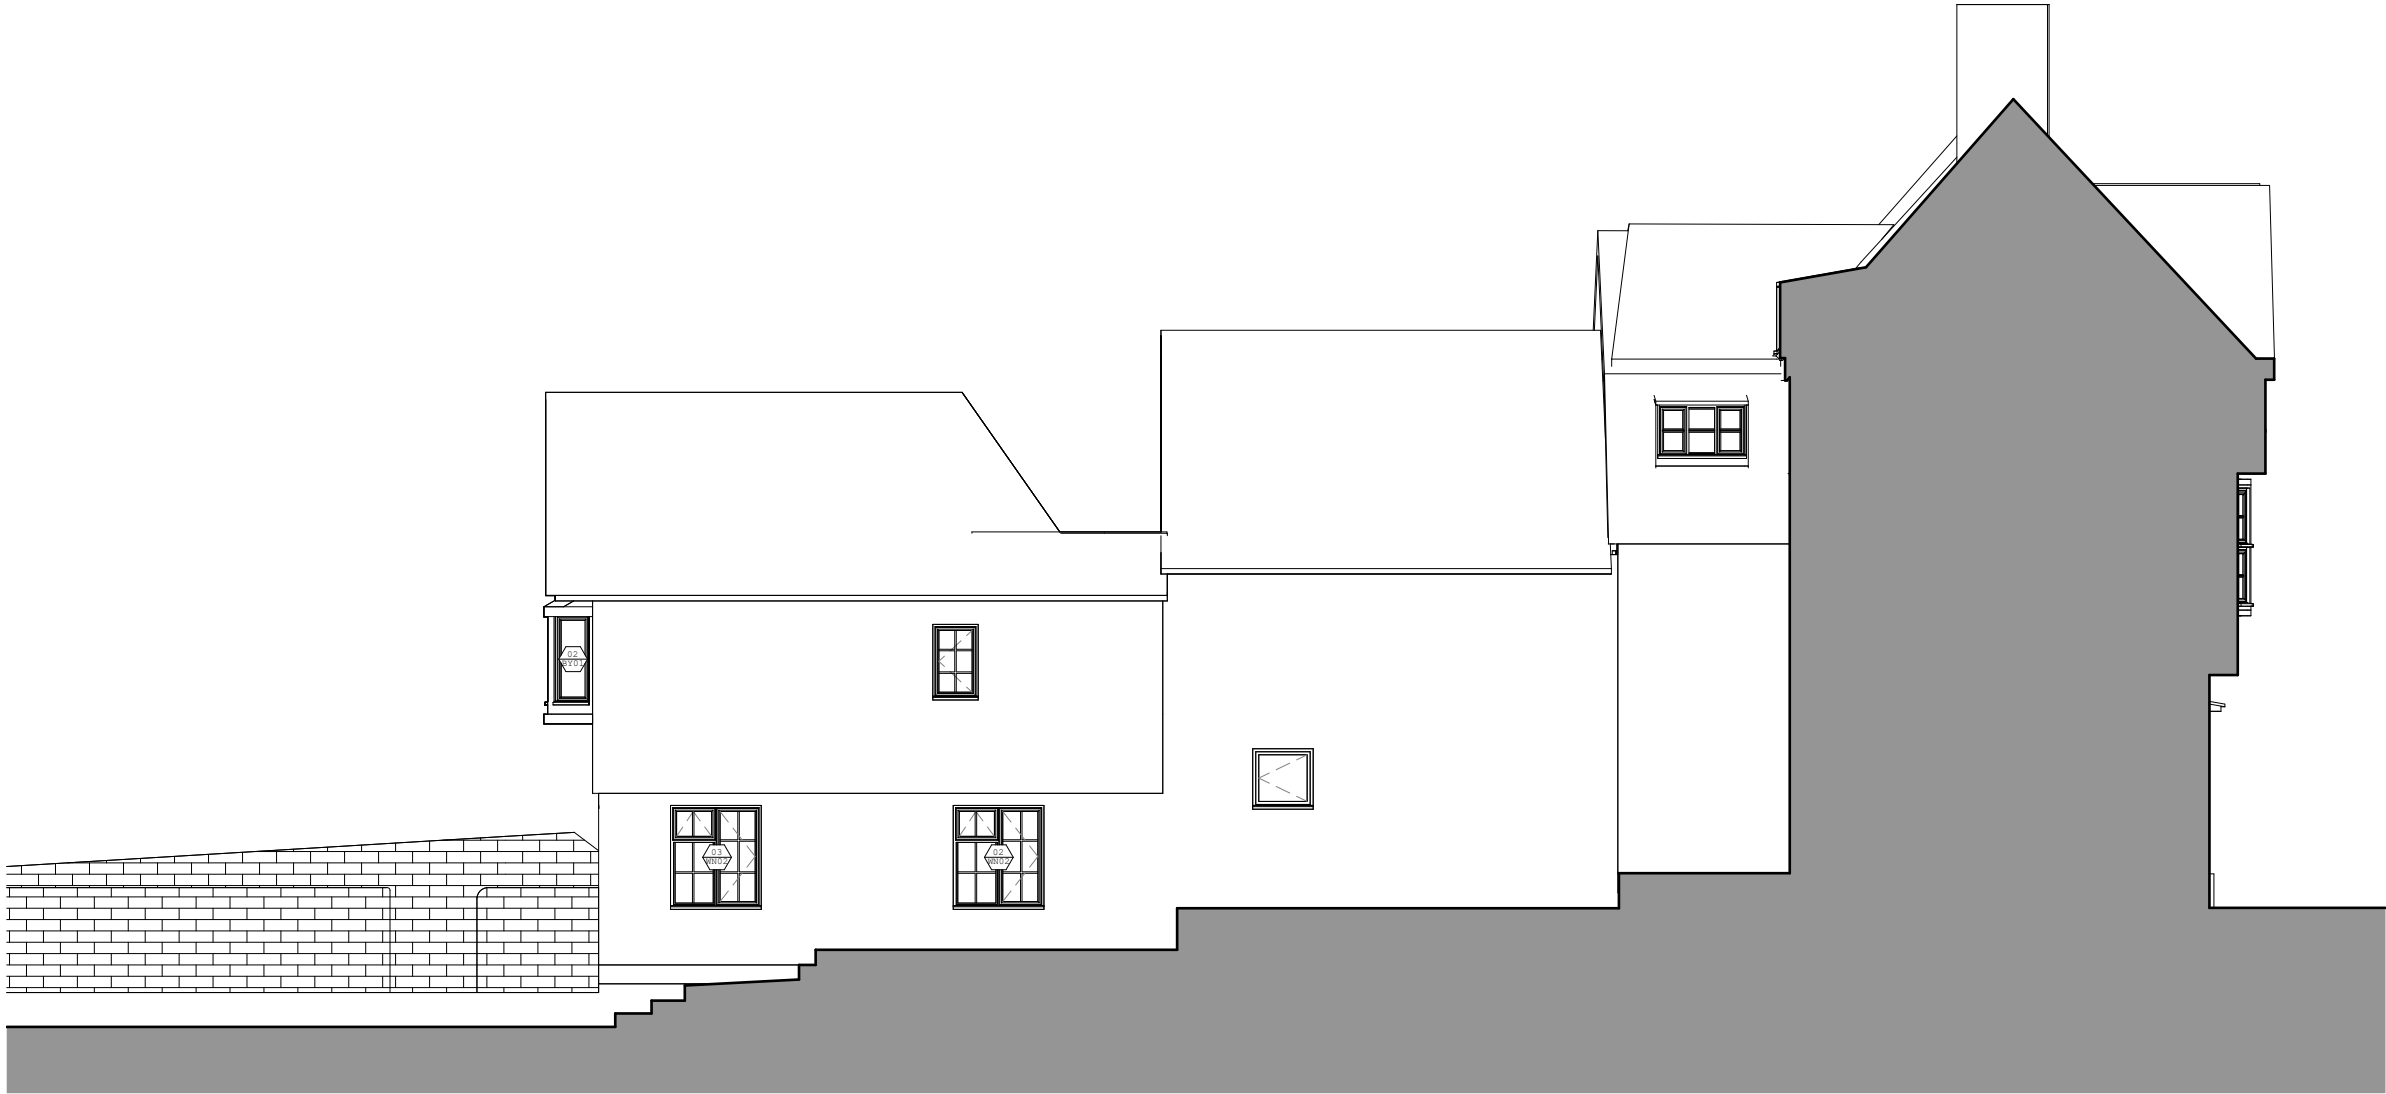
Replacement doors and windows to be timber frame  
fenestration and the latter to be double glazed
