## Preliminary Roost Assessment

3 Downshire Square, Reading, RG1 6NJ

This report is prepared to inform a planning application with Reading Borough Council. This proposal can be described as "Single storey extension to rear, loft conversion, studio unit in rear of garden"

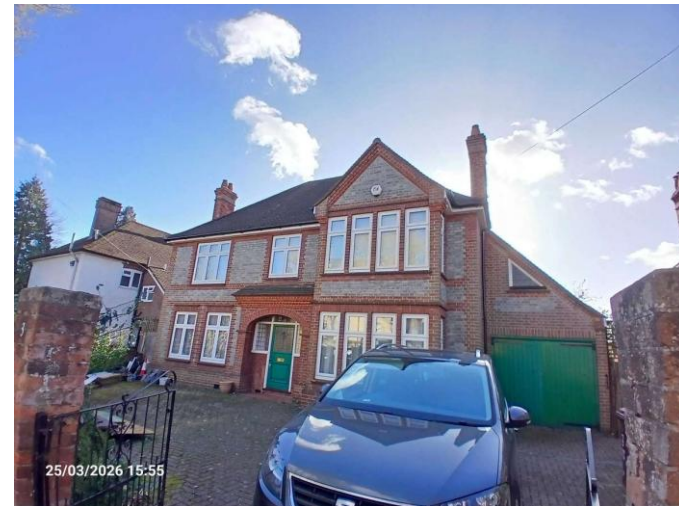
*B1 - eastern elevation*

B1 is a two-storey, detached, brick-built dwelling. The main roof is hipped and constructed of tiles, recorded in good condition with an intact covering and no apparent gaps. The windows, eaves, walls and chimneys were also observed to be in good condition with no significant signs of wear. Internal voids were recorded within the building. No evidence of bats was found during the survey.

In line with Good Practice Guidelines (Collins, J (Ed) 2023), B1 is assessed to have negligible habitat value for roosting bats due to a lack of suitable features for roosting bats.

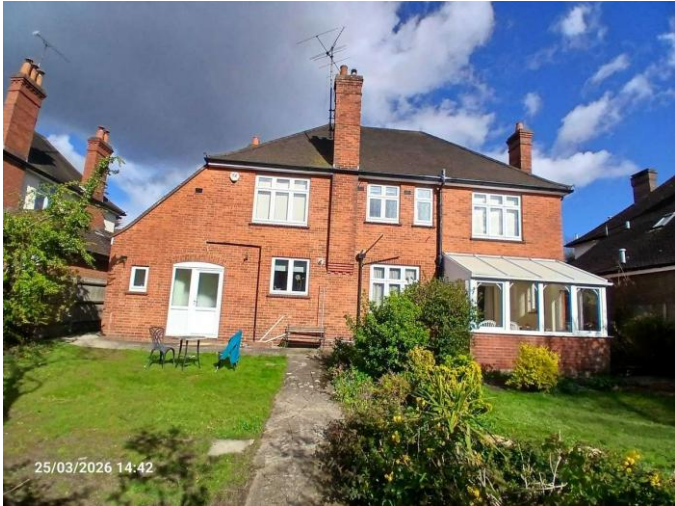
| | | | <p>25/03/2026 14:42</p> <p>B1 - western elevation</p> |

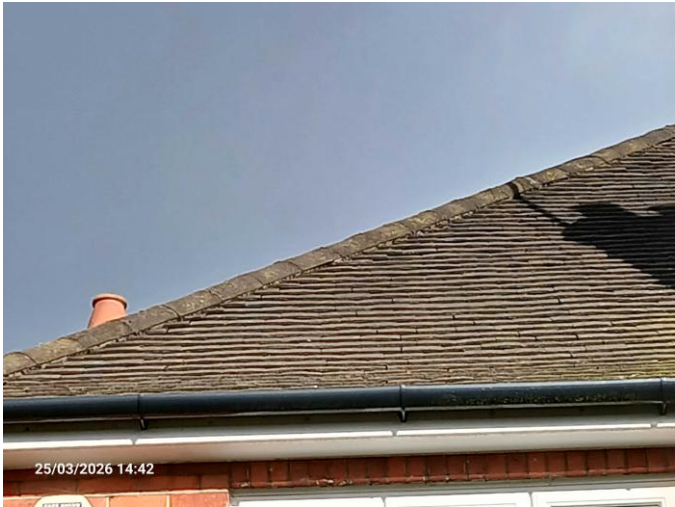
| | | | <p>25/03/2026 14:42</p> <p>B1 - western elevation</p> |
|---|---|---|---|
| Roof | Tiles | The roof tiles were observed to be in good condition with no lifted or missing tiles. | <p>25/03/2026 14:42</p> |

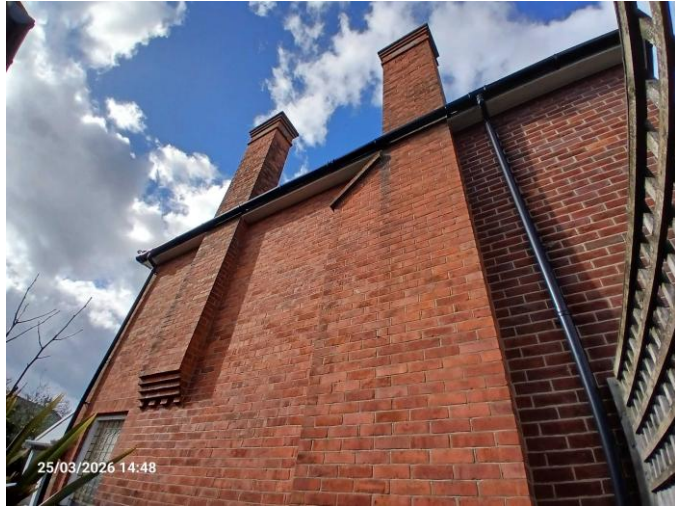
| | Walls | Brick-built | The brickwork was observed to be in good condition with no cracks or missing mortar. | | |

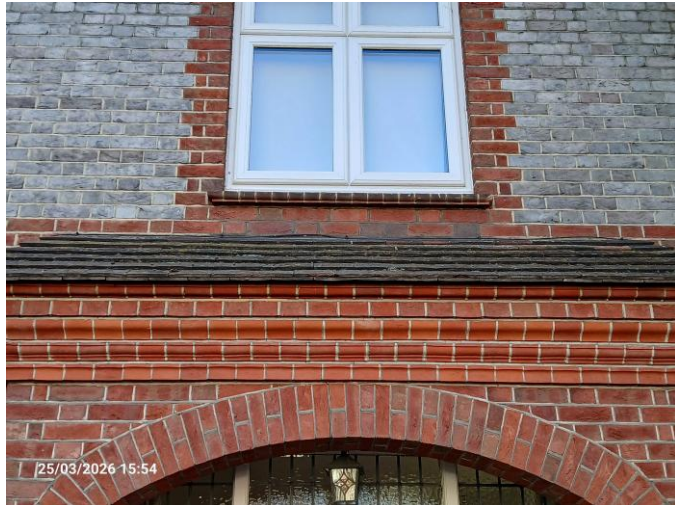
| | Windows | PVC | The windows and doors were observed to be in good condition, fully sealed with no gaps. | | |

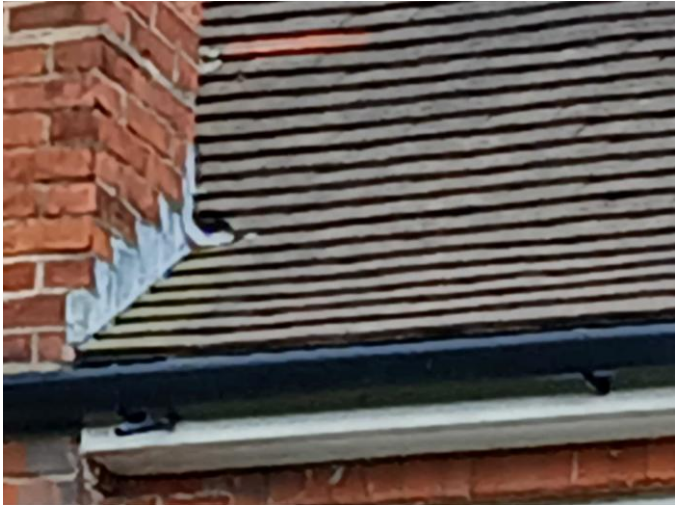
| | Eaves | PVC | The eaves were observed to be in good condition with no gaps or damage. | | |

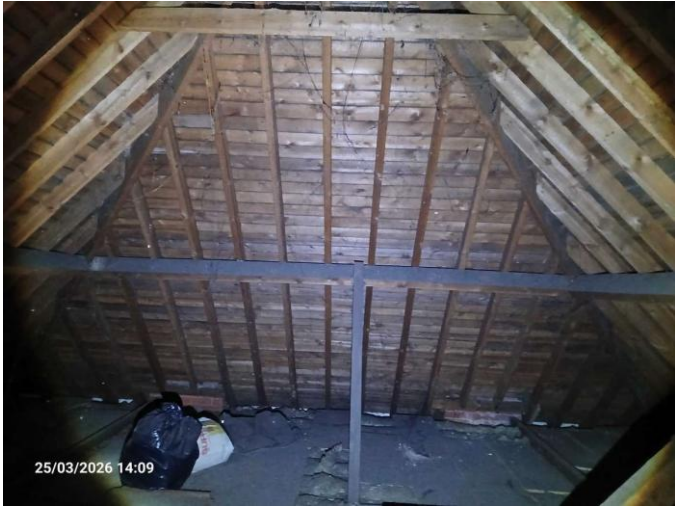
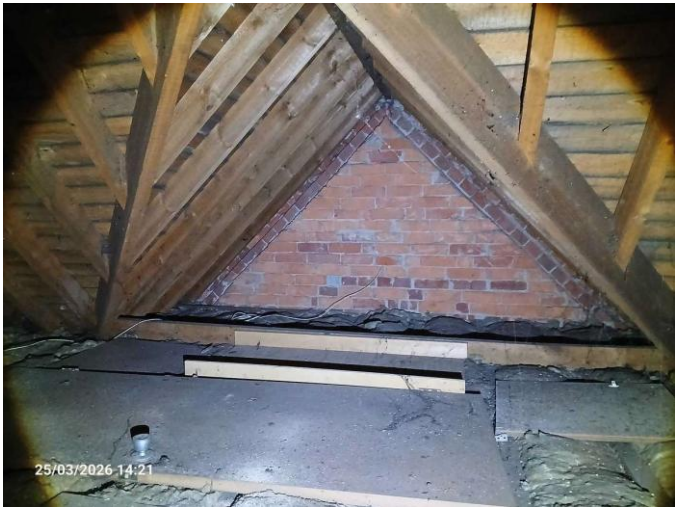
| | Voids | Timber planks | A void was recorded within B1, described as Loft 1. This void was accessible and was internally lined by timber planks. No specific roosting features or bat evidence were noted within this void. | <p data-bbox="1543 1251 1615 1278">Loft 1</p> | |

| | | | | <p>25/03/2026 14:21</p> <p>Loft 1</p> | |

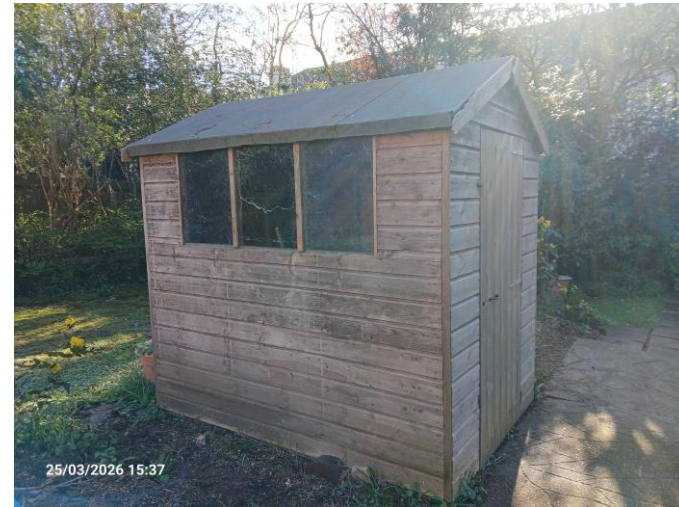
B2 is a single-storey, detached, timber garden shed. The main roof is gabled and lined with roofing felt, recorded in good condition with an intact covering and no apparent gaps. The windows, eaves and walls were constructed from timber and were also observed to be in good condition with no significant signs of wear. Internal voids were recorded within the building. No evidence of bats was found during the survey.

In line with Good Practice Guidelines (Collins, J (Ed) 2023), B2 is assessed to have negligible habitat value for roosting bats due to a lack of suitable features for roosting bats.
