## Phase II Site Investigation Report

220 Elgar Road South, Reading, RG2 0BW

On behalf of Abri

| Report Reference: GWPR6817/SIR/April 2026 | | | Status: Final |

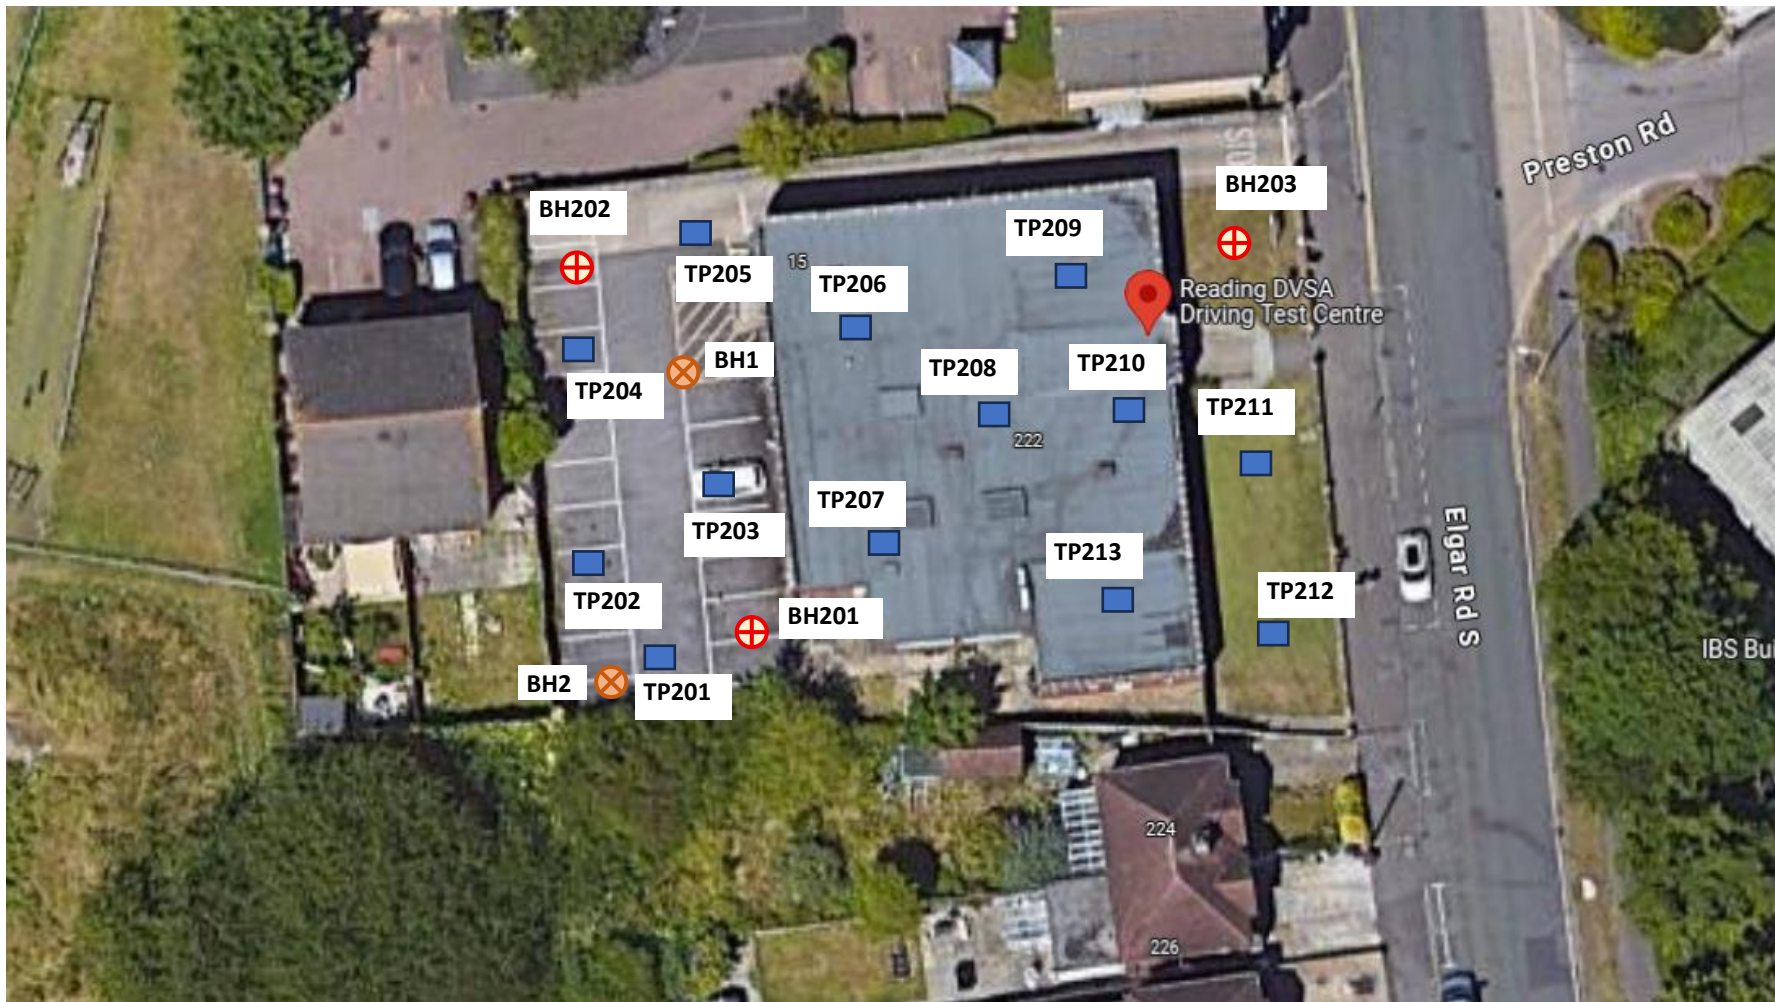
Figure 3B – GWPR6817 Trial Hole Location Plan

Site boundary

G&W SI Visit 1:
