## Preliminary Roost Assessment

4 Treforgan, Caversham, Reading, RG4 7XG

This report is prepared to inform a planning application with Reading Borough Council. This proposal can be described as a first-floor extension over the existing garage

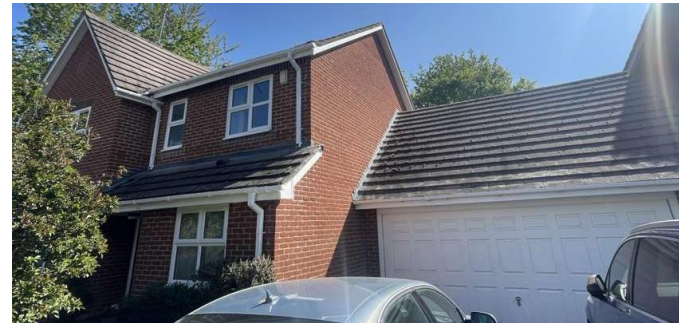
B1 is a two-storey, detached, brick-built dwelling. The building has a gabled roof constructed of concrete tiles, which are in relatively good condition, with a minor gap on the ridge. The brickwork around the building appears in excellent condition with no gaps or cracks within which crevice-dwelling bats could roost. There are UPVC soffits and bargeboards around the building which are in good condition. There is one chimney located on the northern elevation of the building. The brickwork on the chimney is in good condition. There is lead flashing around the base of the chimney, which is raised under one section. No bat evidence was found during the survey of this building.

*Southern and western elevations of B1*

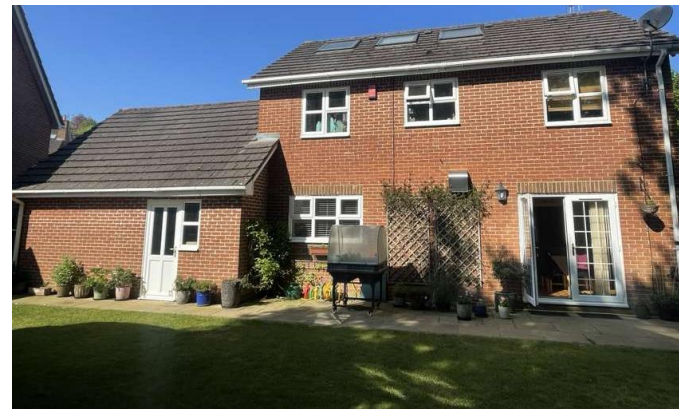
*Eastern elevation of B1*

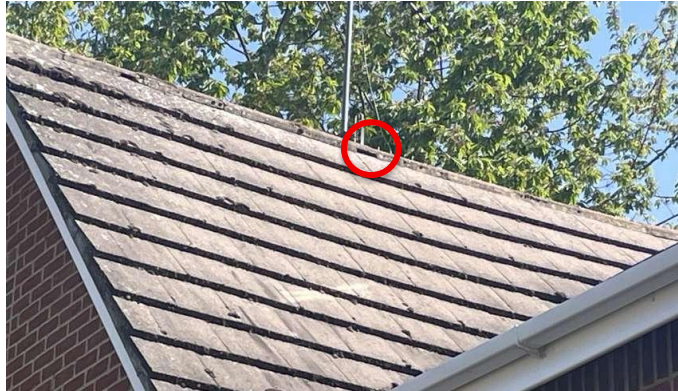
In line with Good Practice Guidelines (Collins, J (Ed) 2023), B1 is assessed to have low habitat value for roosting bats due to a missing section of mortar under a ridge tile and a raised section of lead flashing around the chimney.

| | Roof | Tiles | <p>The roof structure is gabled and constructed of concrete tiles. On the southern elevation of the front gable, a section of missing mortar under the ridge was identified, presenting a roosting feature for crevice dwelling bats. However, as the building lacks a main loft space, this feature is unlikely to be utilised by void-dwelling bat species.</p> | <p><i>Missing section of mortar under ridge on the southern elevation</i></p> | |

The proposed development will not affect any of the features that could be used by roosting bats which were noted on the building during the survey and therefore no impacts to bat roosts are anticipated.

In the unlikely event that a bat or evidence of bats is discovered during the development all work must stop and a bat licensed ecologist contacted for further advice.

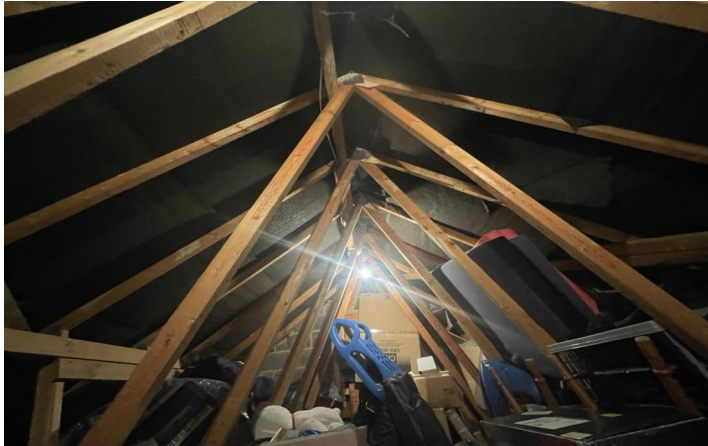
There are no loft spaces within B1 as the loft has been previously converted into habitable accommodation and the roof above the garage is vaulted.

| | Voids | | <p>There are no loft spaces within B1 as the loft has been previously converted into habitable accommodation and the roof above the garage is vaulted. The roof within the garage is built from modern timber beams and has no ridge beam. The roof is lined with bitumen felt which is in good condition with no gaps or tears.</p> | <p><i>Roof space above the garage</i></p> | |

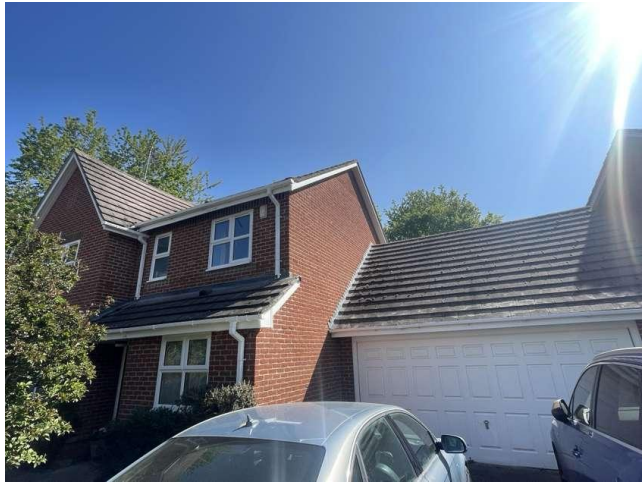
*Photo 1: Southern and western elevations of B1*

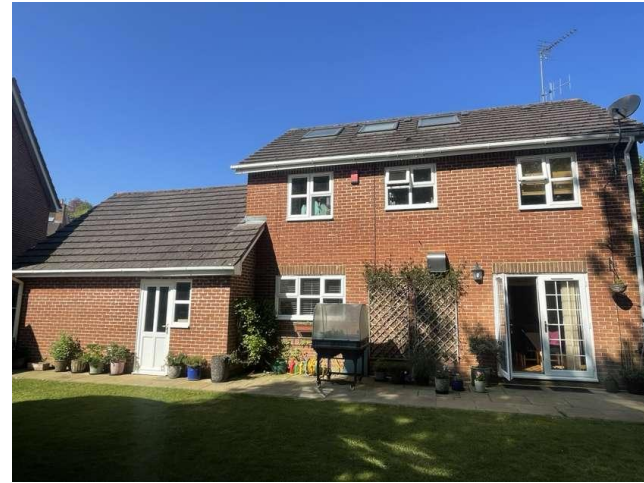
*Photo 2: Eastern elevation of B1*
