**GAZEBO, CAUSEWAY (RAISED WALKWAY), STABLE BLOCK COURTYARD WALL &  
GATE PIER, GATES & SCREEN WALL**

**CAVERSHAM COURT GARDENS  
CAVERSHAM  
READING**

**STRUCTURAL REPAIR AND CONSERVATION WORKS**

**HERITAGE STATEMENT**

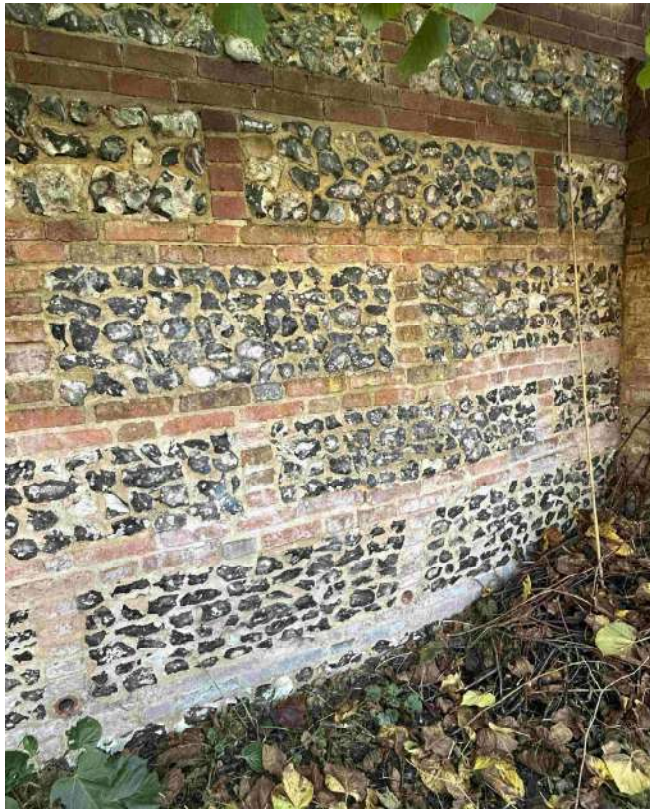
Raised Walk (Causeway) – west facing retaining wall towards the south end. View showing 'bulging brick and flintwork panel.

Generally, the retaining walls and parapets are in a satisfactory condition. However a bay between buttresses at the south end of the west retaining wall has bulging brick and flintwork indicating a possible structural defect that needs to be addressed.

Essential repairs to rectify defects in a section of flintwork to the face of the wall.

- Carry out investigations on site to determine the cause of the cracking of flintwork to the existing bulge in the west face of the west retaining wall.
- Excavate a trial pit to expose the concealed reverse face of the west retaining work to allow the brickwork wall to be inspected to determine condition and to specify any necessary repairs. Backfill and reinstate planting bed to former condition following the completion of the repair works.
- Dismantling and rebuilding of a Localised area of exposed flintwork to the west face of the west retaining wall incorporating new stainless steel ties.
- Localised repointing of flintwork and brickwork around the existing bulge in the wall.

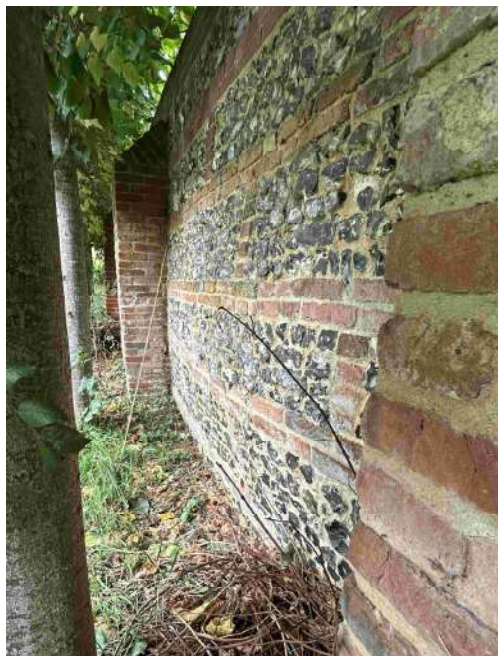
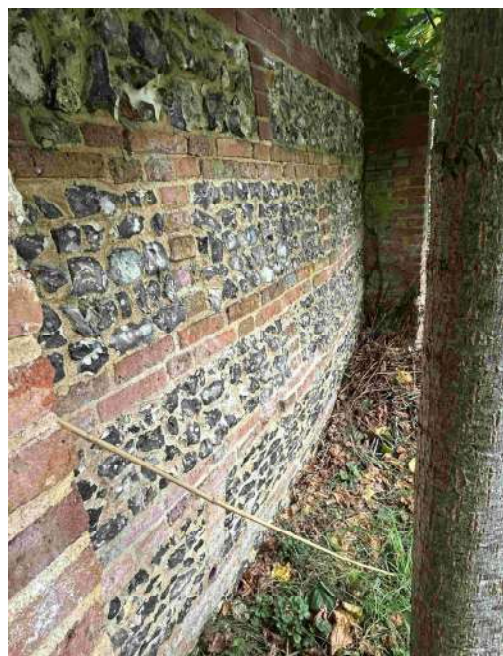
Raised Walk (Causeway) – west facing retaining wall towards the south end. Views showing 'bulging brick and flintwork panel.

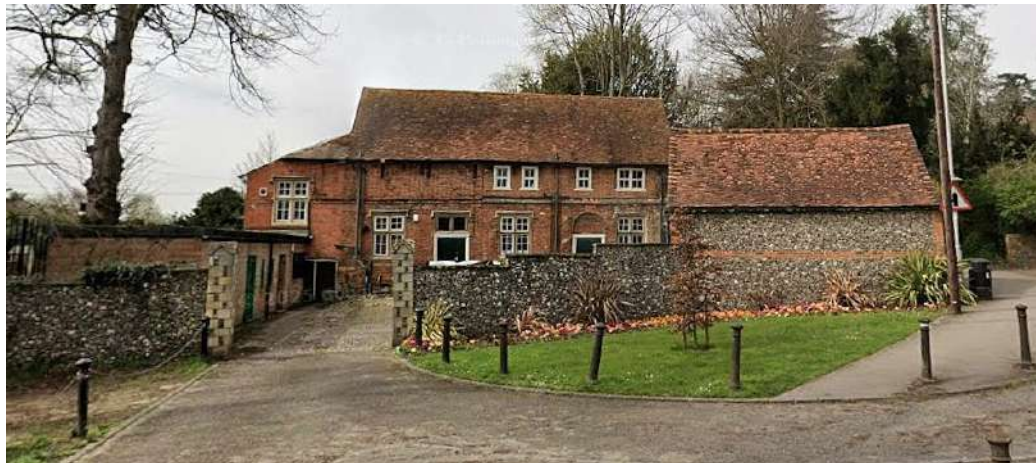
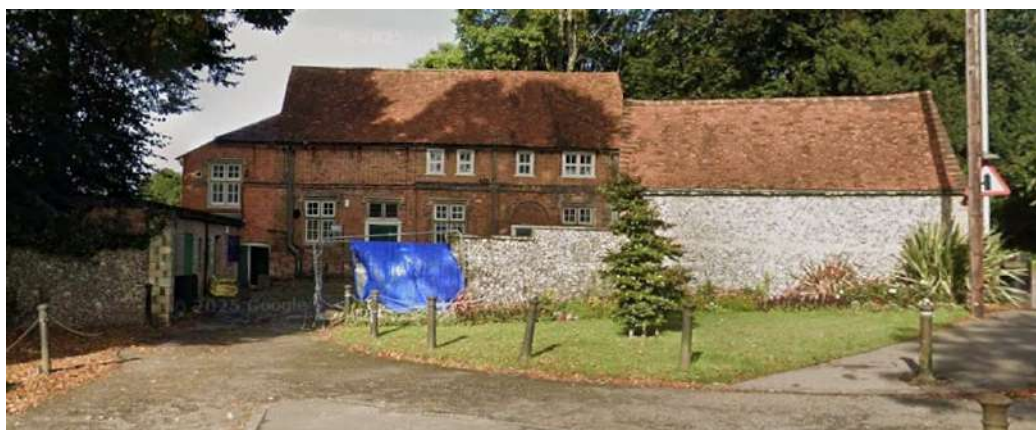
Stable Block – east boundary wall and gate piers before and after vehicle impact damage

Unfortunately, in 2024 part of the north wall and the corresponding north gate pier were hit by a vehicle and collapsed. Materials from the collapsed section of wall and gate pier were recovered and are currently stored in the stable courtyard.

Reinstatement of the stone and flint north gate pier and section of the north flintwork wall after these collapsed as the result of vehicle impact damage, along with essential associated adjacent repairs.

- Inspect and review the existing salvaged materials from the original wall retained on site.
- Repair and consolidation of the remaining north wall and base of the north gate pier retained in situ in readiness for the rebuilding of these elements.
- Rebuilding of the collapsed section to the north wall over the remains retained in situ using existing flints bedded and pointed in lime mortar to match existing on a like for like basis. Reinstatement of the coping stones to the wall.
- Rebuilding of the collapsed gate pier using the existing salvaged stones bedded and pointed in lime mortar to match existing on a like for like basis.
- Localised repointing of flintwork to the existing north and south walls.

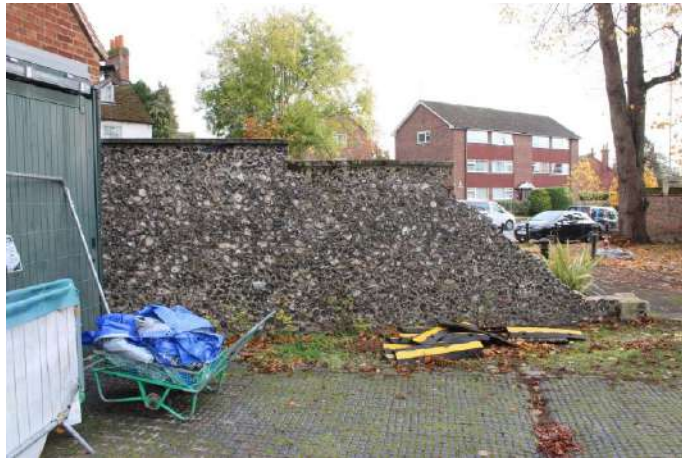
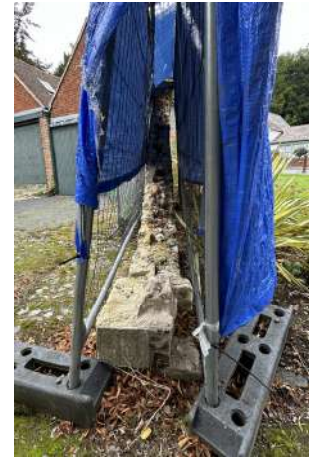
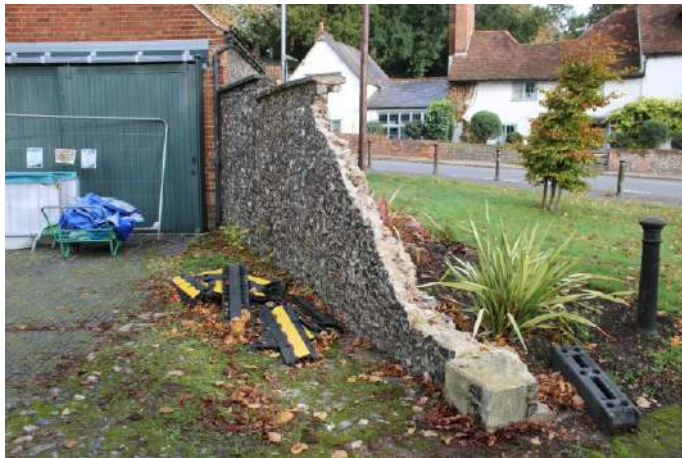
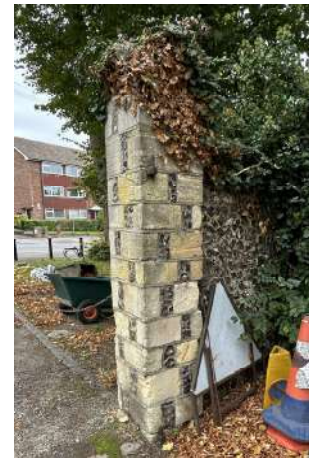
Stable Block – east boundary wall and gate piers after vehicle impact damage

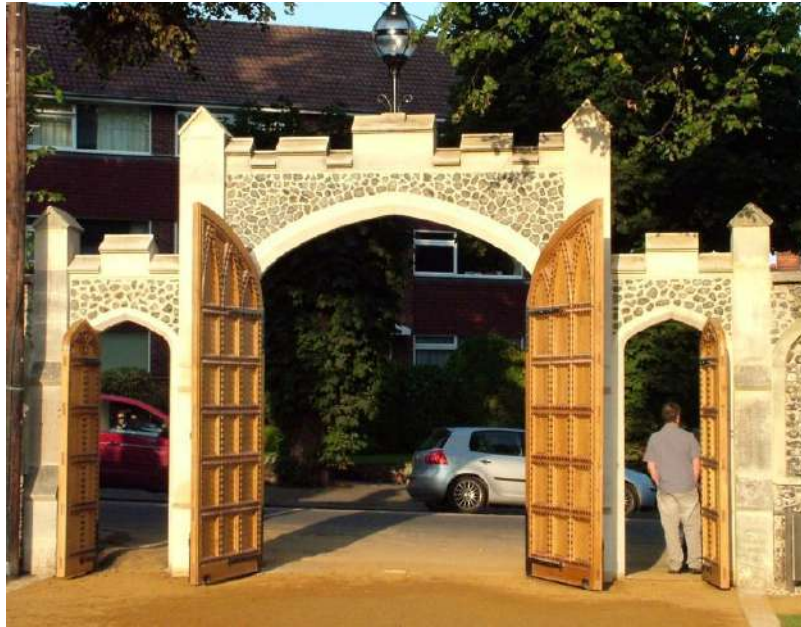
During the repair works carried out in 2008, the central double vehicular gates, along with the two side pedestrian gates, were replaced with new oak gates. Unfortunately, the central double vehicular gates were hit by a vehicle and destroyed in 2025. The impact also caused damage to the gate hinge pins and some minor surface cosmetic damage to the lower parts of the stonework reveals to the opening.

Eastern boundary (screen) wall (part): replacement double vehicular gates fitted in 2008.

New oak double gates to replace the existing that were destroyed as a result of vehicle impact damage, along with essential associated adjacent masonry repairs to damages stonework.

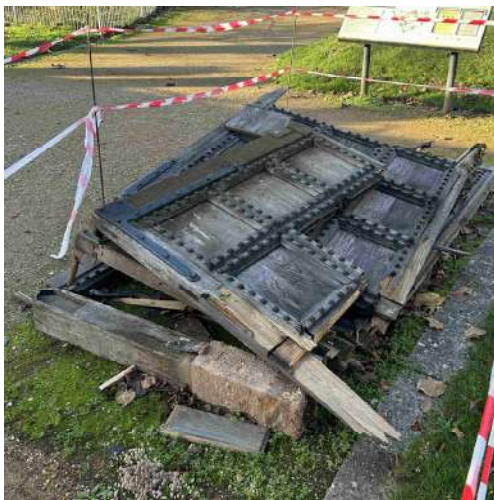
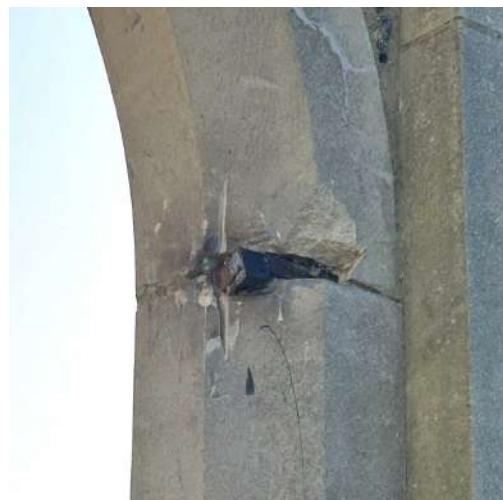
Eastern boundary (screen) wall (part): replacement double vehicular gates – destroyed gates and damage to gate hinge pins.

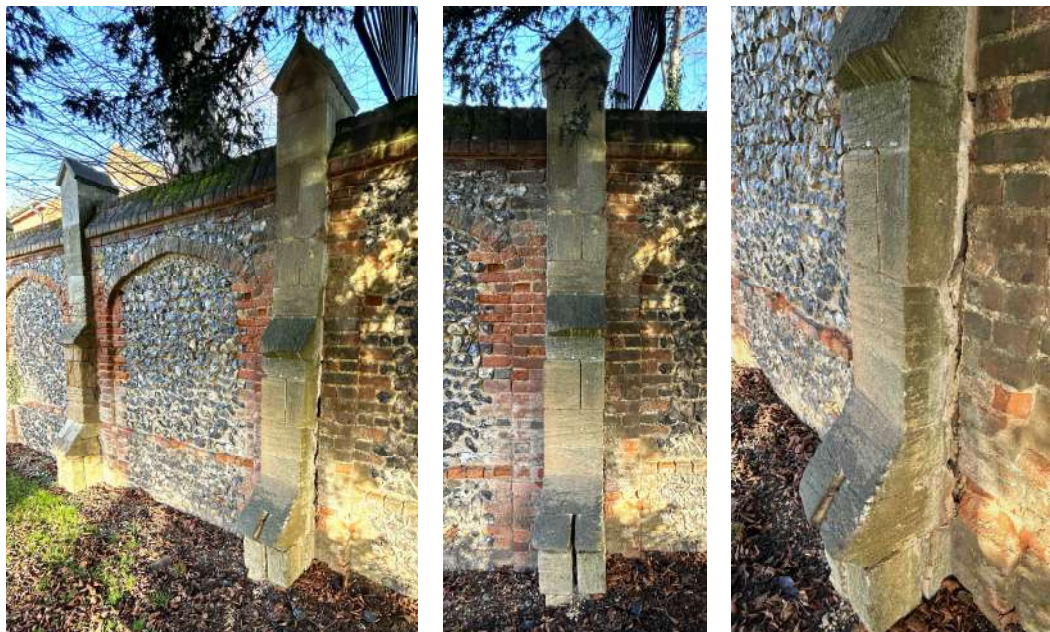
Courtyard Forecourt North Wall: damaged sustained to the natural stone ashlar block buttresses caused by vehicular impact.

When the vehicle hit the main vehicular entrance gates to the east (screen) wall the car continued across the courtyard and hit the one of the buttresses to the courtyard forecourt north wall displacing a number of the ashlar blocks, cracking and dislodging stonework joint mortar and causing some minor stonework surface damage.

Dismantling and rebuilding of one of the wall's stone buttresses damaged and displaced as the result of vehicle impact damage, along with essential associated adjacent repointing.

- Inspect and review the damaged buttress on site.
- Dismantle the damaged/displaced stone buttress.
- Rebuilding of the damaged/displaced stonework of the buttress bedded and pointed in lime mortar to match existing on a like for like basis. Reinstatement of the coping stones to the buttress.

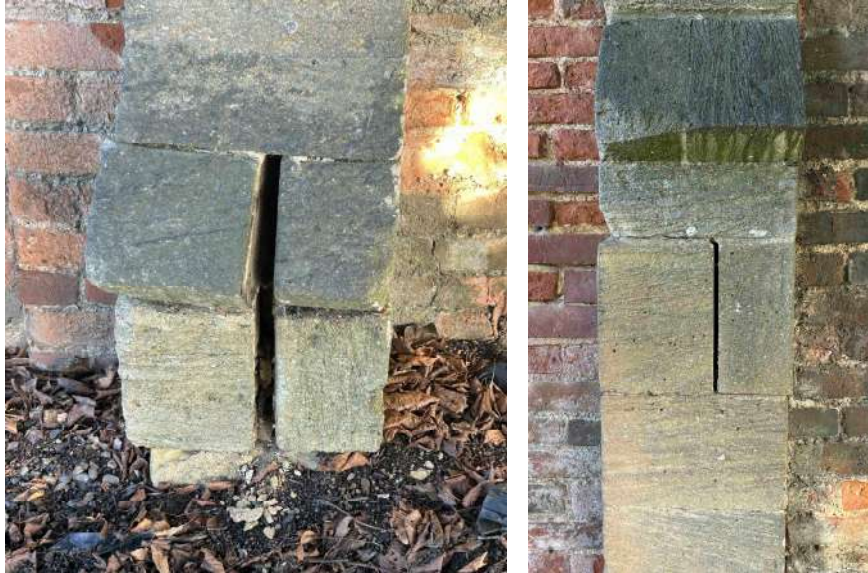
Courtyard Forecourt North Wall: damaged sustained to the natural stone ashlar block buttresses caused by vehicular impact.

When the vehicle hit the main vehicular entrance gates to the east (screen) wall the car continued across the courtyard and hit the one of the buttresses to the courtyard forecourt north wall displacing a number of the ashlar blocks, cracking and dislodging stonework joint mortar and causing some minor stonework surface damage.

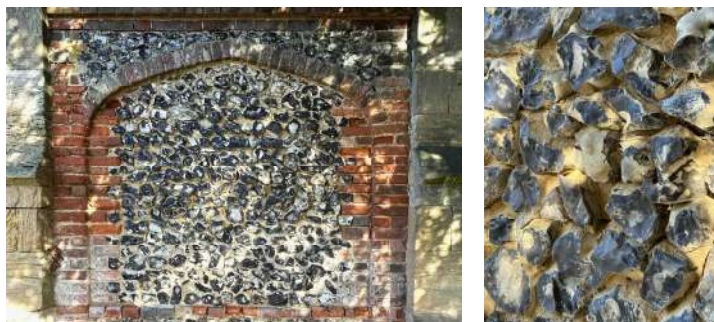
Although not attributed to the vehicle impact, several of the panels are also defective with deteriorating existing mortar bedding and pointing to the flintwork leading to loose and detaches individual flints leading to a small number of flints that have fallen from the wall face.

Courtyard Forecourt North Wall: defective flintwork – weathered and recessed mortar pointing and perished mortar bedding leading to loose/detached individual flints with some flints falling from the wall surface.

- Localised repointing of flintwork to the existing panels between buttresses to the bays of the south face of the north courtyard wall to secure loose flints or to reinstate individual flints, which have fallen or become detached, back into the wall.
- v. The double oak gates to the principal entrance situated in the north east screen wall running along Church Road
