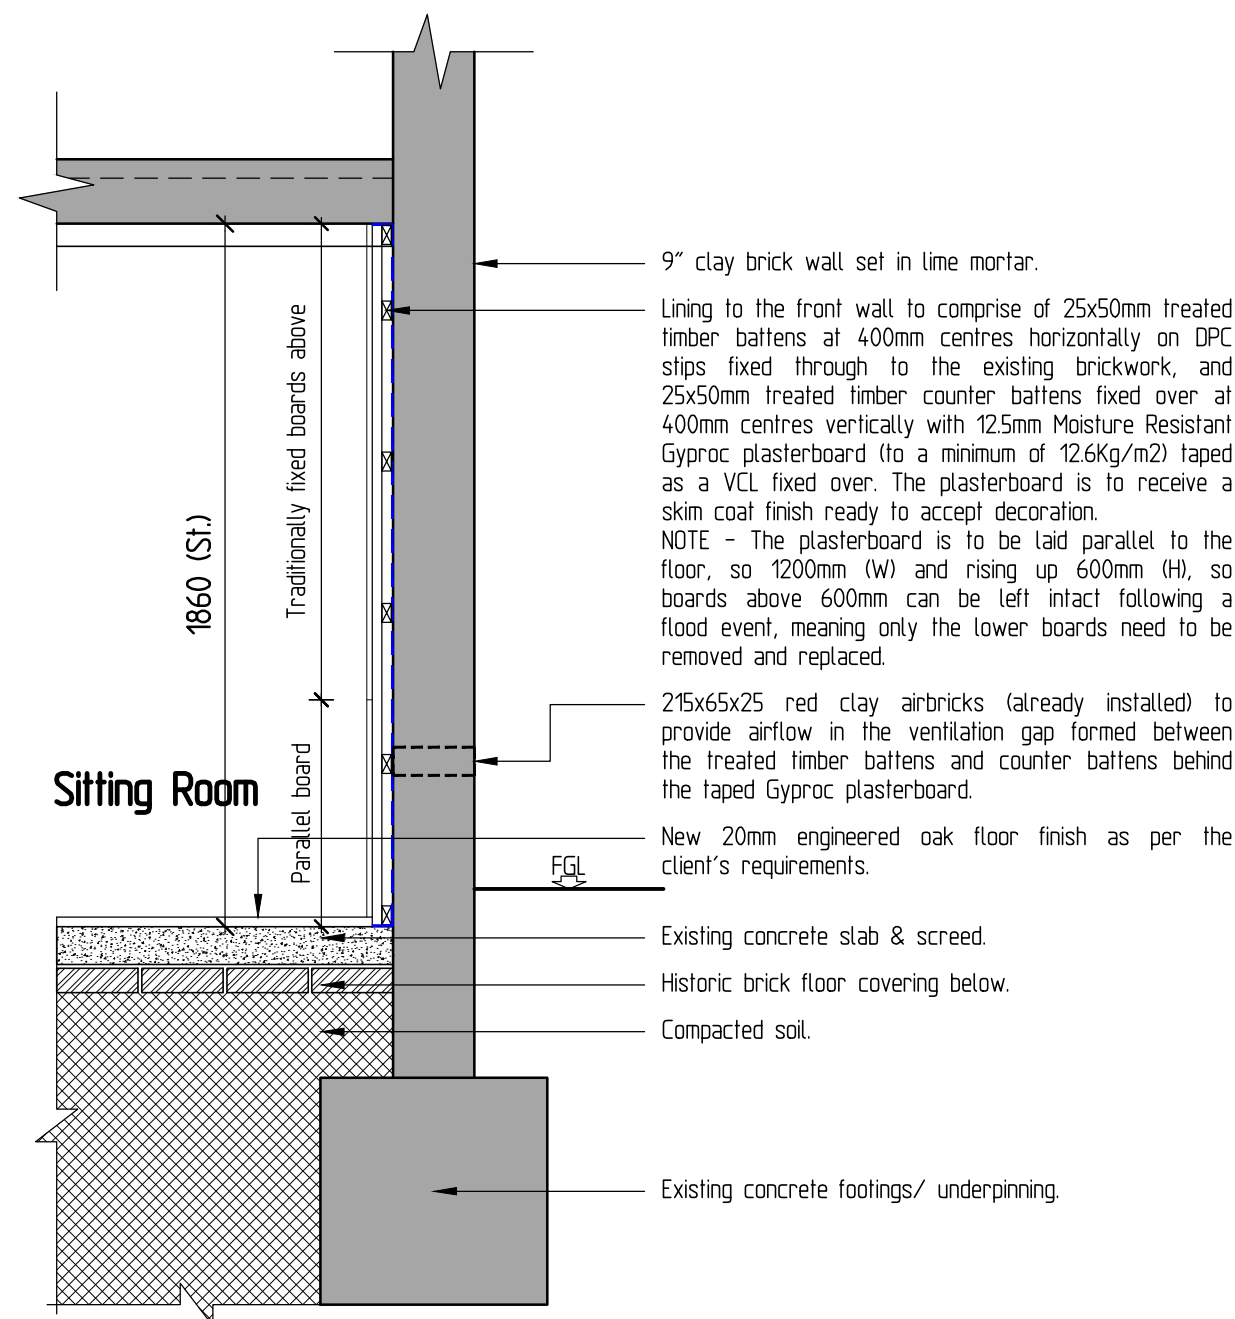
Detail A (Section through the Sitting Room wall & floor) - 1:20

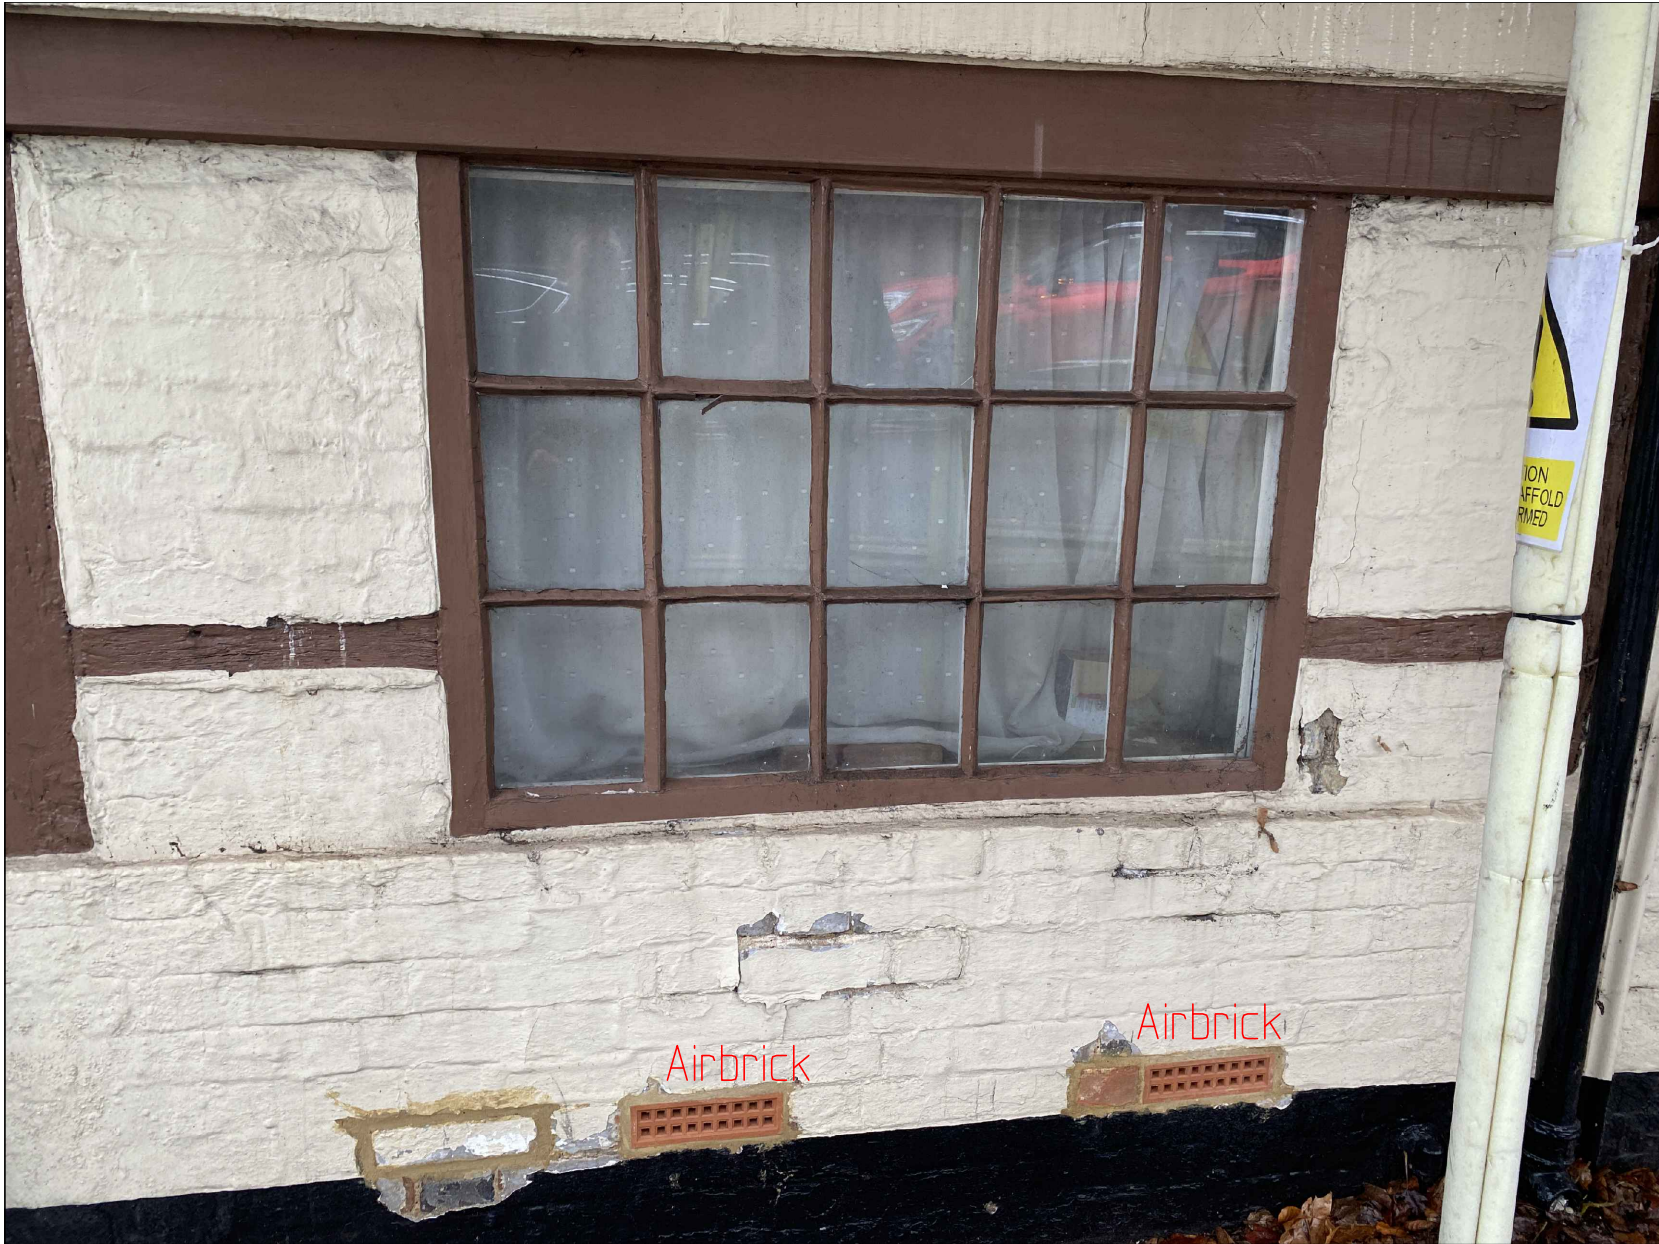
The installed airbricks in-situ - NTS

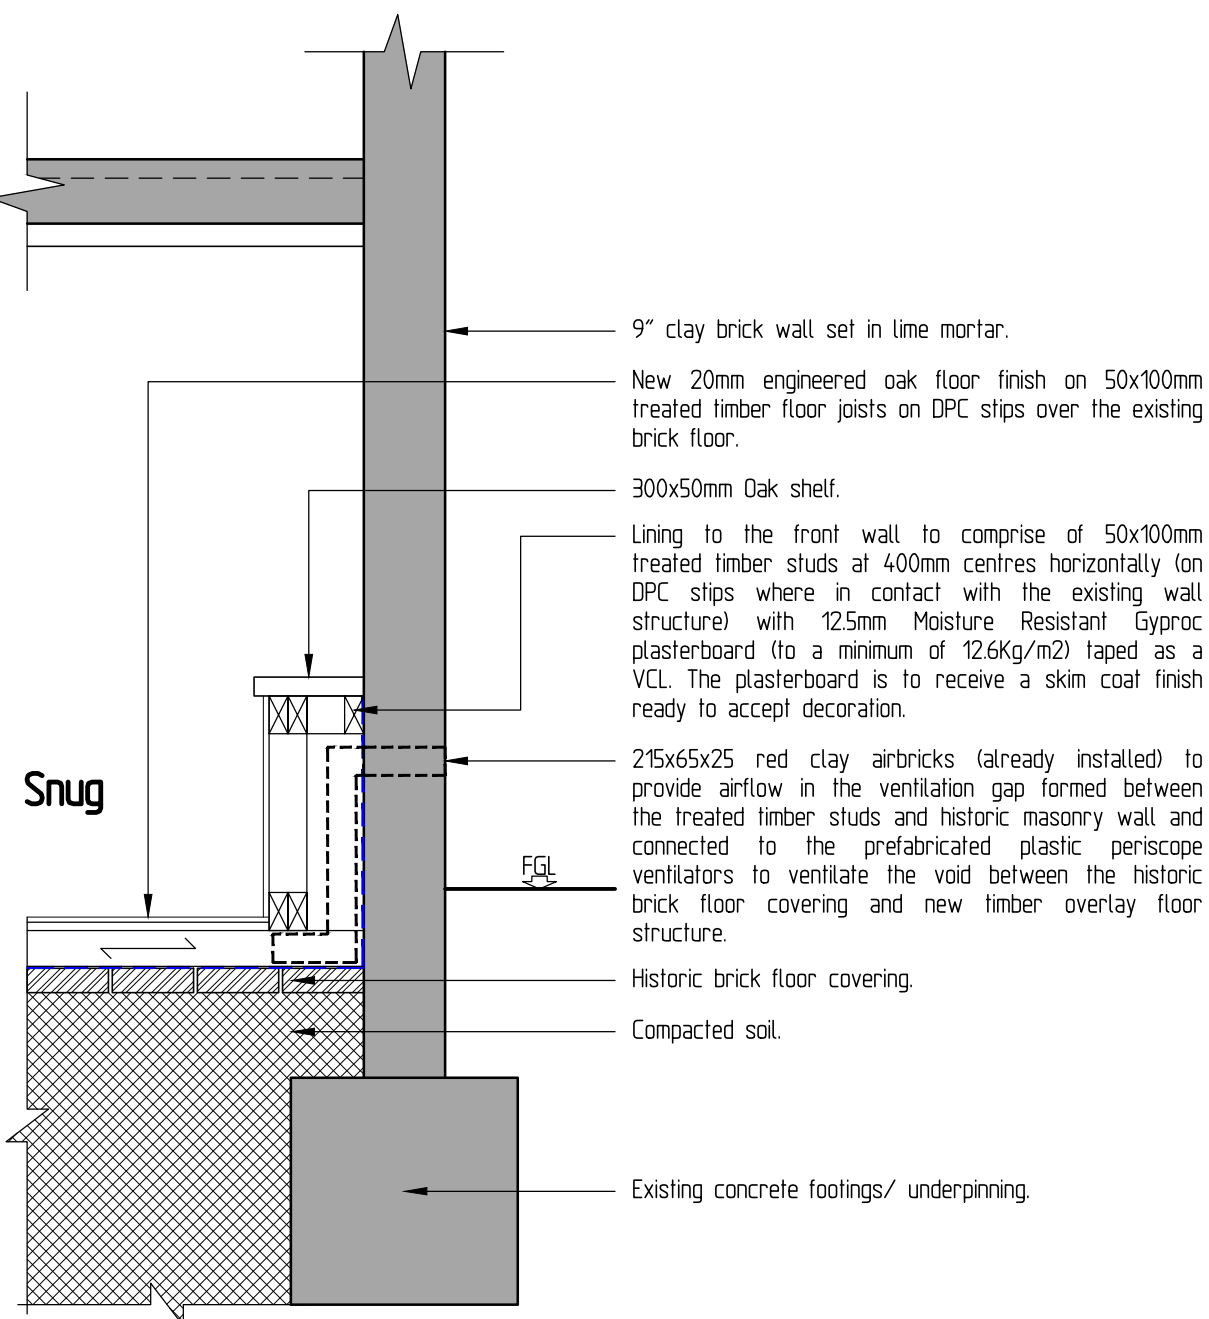
Detail B (Section through the Snug wall & floor) - 1:20

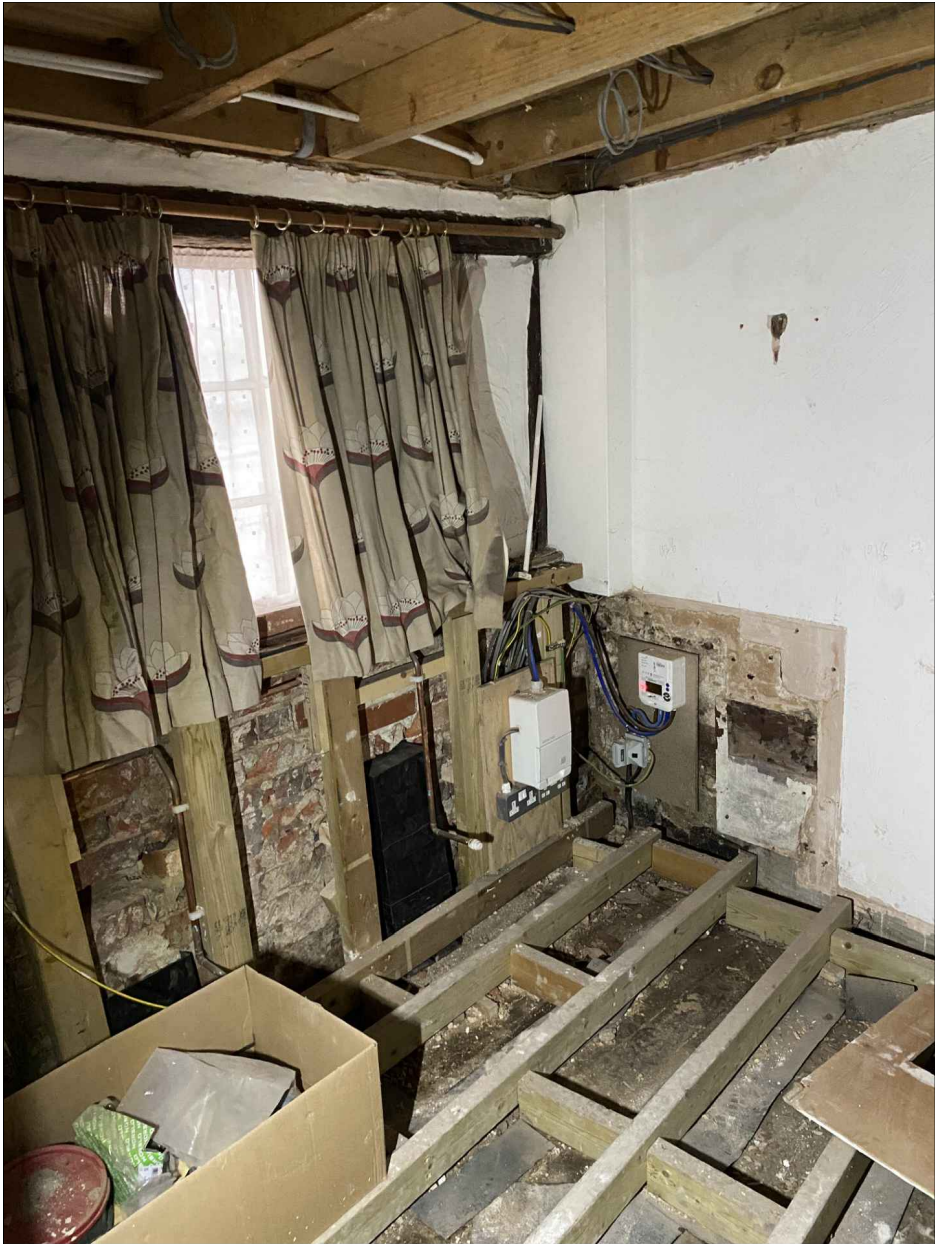
The existing mid-C20 softwood Snug ceiling & Dressing Room floor joists (top of image) of low significance in-situ - NTS

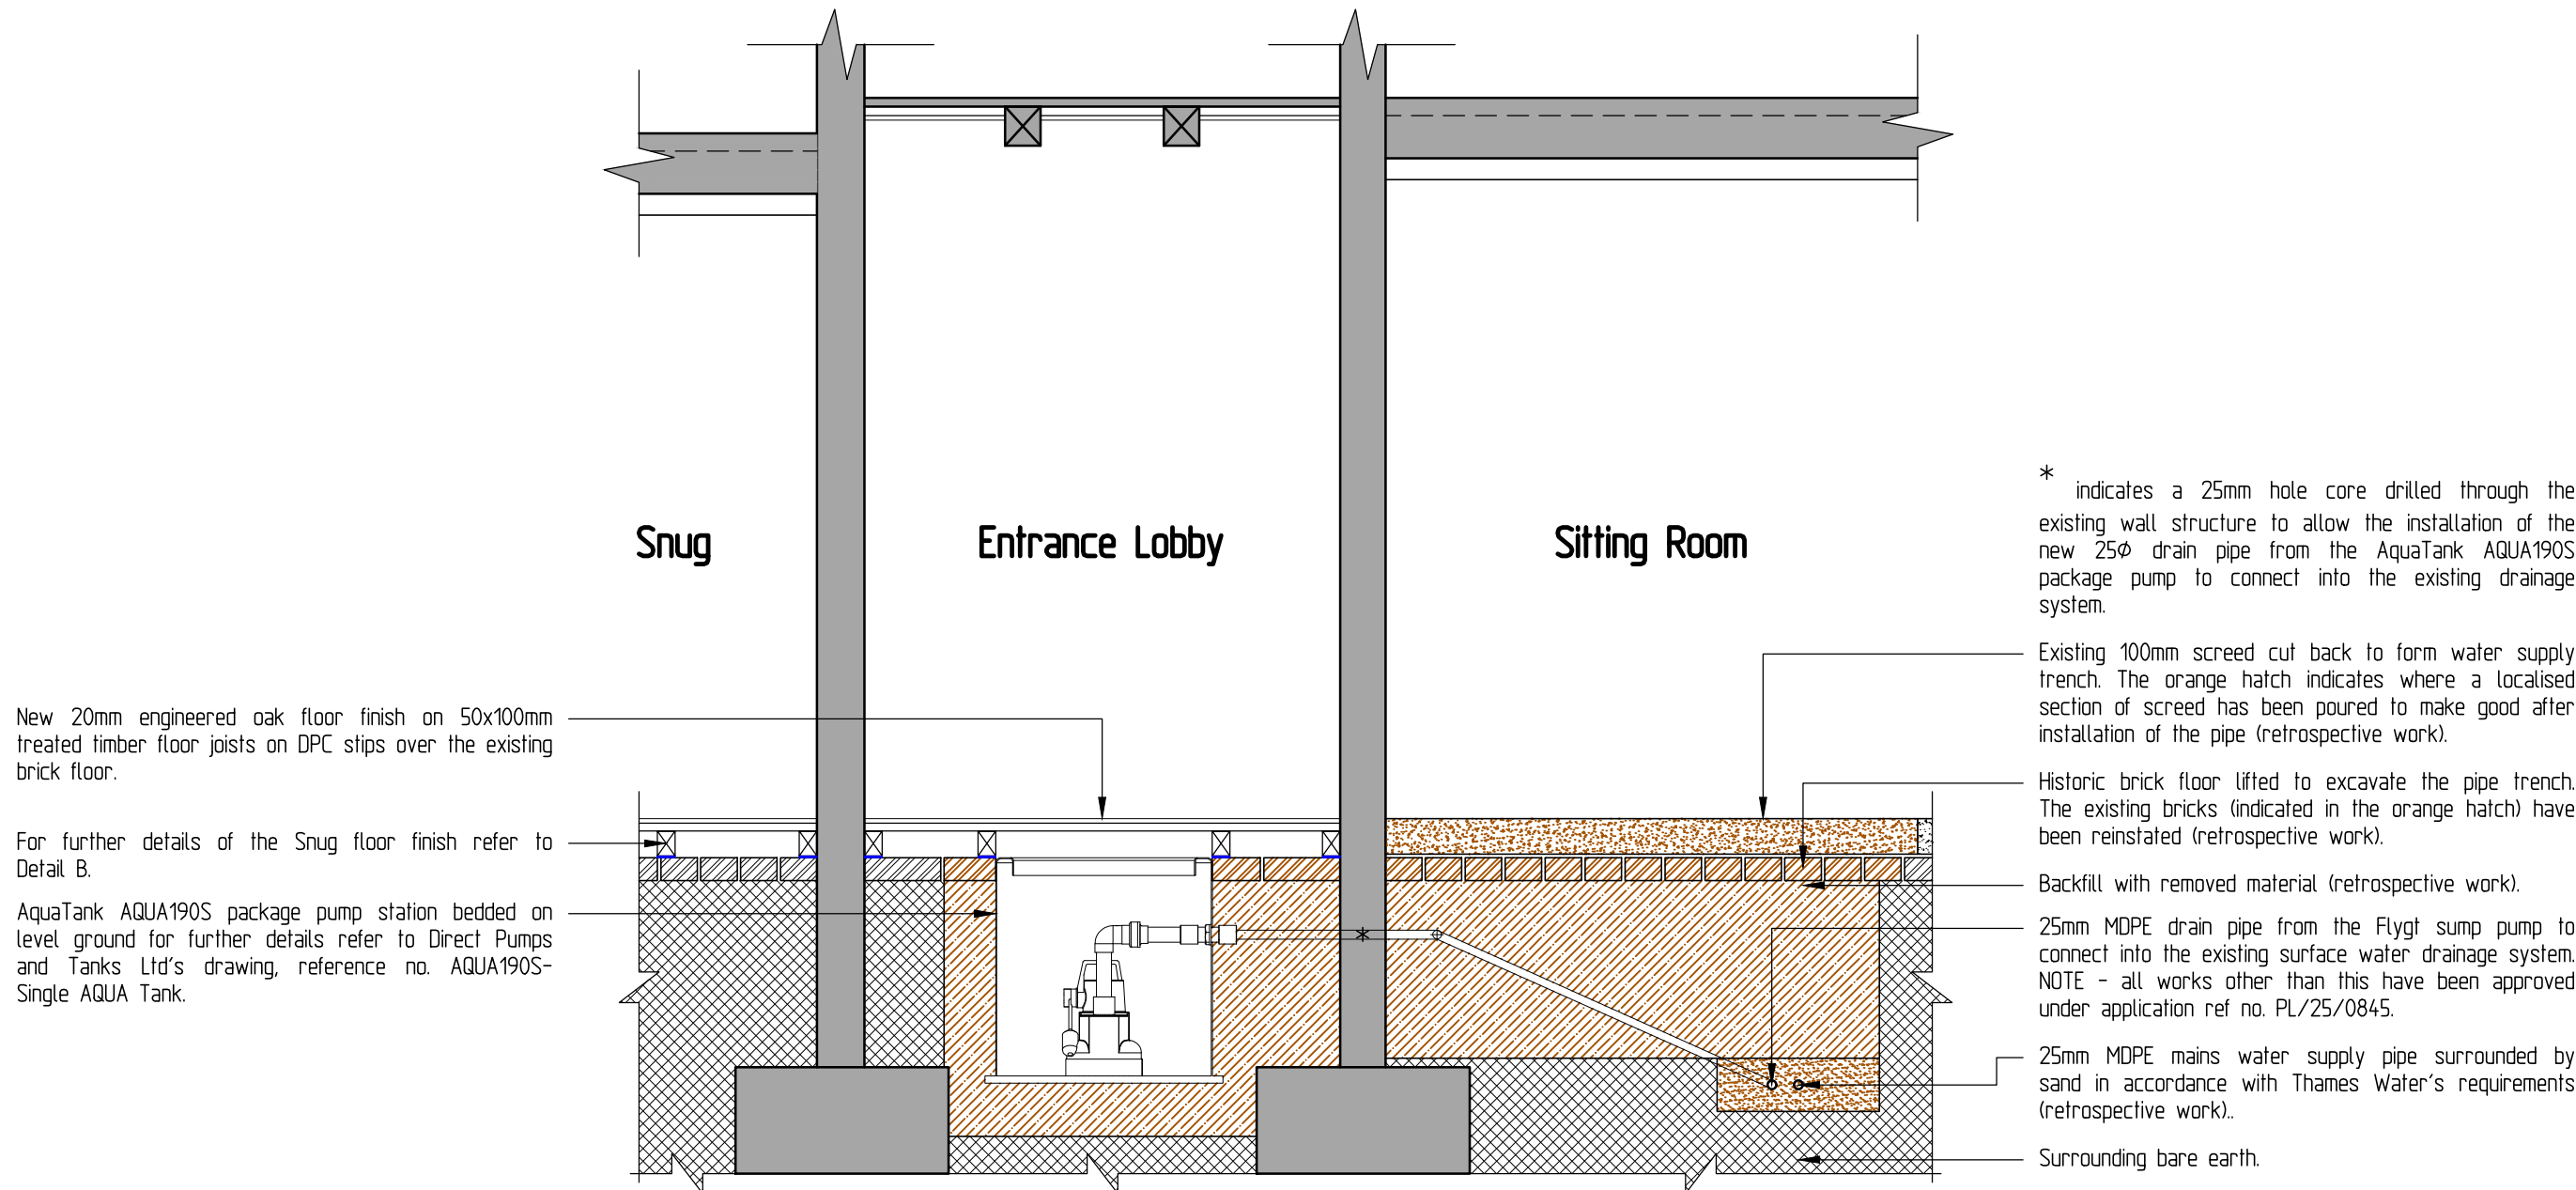
Detail C (Section through the Entrance Hall walls & floor) - 1:20

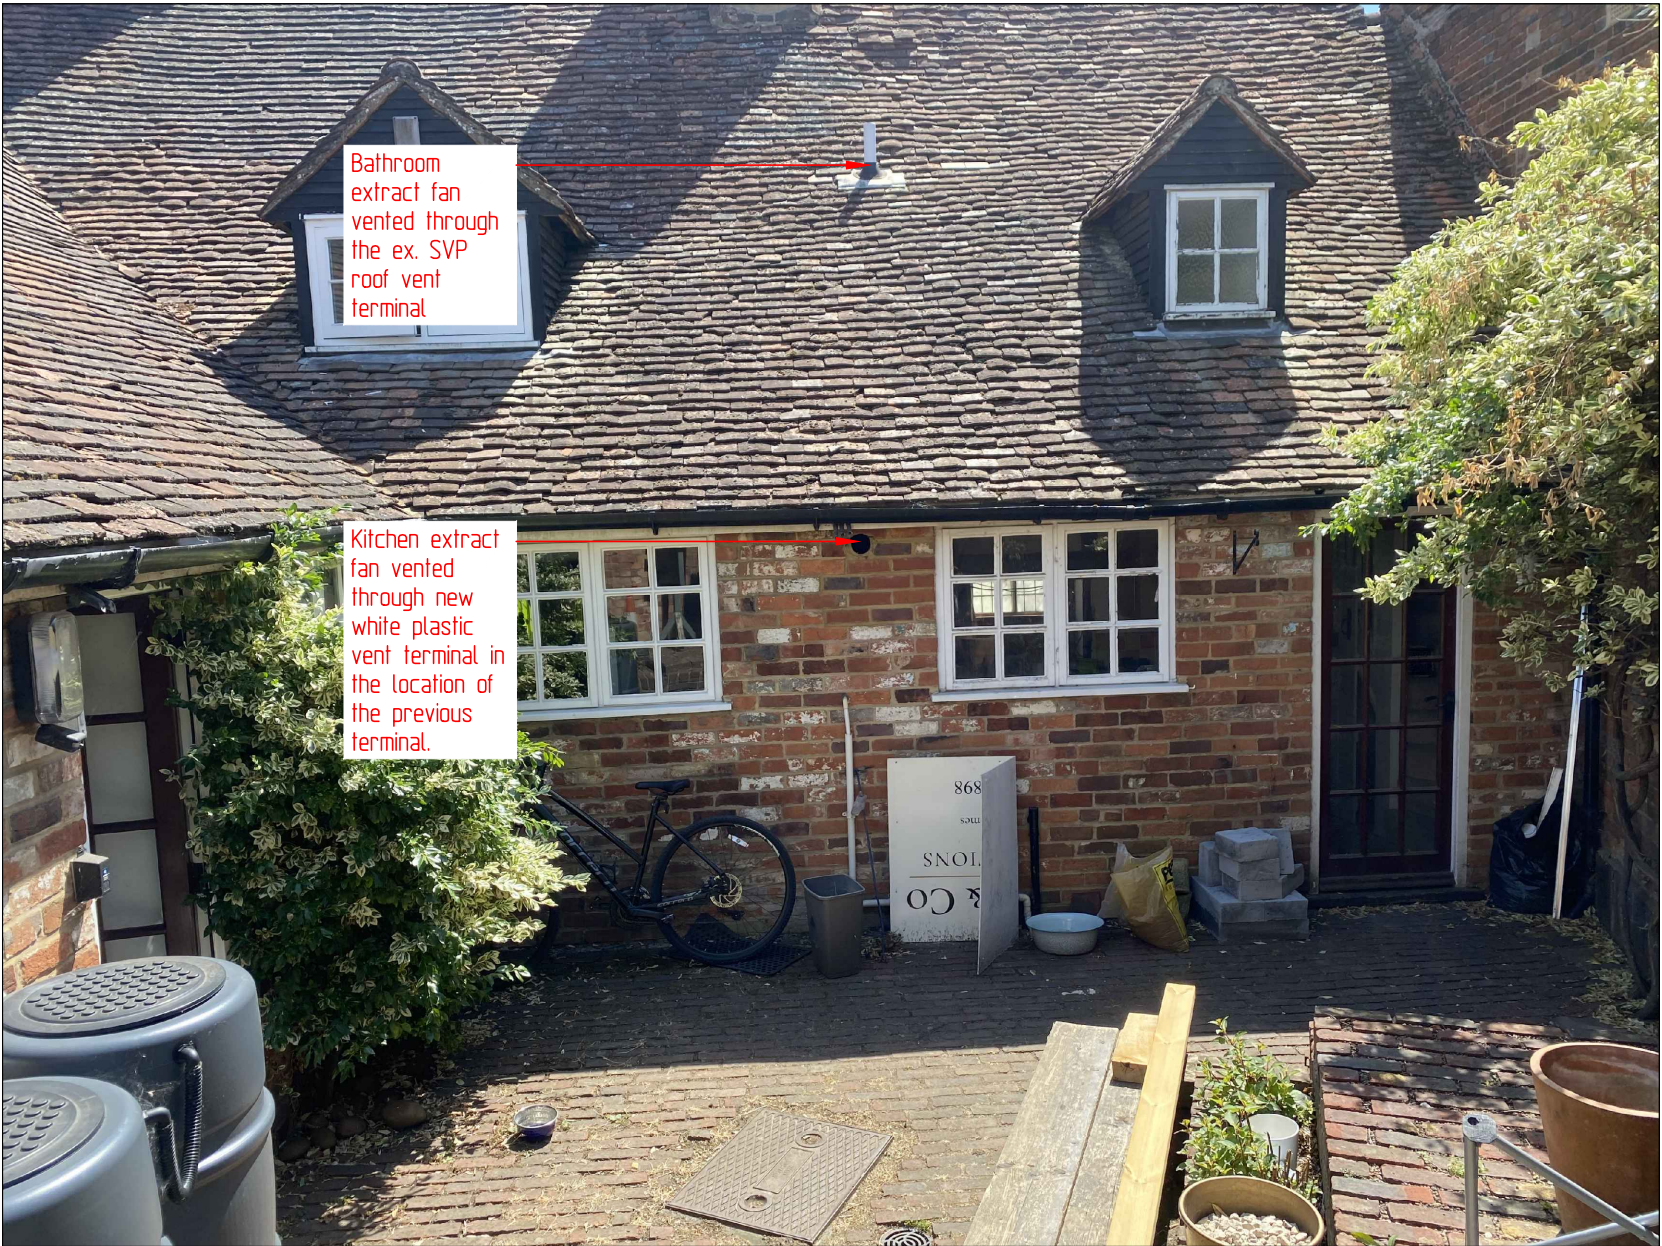
Image showing the locations of the Bathroom & Kitchen extract fan vent terminals - NTS

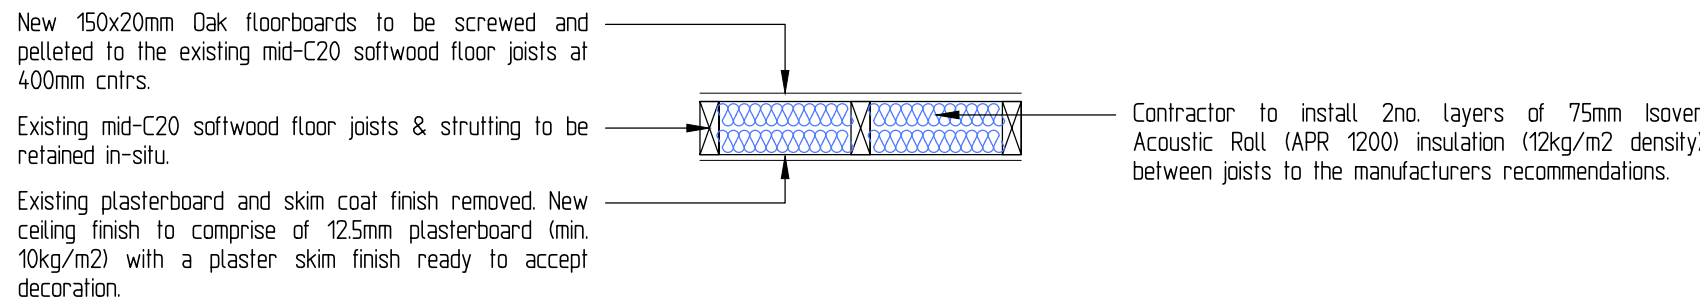
Detail D (Typical section through the Snug ceiling and Dressing Room floor) - 1:20
