# Preliminary Bat Roost Assessment

**151 Whiteknights Rd,  
Earley,  
Reading,  
RG6 7BD**

**May 2026**

**Project Reference:** 0526\_7BD

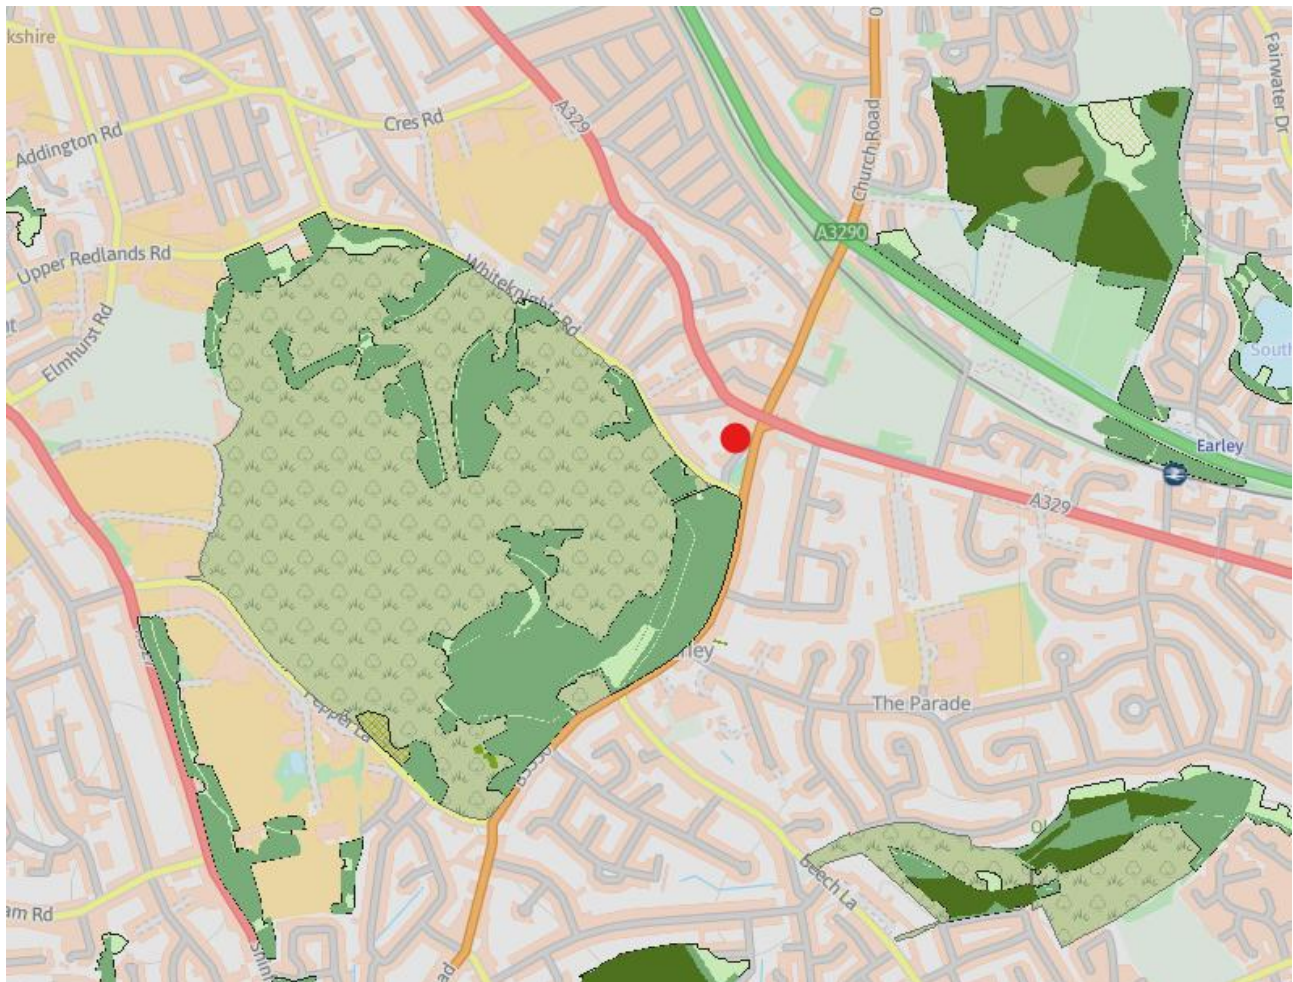
**Figure 3: The site (red) in relation to Priority Habitats**

A substantial area of Wood-pasture and Parkland (a UK BAP habitat), incorporating areas of Deciduous Woodland (Priority Habitat), is located approximately 80 m south of the site.

These habitats are of recognised ecological importance and have the potential to support a diverse assemblage of bat species. Review of aerial imagery indicates that the site maintains clear ecological connectivity with these habitat areas.

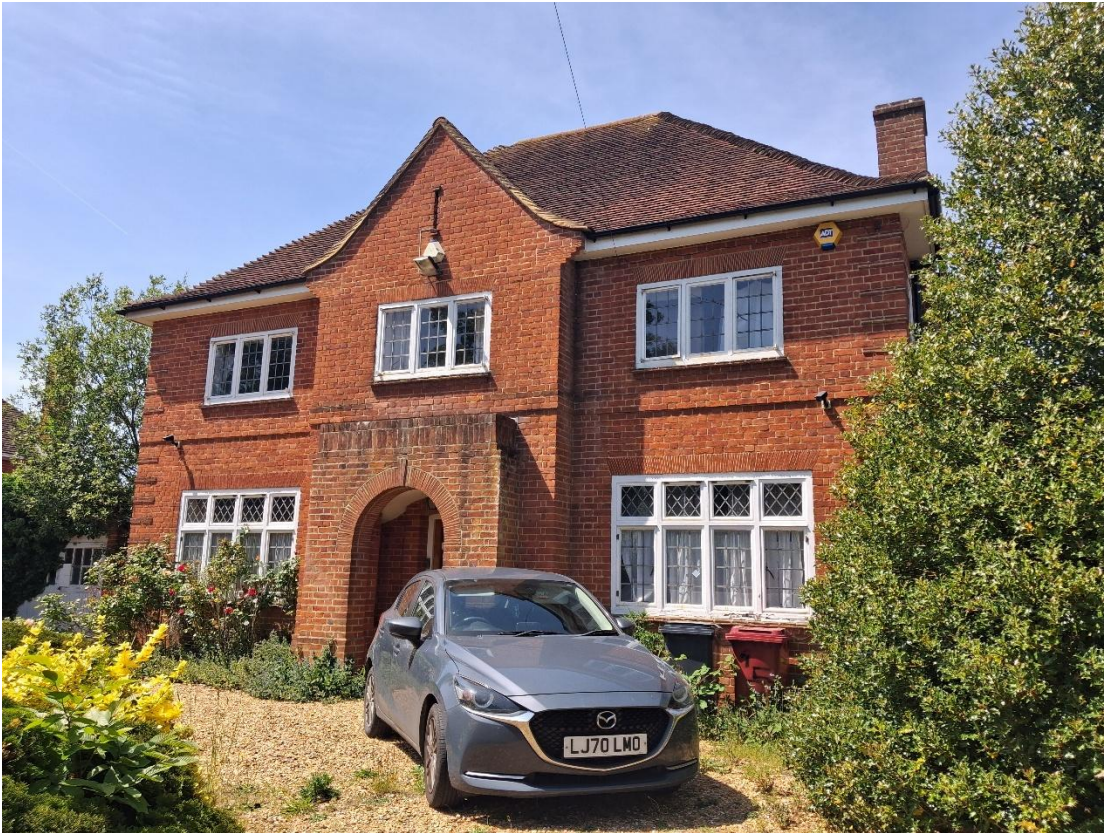
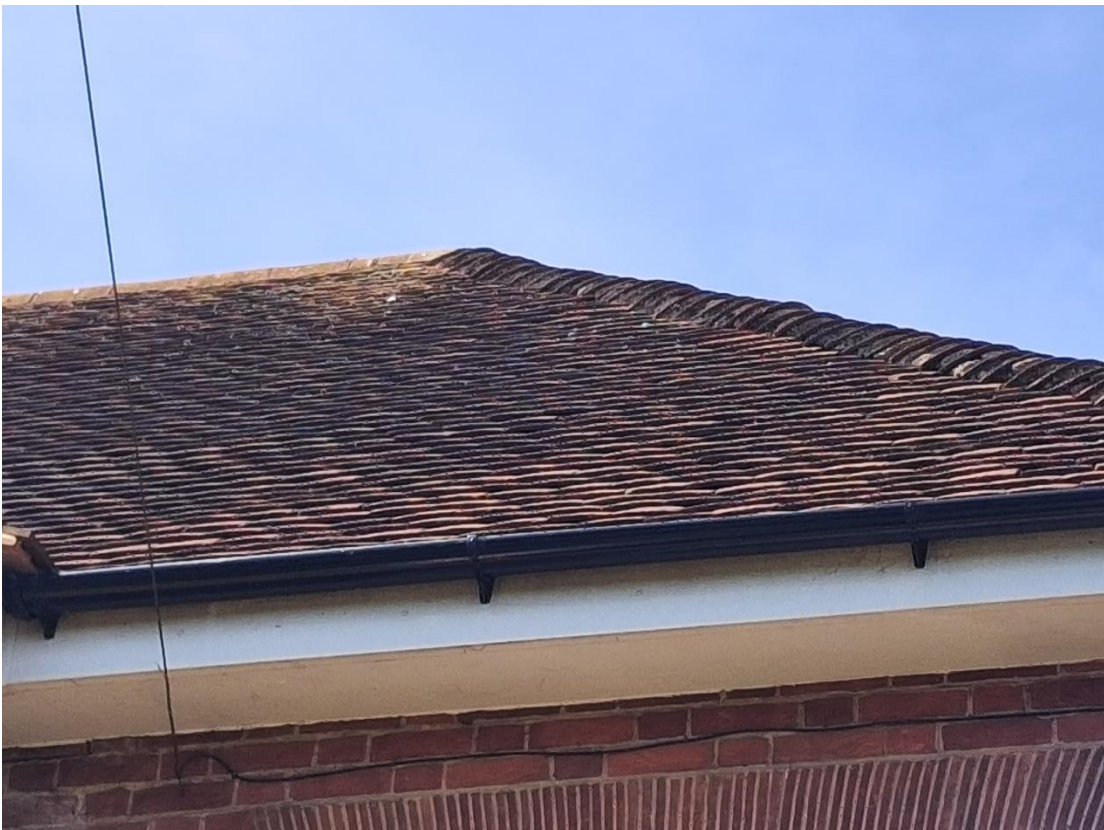
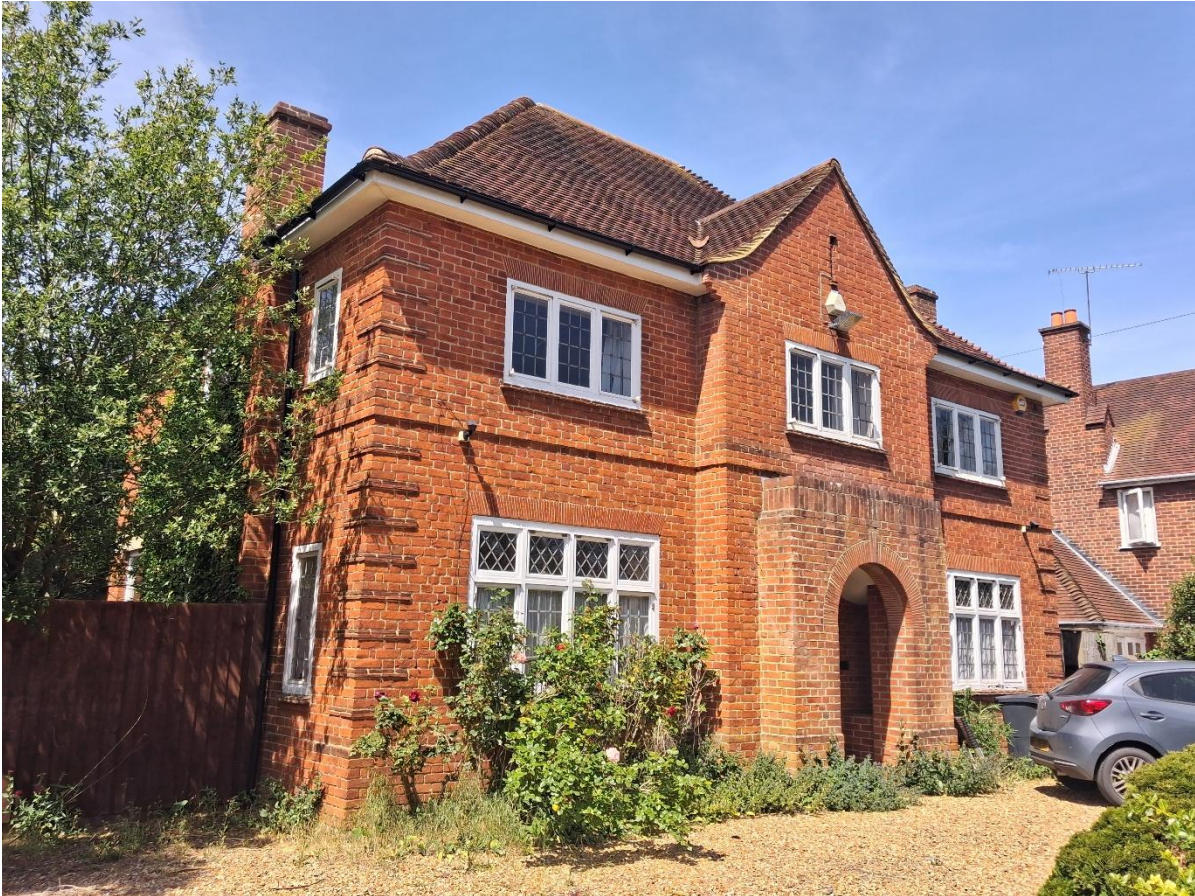
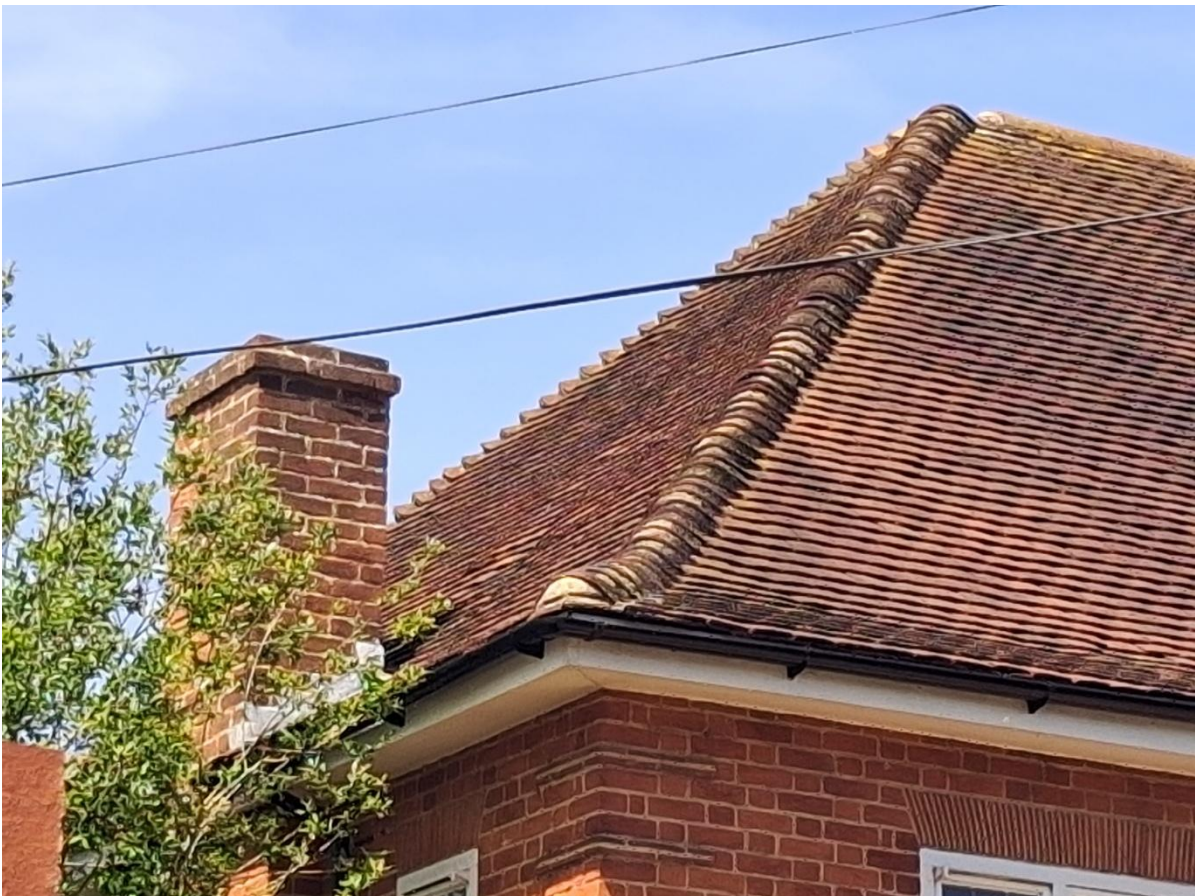
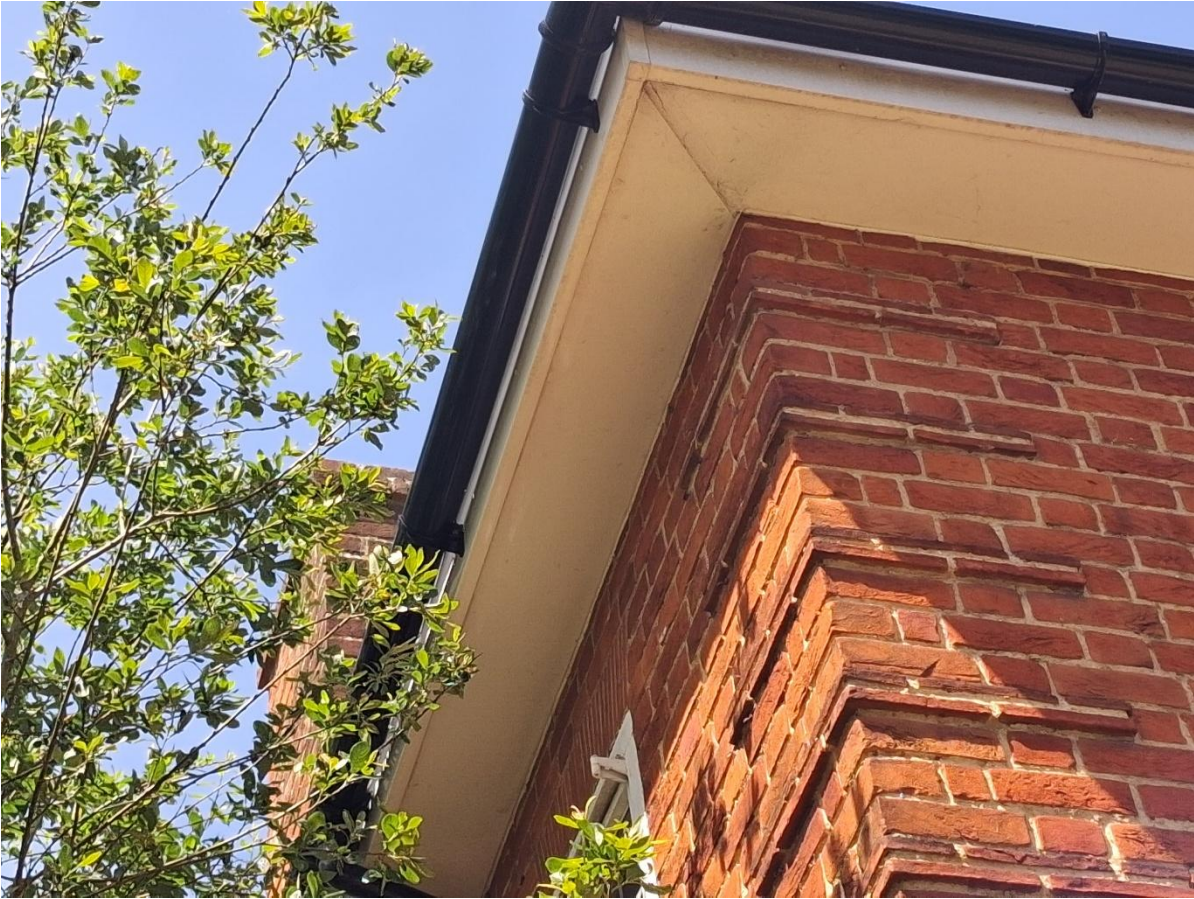
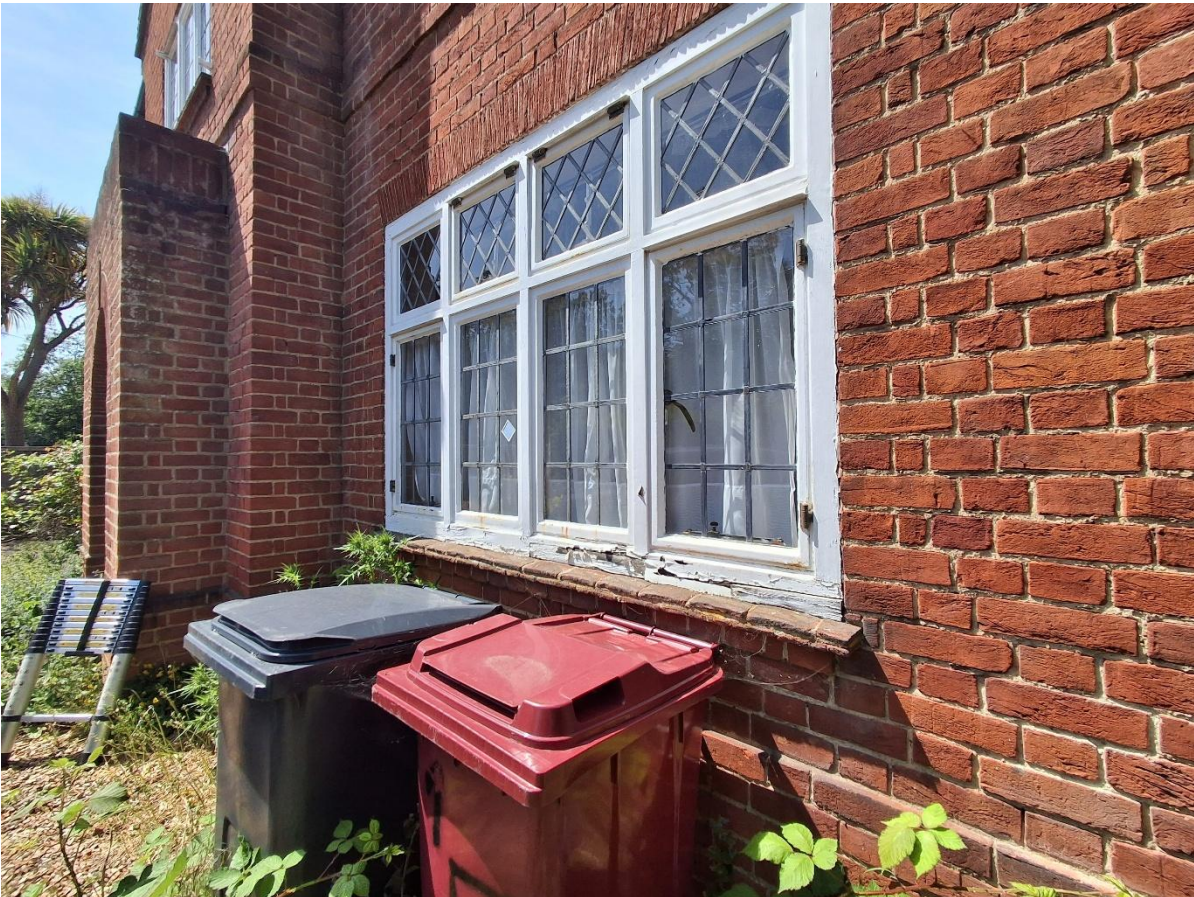
### 6.1 Photos from 22 May 2026

Overall, the windows and soffits were found to be in good condition and generally well-fitted to the structure. However, several localised gaps were identified between the soffits and the brickwork, particularly along the northeast elevation. Additional gaps were noted between the fascia and brick wall of the rear flat-roofed extension. Areas of missing mortar were also identified beneath several bonnet tiles.

Observations of the southwest and northeast roof slopes were partially restricted by boundary fencing. Nevertheless, inspections undertaken from the adjacent road using binoculars identified several potential roost features (PRFs) suitable for bats. These included lifted and gappy roof tiles, particularly around the northeastern chimney, including adjacent to the lead flashing, as well as above the chimney on the southwest roof slope. Additional gaps beneath roof tiles were also observed on both the front and rear roof slopes.

Several potential bat access points into the loft void were identified. In particular, light ingress was visible at the southeast ridge line, indicating potential access beneath the roof covering. Additional potential access opportunities were noted around the flue and chimney on the northeast roof slope, corresponding with areas of gappy roof tiles identified during the external inspection.

In accordance with Bat Surveys for Professional Ecologists: Good Practice Guidelines (Collins, 2023), **a programme of two dusk emergence surveys is required to confirm the presence or likely absence of roosting bats within B1.** Surveys should be undertaken between mid-May and September and spaced at least three weeks apart, with at least one survey taking place no later than July.
