# PRELIMINARY BAT ROOST ASSESSMENT

## ST PETER'S CHURCH THE WARREN, CAVERSHAM READING RG4 7TH

Client: Caversham Thameside & Mapledurham Parish

Our reference: Eco4025

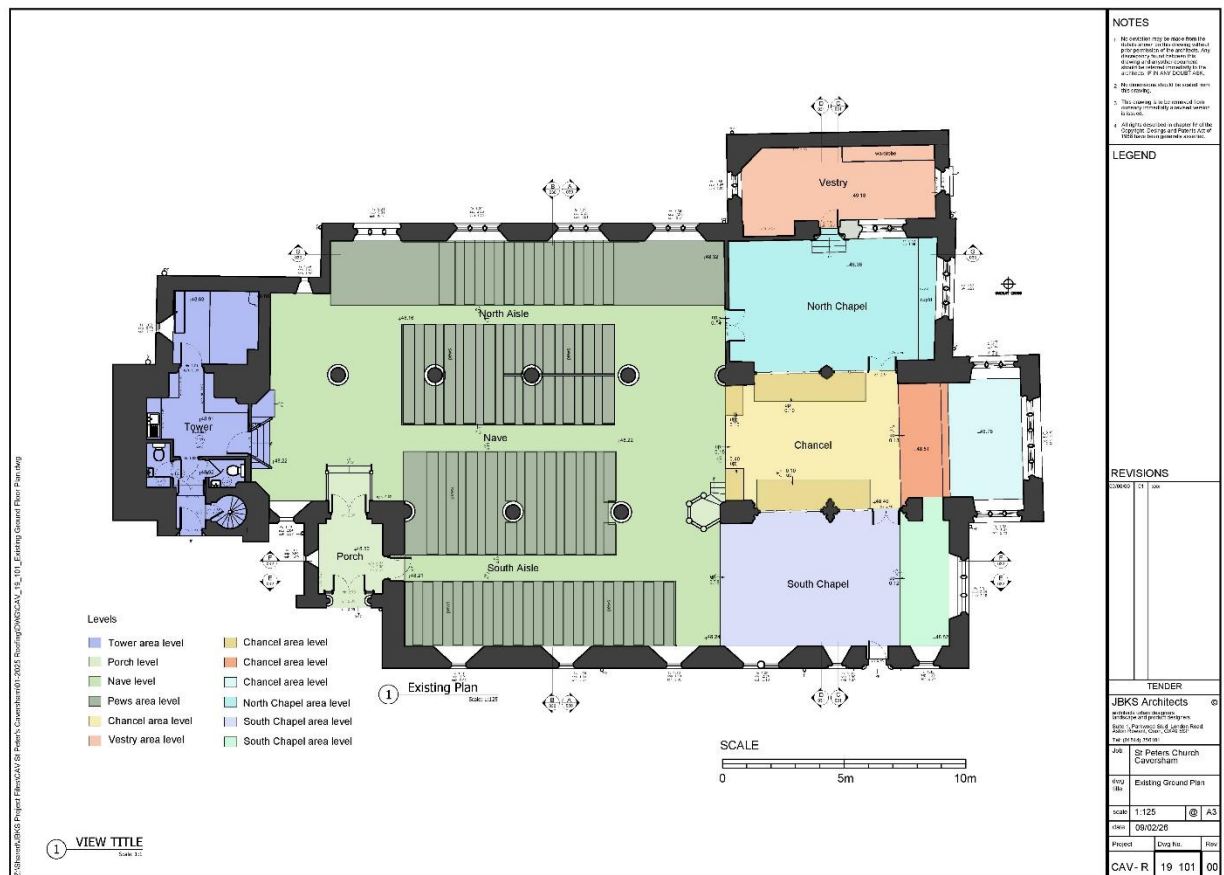
**Figure 3 – Floor plan of St Peter's Church**

- 3.10 St Peter's Church dates back to 1162 and has been expanded in size and complexity over the centuries. It has a chancel, north and south chapels, north vestry, nave, north and south aisles, south porch and a church tower at the west (see floor plan in Figure 3).

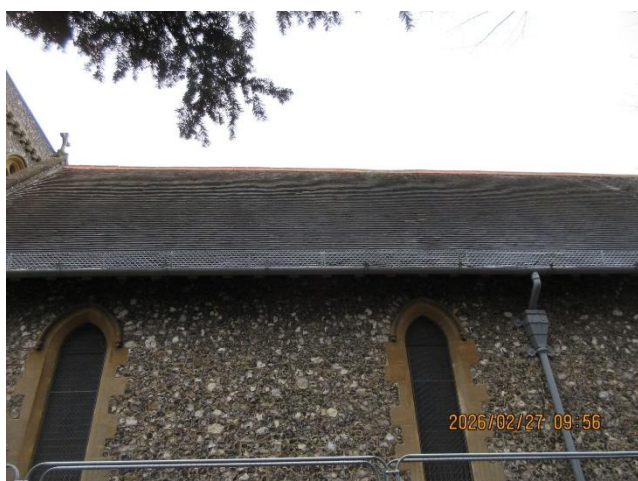
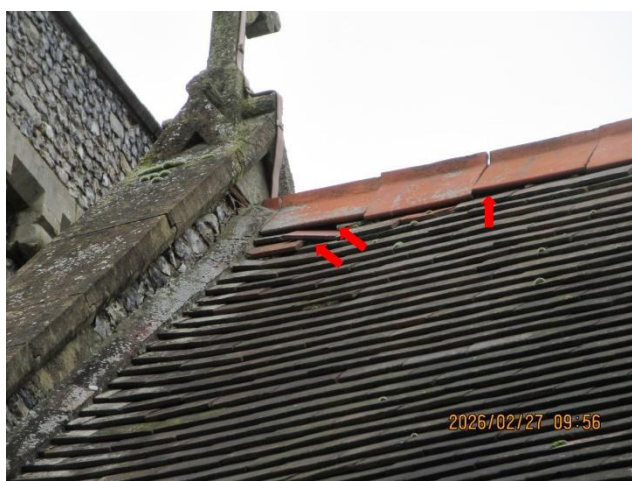
- 3.5 Externally the building has numerous features potentially suitable for use by roosting bats including:
- Gaps under raised tiles on all roof surfaces, in particular on the central and northern pitches (the areas to be re-roofed are in general in better conditions with fewer gaps under the roof tiles).
  - Gaps at the eaves between the rafters and walls

Photos 3 and 4 – The south face of the southern pitch (snowguards have been installed to prevent the falling of tiles) and examples of gaps under raised tiles

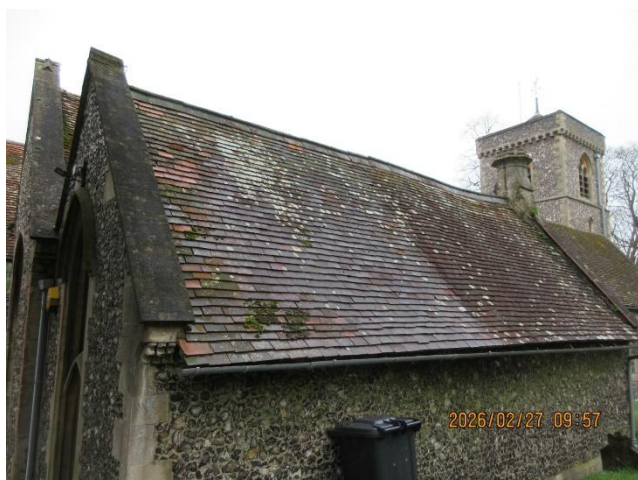
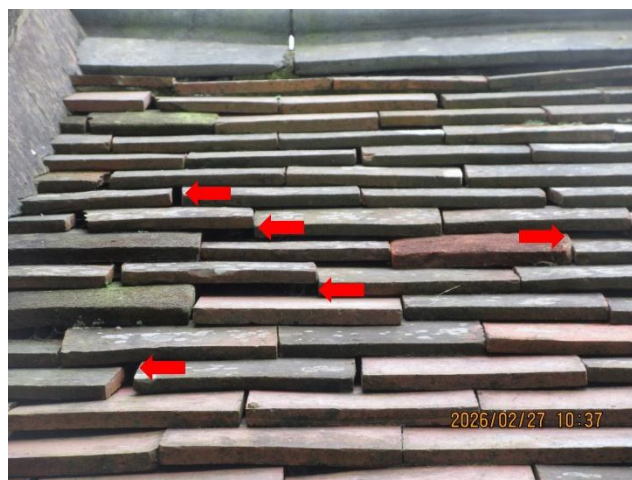
Photos 5 and 6 - The north face of the vestry roof and examples of gaps under raised tiles

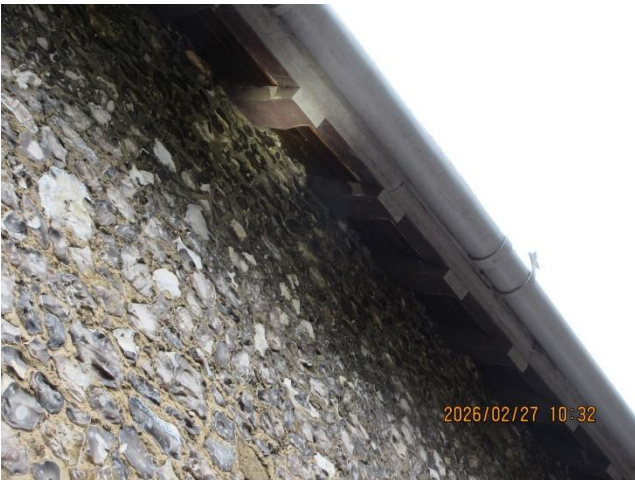
Photo 7 – Gap between the roof overhang and flint wall on the southern elevation, and Photo 8 – The roof viewed from the bell tower [from left to right: vestry, northern pitch, central pitch and southern pitch]

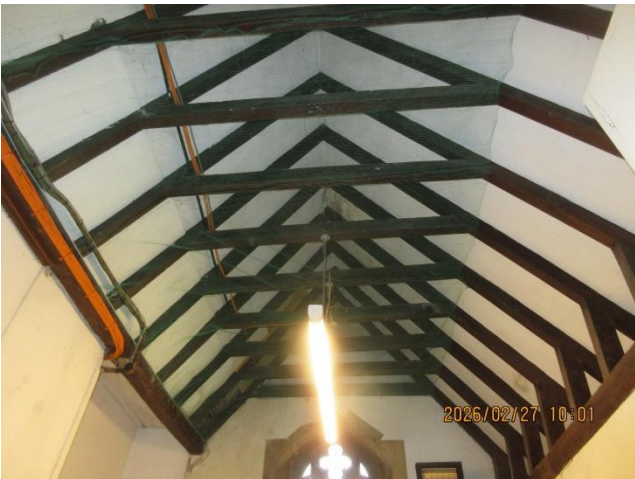
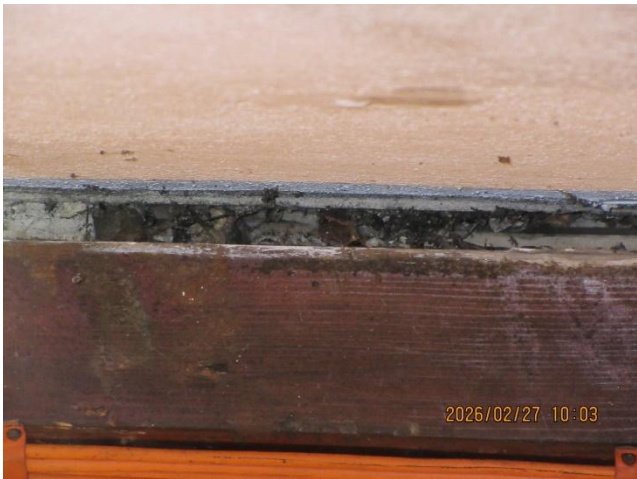
- 3.6 A description of the inside of the church is provided below:
- 3.7 **The Vestry.** The roof of the vestry has timber exposed timber rafters with plaster in between and no exposed ridge boards. There are gaps between the timber frame and southern end wall potentially suitable for use by roosting bats but these were inspected and found to be blocked by cobwebs.

- 3.8 No bats or signs of bats were found in this room.
- 3.9 **The North Chapel.** The roof of the north chapel has wooden beams, exposed ridge boards and timber roof lining.

Photo 5 – Inside the vestry, and Photo 6 – Gap between the timber frame and wall in the vestry blocked by cobwebs

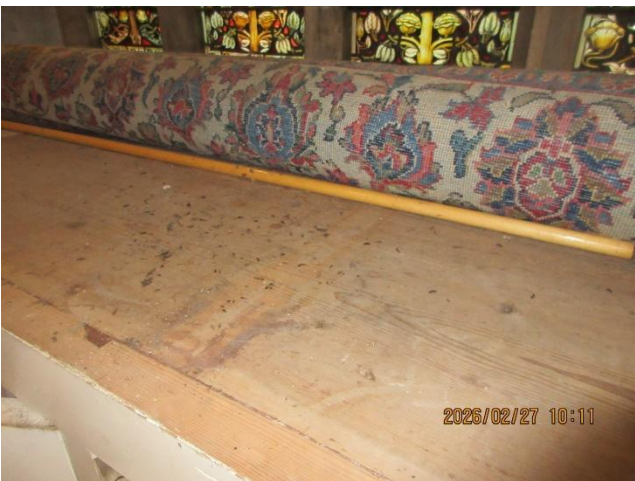
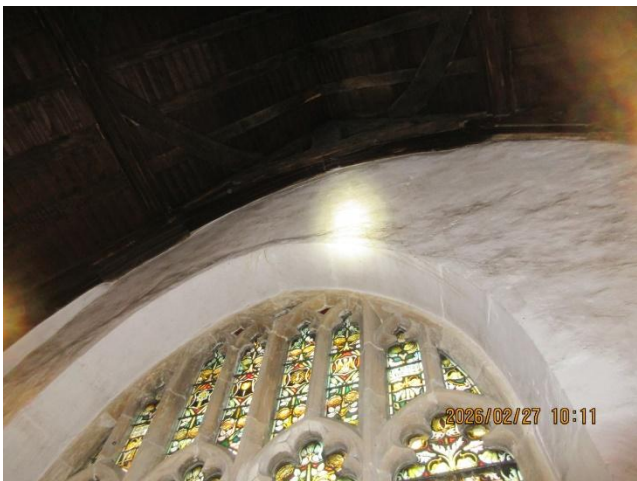
- 3.10 Approximately 150 bat droppings were found on the top of a cupboard by the eastern end wall. There are gaps between the wooden roof frame and wall where the bats which deposited these droppings are likely to roost.

- 4.3 St Peter's Church hosts roosting bats with bats roosting inside the church in at least one location - confirmed by the presence of bat droppings at the eastern end of the north chapel. The bats in this location are likely to be roosting between the wooden roof timbers and the wall.

Photos 7 and 8– Bat droppings found inside the north chapel and gap between the timber frame and the eastern end wall

- 4.8 As such to determine if, and if so how, bats will be affected by the re-roofing works, further surveys would need to be undertaken. This information would be needed to obtain a licence for derogation from the provisions of The Conservation of Habitats and Species Regulations 2017 for works affecting bats (should surveys show that a licence is required).

- 5.4 As such to determine if (and how) bats will be affected by works further surveys would need to be undertaken. This would comprise two dusk emergence surveys between 1 May and 31 August - with an additional survey to confirm the status of the roost should a bat roost be found.

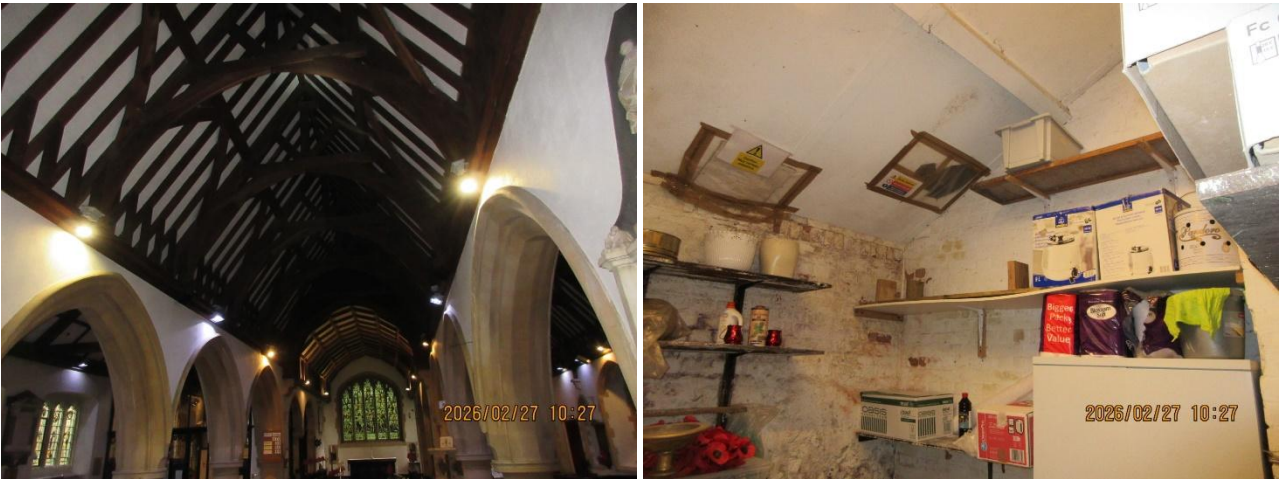
- 3.13 **The Nave.** The roof of the nave has timber exposed rafters, timber pointed arches (kingpost and wind brace construction) and vaulted ceiling.

- 3.14 No bats or signs of bats were found in this room, although it is regularly cleaned so any bat droppings that may have been present are likely to have been swept away.

- 3.19 **The Storage Room.** The storage room is open to the roof with plastered linings. No bats or signs of bats were found in this room.
- 3.20 **The Kitchen.** This room is located at the base of the bell tower. It has a flat plastered and painted ceiling. No bats or signs of bats were found in this room.

Photo 9 – Inside the nave, and Photo 10 – Inside the storage room
