## Preliminary Roost Assessment

12 Grafton Road, Tilehurst, Reading, RG30 1QJ

This report is prepared to inform a planning application with Reading Borough Council. The proposal is described as:

*“Two-storey rear wrap around extension and front porch extension.”*

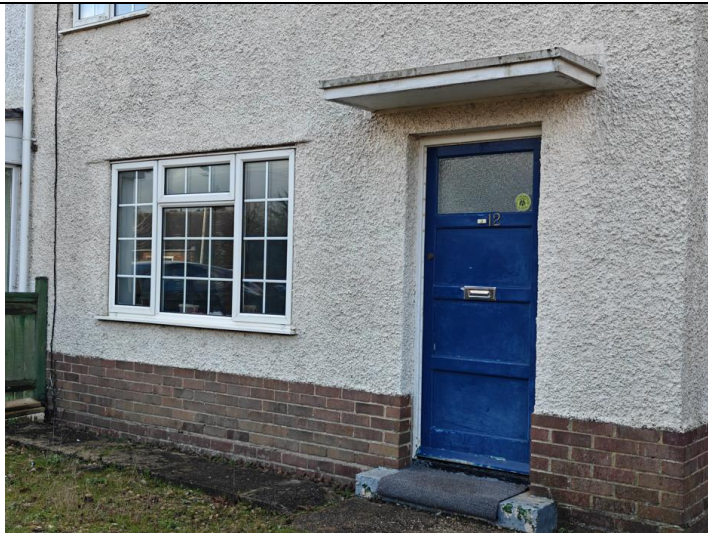
| Window/door frames/porchway | uPVC window and doorframes | <p><b>Condition/description</b></p> <p>The window and door frames within themselves were in a good state of repair and well-sealed, with no visible gaps recorded. The small porchway above the front door on the northern aspect was also noted to be well-sealed with no visible gaps recorded.</p> <p><b>Suitability/access/evidence of bats</b></p> <p>No suitable roosting features observed.</p> | <p>Northern aspect</p> |

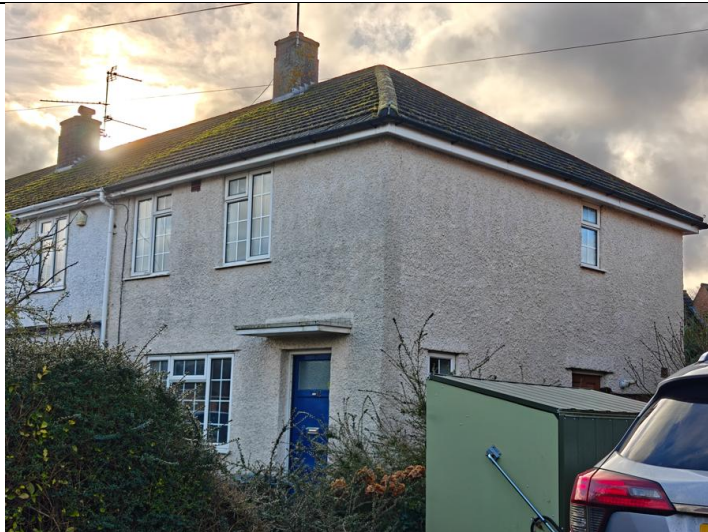
| Chimney | Brick with mortar | <p><b>Condition/description</b></p> <p>The chimney itself appeared to be in a good state of repair, with no signs of deterioration of the mortar or bricks, and no gaps were recorded.</p> <p><b>Suitability/access/evidence of bats</b></p> <p>No suitable roosting features observed.</p> | <p>North-western aspect showing the chimney</p> |

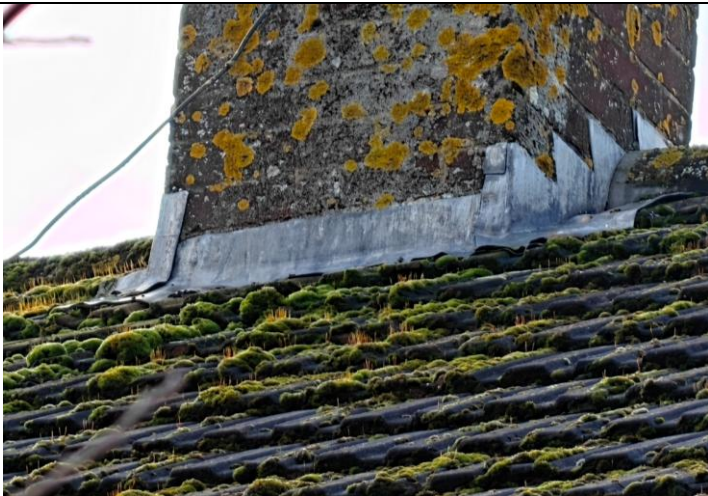
| Lead flashing | Lead | <p><b>Condition/description</b></p> <p>Lead flashing is present on all aspects of the building at the base of the chimney. Gaps were recorded underneath the lead flashing where it has become raised.</p> <p><b>Suitability/access/evidence of bats</b></p> <p>Gaps underneath raised areas of lead flashing may provide roosting opportunities for crevice dwelling bats.</p> | <p>Raised lead flashing and gaps at the base of the chimney on the northern aspect</p> |

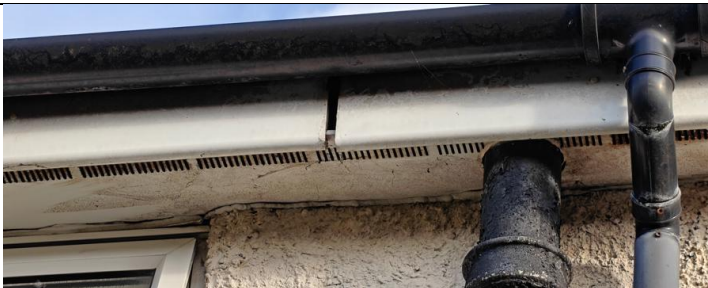
| Soffits and fascias | uPVC | <p><b>Condition/description</b></p> <p>Soffits and fascias are present along the northern, western, and eastern aspects of the building. The soffits were noted to be well-sealed and flush against the walls with no visible gaps recorded. Vent gaps are present within the soffit along all aspects, although these gaps were noted to be very small and narrow. Two gaps were recorded between the fascia boards, on the southern aspect and on the south-western corner of the building.</p> <p><b>Suitability/access/evidence of bats</b></p> | <p>Gap between fascia boards on the southern aspect</p> |

| | | <p>The gaps between the fascia boards could provide roosting opportunities for individual crevice dwelling bats. It was not possible to determine during the survey if these gaps are connected behind the fascia boards, and lead to a larger void. It was also not possible to determine if the gaps between the fascia boards provided internal access into the roof void. It is noted that the vent gaps along the soffits are very small and narrow, due to their small and narrow size, it is considered these vent gaps are unlikely to be suitable for roosting bats.</p> | |

Gap between the fascia boards on the south-western corner

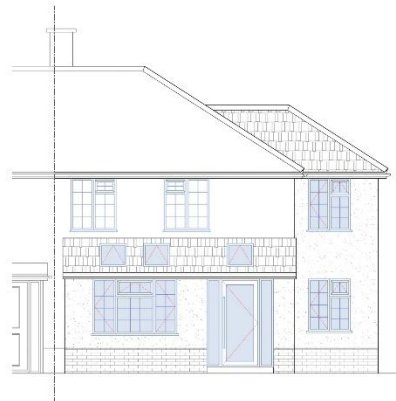
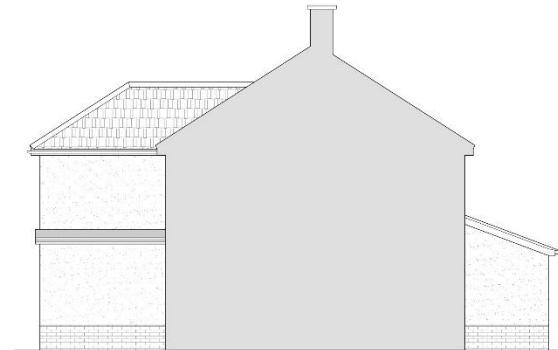
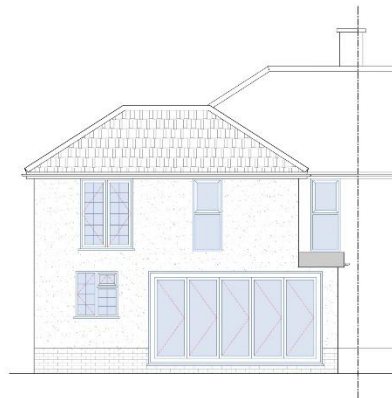
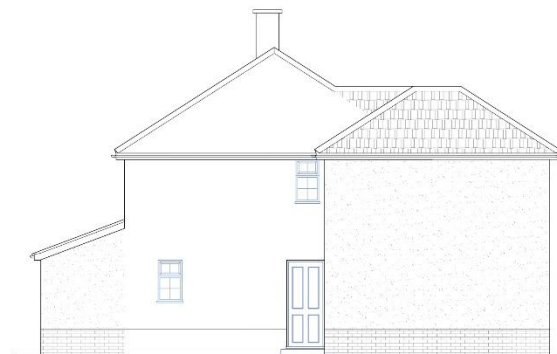
PROPOSED  
ELEVATIONS

PROPOSED FRONT ELEVATION

PROPOSED SIDE ELEVATION

PROPOSED REAR ELEVATION

| <i>Foreseen Impacts</i> | <p><b><i>Roosting bats</i></b></p> <p>Building B1 is to be significantly impacted by the proposed works, as the two-storey extension will join the existing roof, covering approximately 2/3, stopping around 1/3 of the way below the ridge line. This could result in the destruction of any bat roosts present and could cause disturbance, death or injury to bats. No impacts to roosting bats will occur during the single-storey porch extension on the northern aspect of building B1 as no suitable roosting features are present.</p> <p>The off-site neighbouring single-storey extension is not to be directly impacted as part of the proposed development. However, indirect effects through reducing the flight line to suitable roosting features may occur.</p> <p><b><i>Foraging and commuting bats</i></b></p> <p>Habitats on-site are of limited value to support foraging and commuting bats, due to its small size and developed nature. However, suitable features are present within the wider area including scattered trees, linear features (e.g. lines of trees and hedgerows), grassland, and pockets of woodland. The works are proposed to be restricted to on-site building B1 and immediately adjacent hard standing, and a small area of frequently mown grassland along the southern aspect only. No other habitats will be impacted. However, there is potential for indirect impacts resulting from increased artificial light levels that could deter bats from the site.</p> |
