## TECHNICAL NOTE

**Job Name:** Forbury Retail Park  
**Job No:** 330910122  
**Note No:** TN1  
**Date:** 05/06/2026  
**Prepared By:** Jamie Glossop  
**Subject:** Clarification Response to LPA comments on BNG

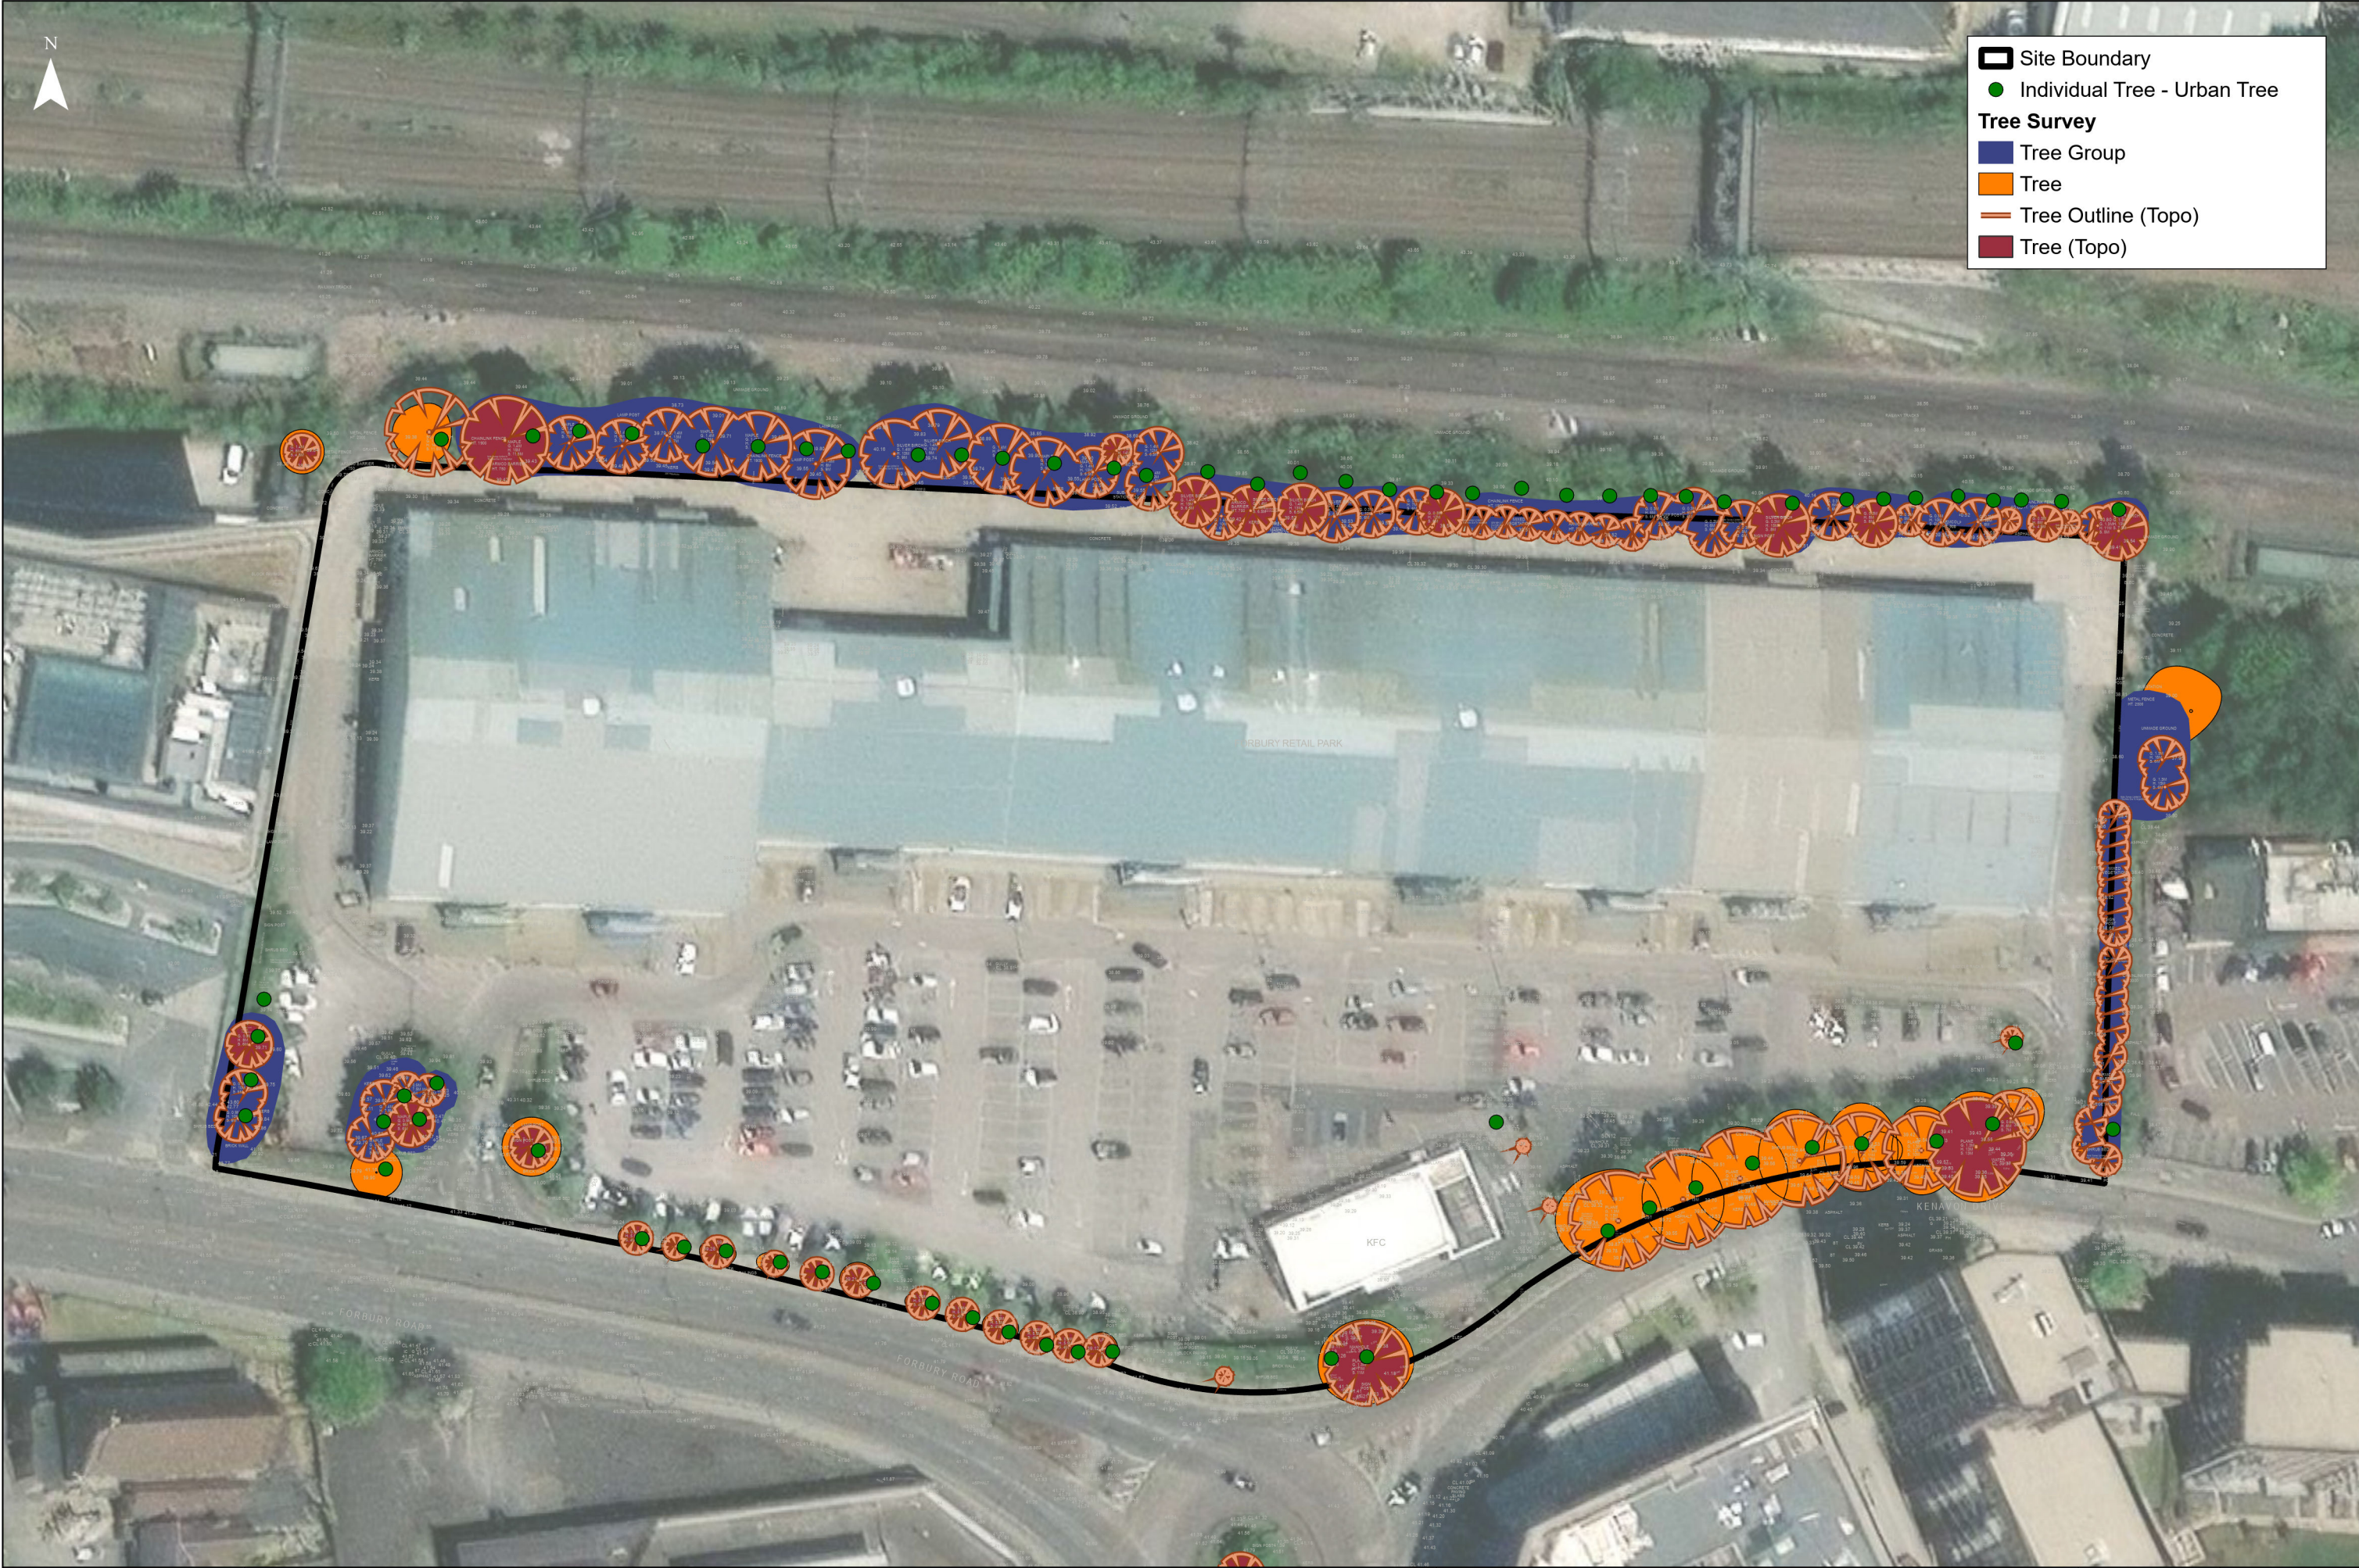
Figure 1 Tree location Figure

- 3.1 The Site was subject to an updated tree survey on 12<sup>th</sup> May 2026 with the results detailed within the Tree Constraints summary (Treeworks, 2026). The updated tree survey and topographical mapping was compared to the previously prepared UK Habitat (UKHab) plan and is provided as Figure 1 to this Technical Note. This identified that the previous topographical mapping used to inform the BNG assessment did not accurately show the location of the trees on the northern boundary. Having compared the updated tree survey with the previously prepared BNG figures, a total of 18 trees along the northern boundary are located inside or on the redline boundary and should have been included as part of the BNG baseline.

- 3.4 With regards to the previous trees included within the Site, the 34 trees included all trees within the redline. The 35<sup>th</sup> tree shown on the UKHab plan located to the south-east of the Site is located outside of the redline boundary and was therefore not included within the calculation.

- 4.1 The updated tree survey has identified that an additional 18 trees along the northern boundary should have been included within the BNG assessment. Clarification with regards to the number of trees previously included within BNG baseline (34 as opposed to 35) has also been provided.
- 4.2 A detailed BNG assessment will be submitted as part of the Reserved Matters Application and will further clarify the trees which have been included within the baseline and which are to be retained and planted. The principles of tree losses and tree retention are however expected to align with the current BNG report
