| 19-21 Castle St - External Works | | |
| TITLE | Existing Elevation - Proposed Works | |
| DRAWING NUMBER<br>P2026-0519-TRI-ZZ-EL-DR-B-2200 | | REV<br>S2 |

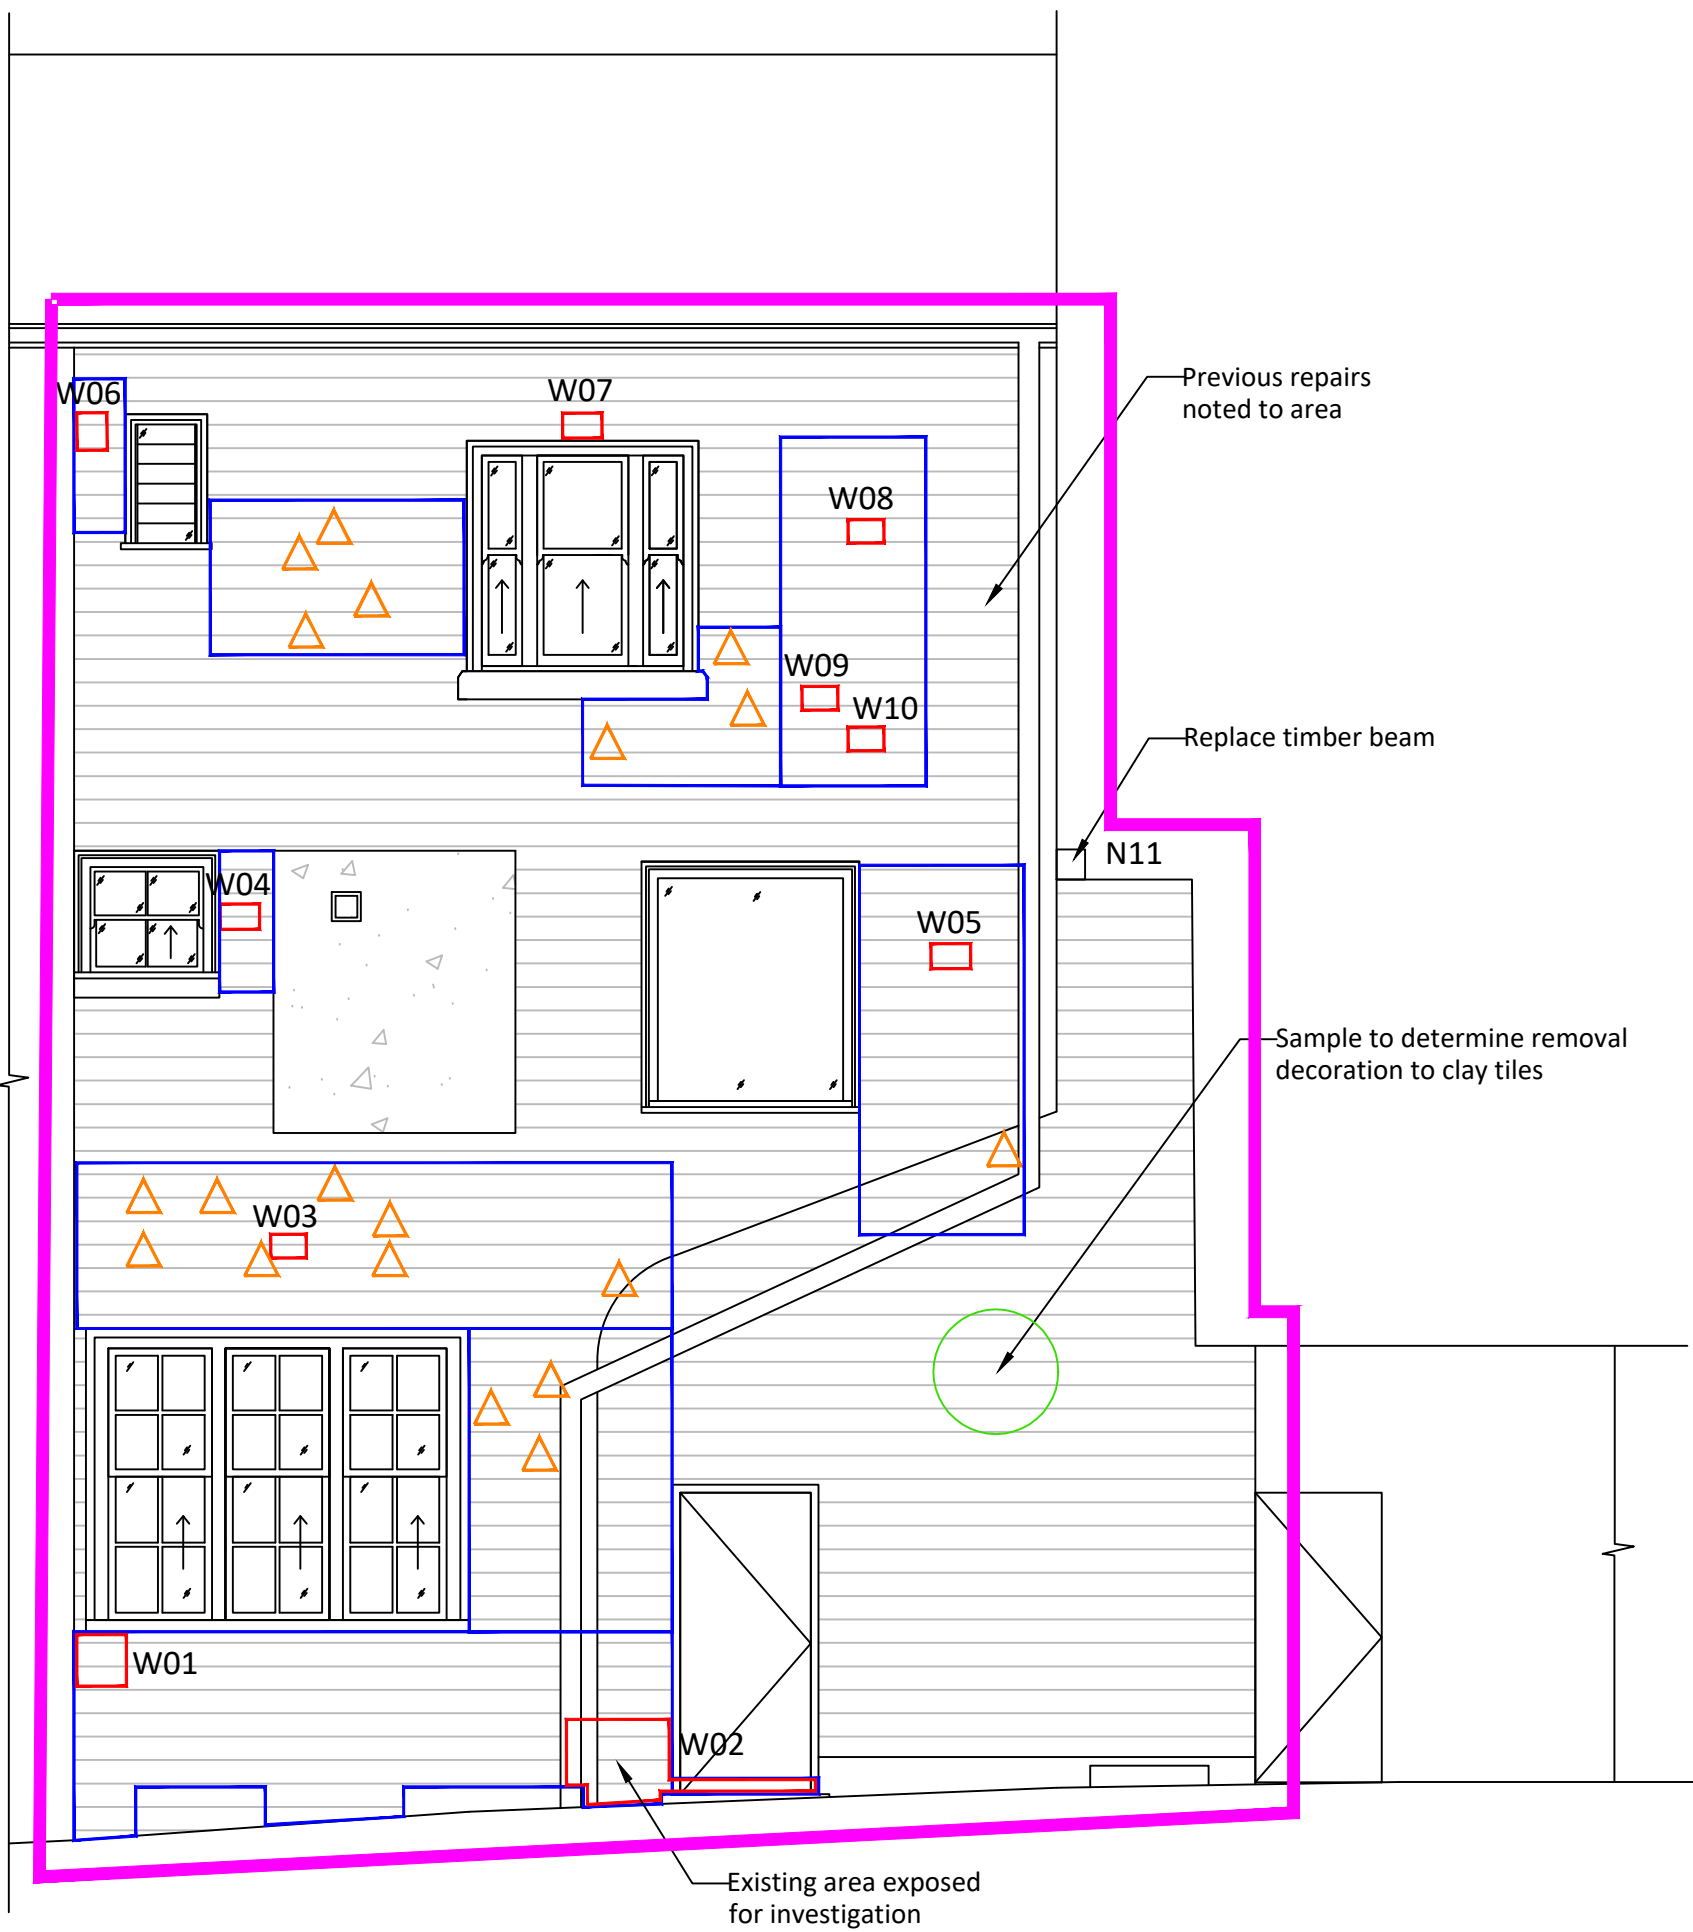
Existing Elevation 01 - Proposed Works

- AREAS INVESTIGATED  
TO FACADE
- EVIDENCE OF DAMAGE  
TO CLAY TILES
- PROPOSED WORKS  
TO FACADE
- EVIDENCE OF DAMAGE  
TO BRICKS
- SAMPLE CLEAN OF BRICK /  
CLAY TILE BEFORE ALL  
WORKS PROGRESSED
- W01

NOTE:  
Extent of repair subject to opening up. Existing clay tiles are likely to be fragile and difficult to salvage; full retention cannot be assured. Supplementary matching replacements may be necessary, subject to Conservation Officer agreement.
