## **BS5837:2012 Arboricultural Survey Impact Assessment & Arboricultural Method Statement**

**Site Address:  
Caversham Court Gardens  
Caversham  
Reading**

**Robert Toll**  
HND Urban Forestry - ND Forestry - MArborA  
Ref: RMT2075  
Site inspection date: 23<sup>rd</sup> June 2026  
Date report published: 30<sup>th</sup> June 2026  
Prepared for Reading Borough Council

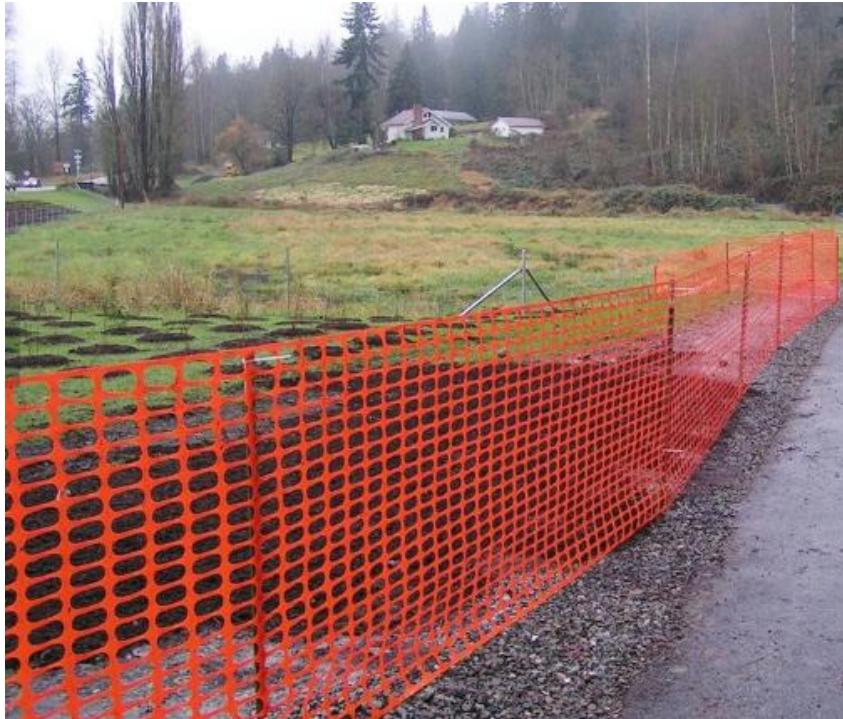
**Figure 4** – Plastic mesh barrier fencing

- 4.5** All lesser tree protection barriers will be erected in the positions shown by red lines at **Appendix 3** and in accordance with the specifications detailed in Figures 4 or 5.

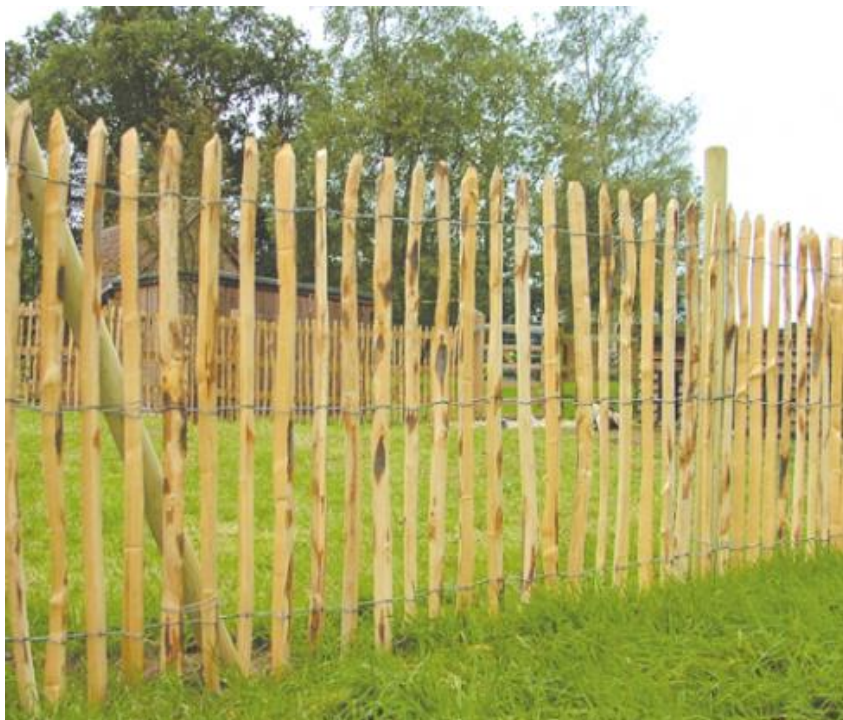
**Figure 5** – Chestnut pale fencing

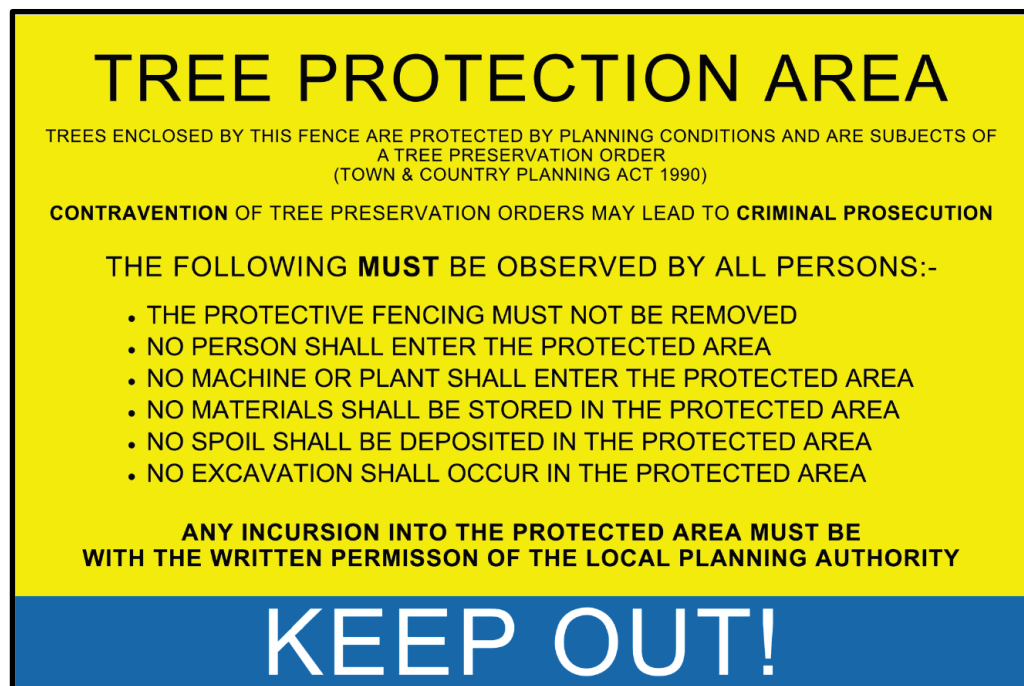
**Figure 6** – Examples of tree protection warning sign

- 4.6 All weather notices will be attached to the tree protection fencing.

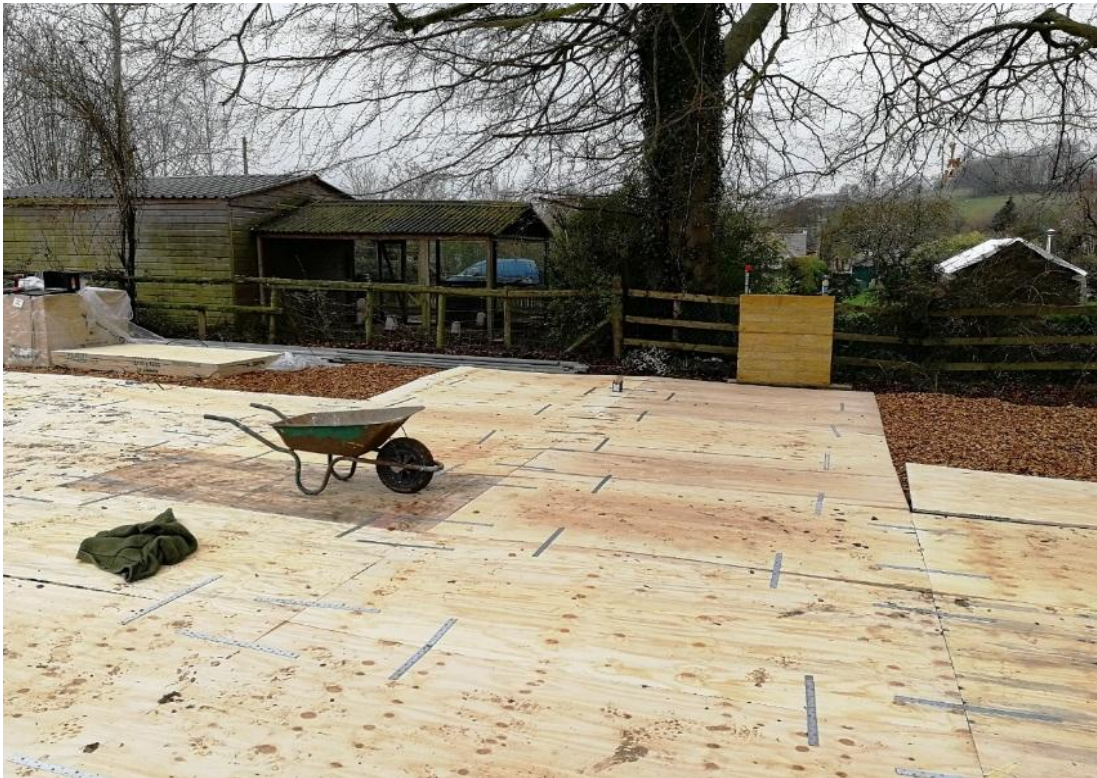
**Figure 8** – Plywood sheeting used as ground protection

- 4.7 A permeable geotextile such as Terram will be laid and onto this will be placed treated timber (100 mm x 80 mm) at spacings of no more than 1m. The area between the timber bearers will be filled with a compressible material such as woodchips and will then be covered by 20 mm thick marine ply which will be screwed down onto the timber (Figures 7 and 8). The plywood may need to be coated with a non-slip paint.

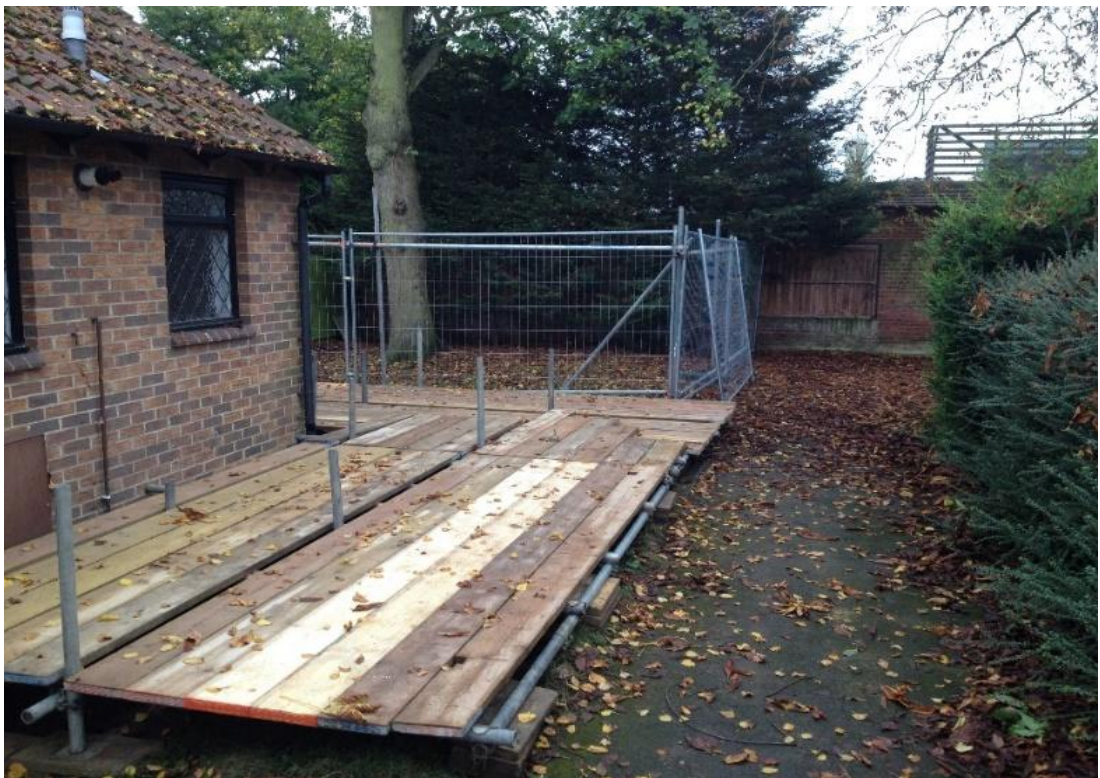
**Figure 9** – Specification for scaffold ground protection

- 4.8** Single thickness of scaffold boards placed on top of driven scaffold frame to form a suspended walkway (Figure 9).
