## **PRELIMINARY ECOLOGICAL APPRAISAL (DBW) AT 101 BELMONT ROAD READING**

**Prepared for:  
Ms S Brar  
101 Belmont Road  
Reading  
RG30 2UY**

**Ref: SPH/NP/PEA-26/16.06**

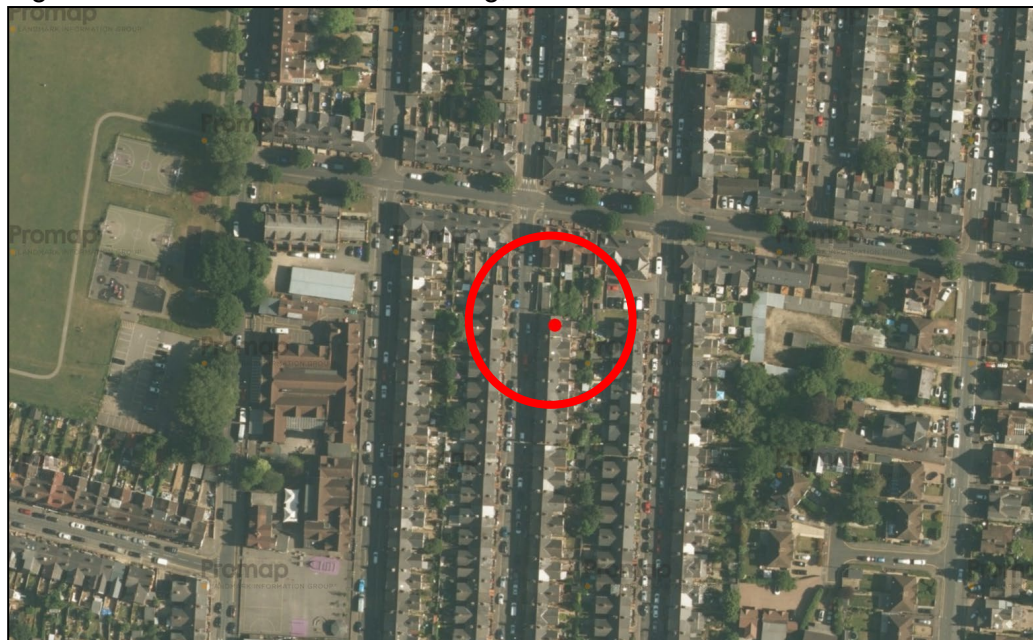
Figure 2. 101 Belmont Road, Reading, overview of the immediate area.

The building is located at Grid Reference SU69787327, see Figure 1 below. An overview of the immediate area is shown on Figure 2, courtesy of Bing Maps.

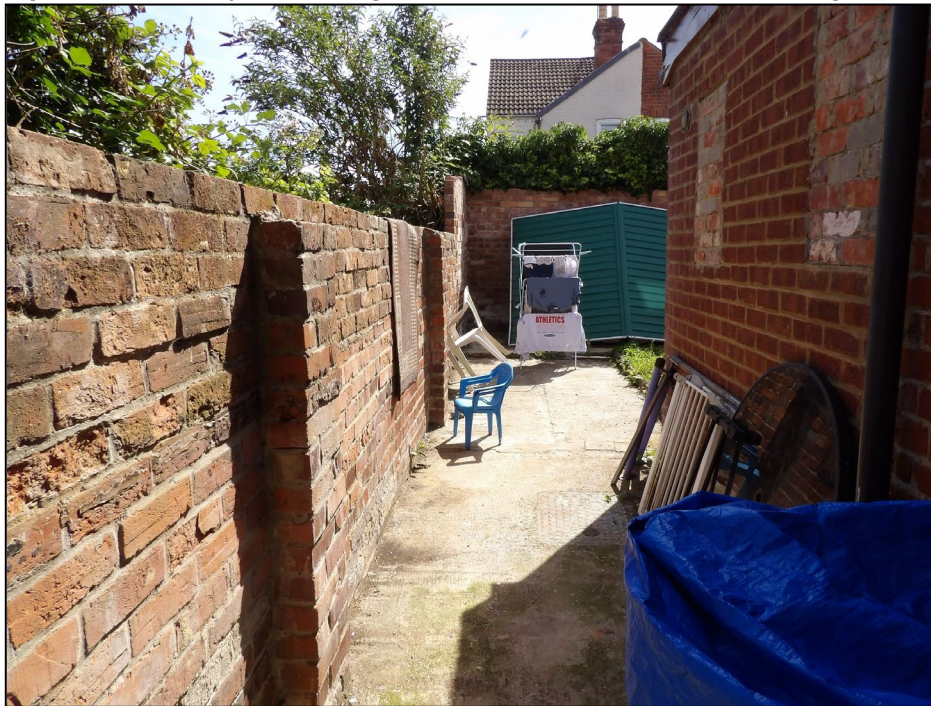
The application site comprises an end of terrace two-storey, brick-built property with rear single storey extension. The property abuts Belmont Road with space for the refuse bins. The small rear garden is approached via a concrete walkway and contains a small area of grass with shrubs in the neighbouring gardens, see Figure 3 below. The site itself offers no foraging and commuting habitat for bats and there is limited ecological connectivity to Prospect Park.

Figure 3. Walkway and rear garden. 101 Belmont Road, Reading. 16.06.26

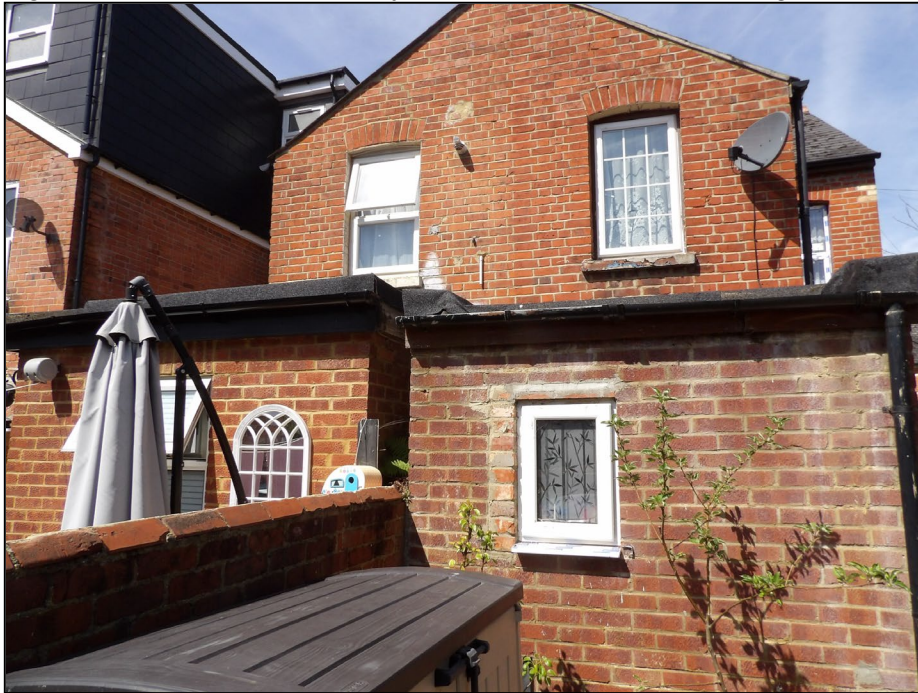
The property is a Victorian end of terrace, two-storey, brick-built building with single storey rear extension (see Figure 4 on page 8), all of which is in a fair to good condition externally. The cross-pitched roof is covered in slate tiles, none of which were broken or missing (see Figure 5 on page 8), and there are no gaps in the ridge tiles suitable for crevice dwelling bat species to utilise for roosting, see Figure 6 on page 9. The verges offer no roosting potential (see Figure 7 on page 9) and the valleys are sealed. The soffits and fascias are tight to the wall plate with no splits or gaps, see Figure 8 on page 10.

Figure 4. Rear view of property. 101 Belmont Road, Reading. 16.06.26

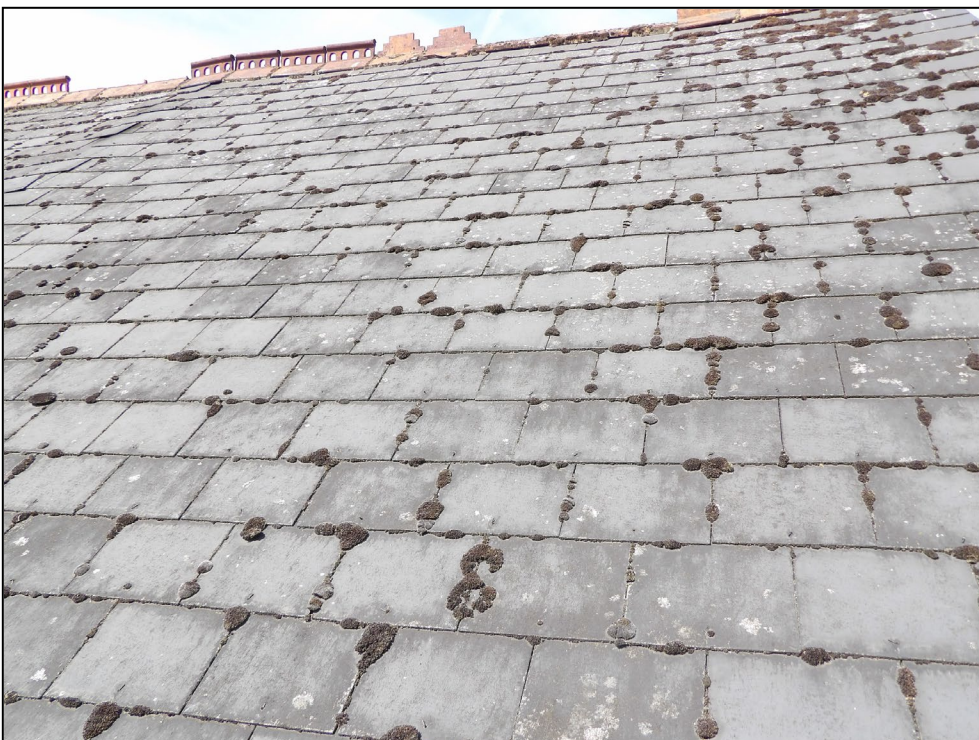
Figure 5. Example slate covering on roof. 101 Belmont Road, Reading. 16.06.26

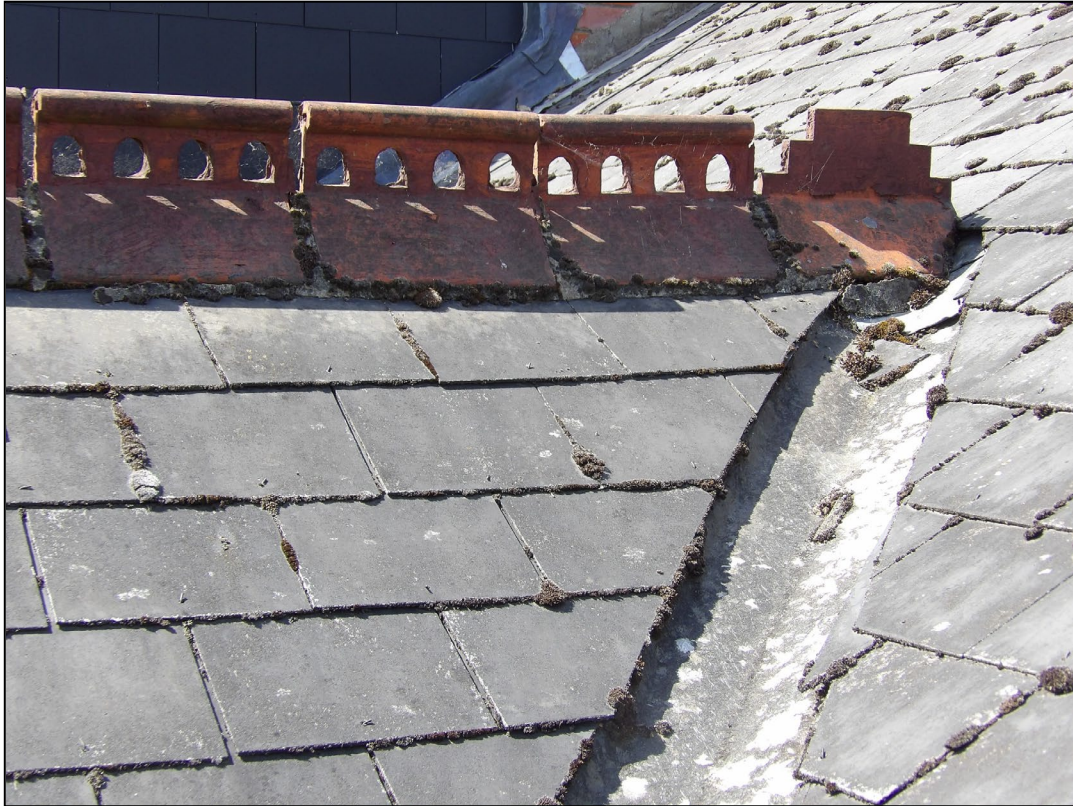
Figure 6. Example sealed ridge tiles. 101 Belmont Road, Reading. 16.06.26

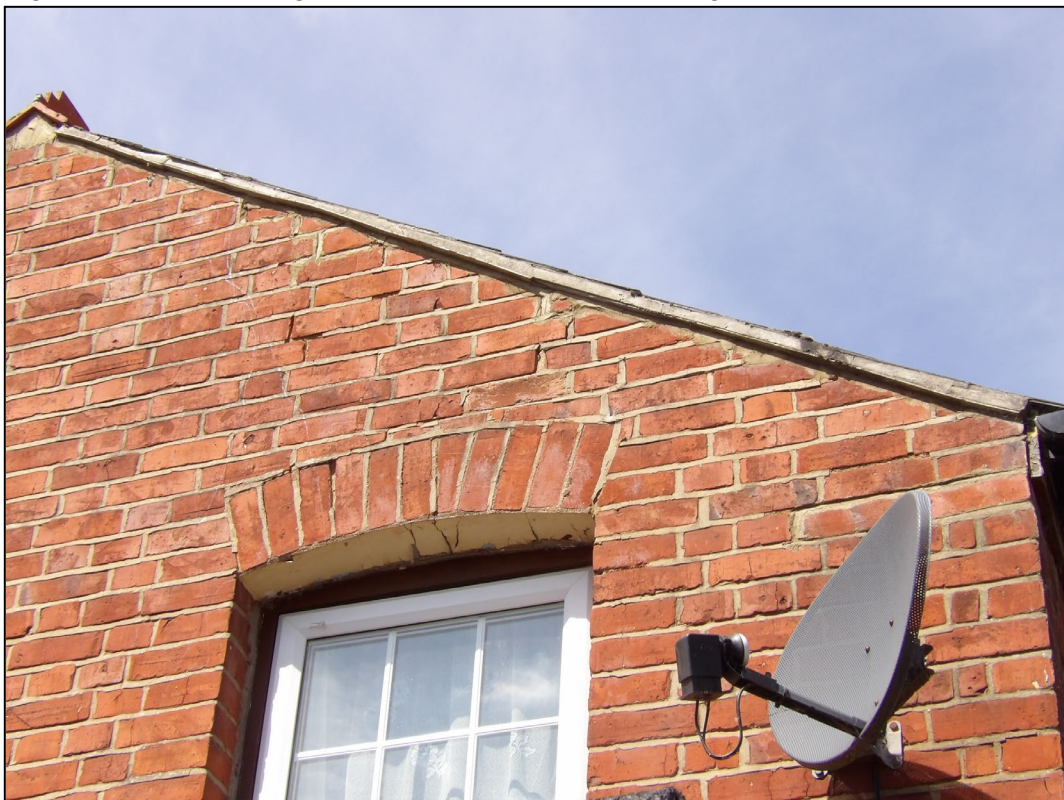
Figure 7. Example verges. 101 Belmont Road, Reading. 16.06.26

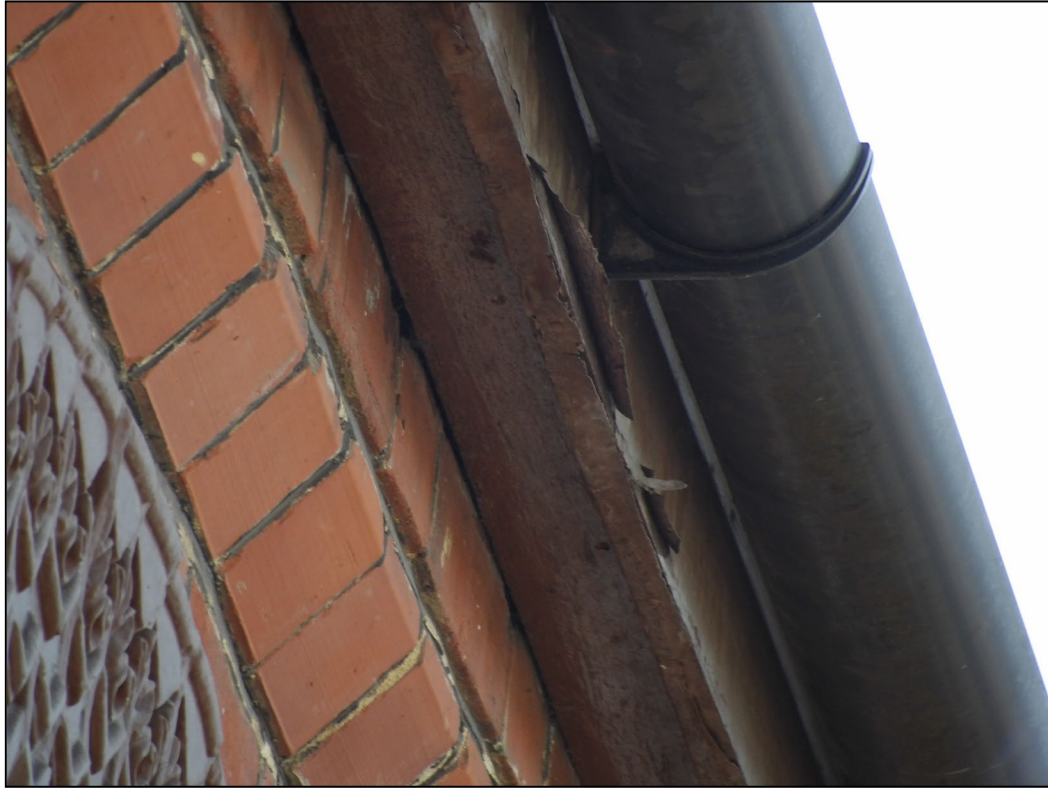
Figure 8. Example well fitted soffits and fascias. 101 Belmont Road, Reading. 16.06.26

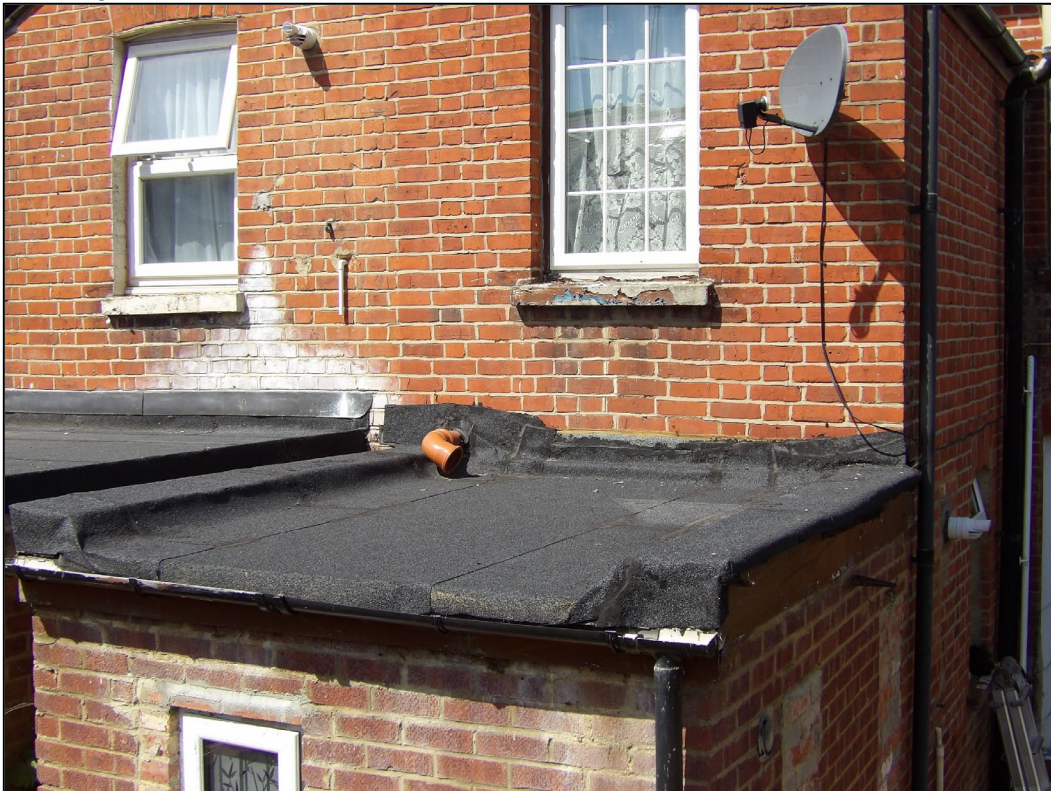
The roof of the rear, single storey extension is covered in well fitted bitumen felt with no rips or tears suitable for roosting and it is firmly affixed to the main dwelling (see Figure 9 on page 10), and the fascias are tightly fitting.

Figure 9. Bitumen covering rear extension and flush fascias. 101 Belmont Road, Reading. 16.06.26

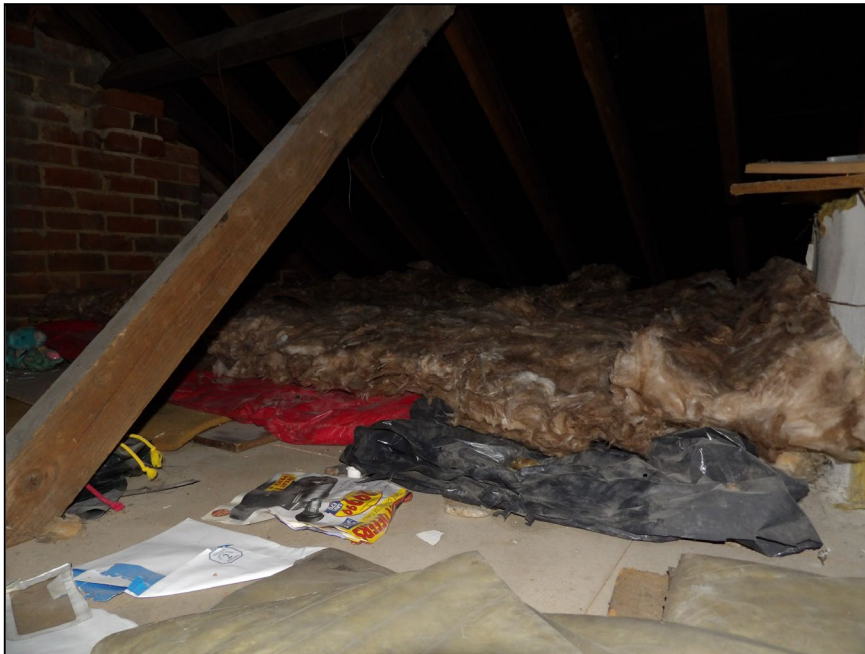
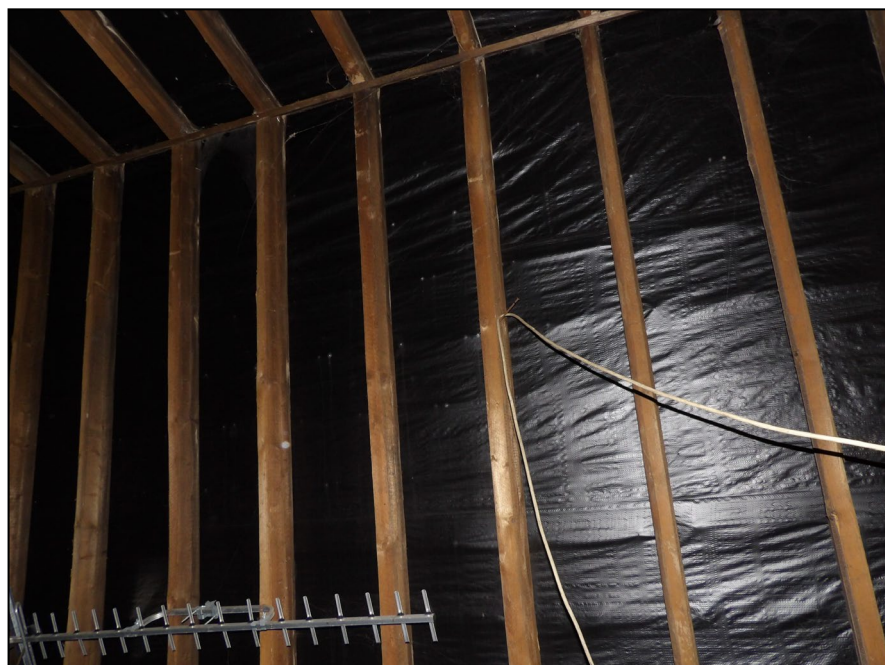
The main loft space of the property was accessed via small hatch in a cupboard. The loft space is in a fair condition internally. The loft is not lit, partially boarded and insulated, see Figure 10 below. The roof tiles were lined with bitumen felt, all of which is in a good condition with no rips or tears, see Figure 10 below.

No bats or evidence of bats was recorded during the internal inspection of the loft space and internally there appeared to be no roosting opportunities for bats within this space.

Figure 10. Example loft space and bitumen felt lining to tiles. 101 Belmont Road, Reading. 16.06.26
