# Preliminary Roost Assessment

59-61 Southampton Street, Reading RG1 2QP

This report is prepared to inform a planning application with Reading Borough Council. This proposal can be described as the extension and conversion to provide 8 x C3 residential units (Application number: PL/26/0029).

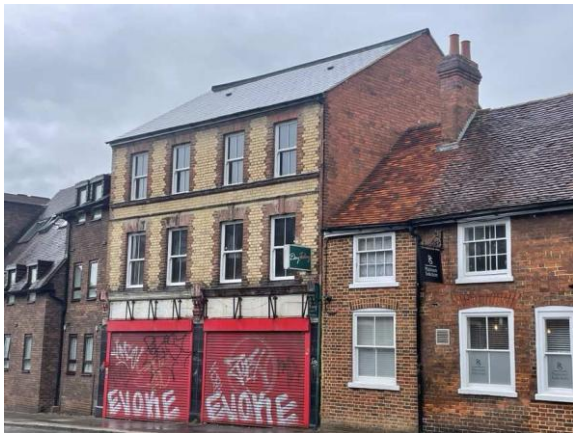
The building is a part three-storey, part two-storey brick-built structure with a pitched tile roof, currently used for commercial and residential purposes. There are flat roof sections located on the main roof of the building. The flat roofs are bitumen felt lined and are in very good condition with no gaps in which bats could roost. The doors and windows are UPVC and wooden framed and appear in good condition with no suitable bat roosting sites. The brickwork around the building appears in excellent condition with no gaps or cracks within which crevice-dwelling bats could roost. There is a superficial gap in the northern gable, which is due to a section of slipped mortar, however, the gap does not lead internally or onto the wall tops as there is still mortar within the gap. The building has negligible habitat value.

South-eastern and south-western elevations

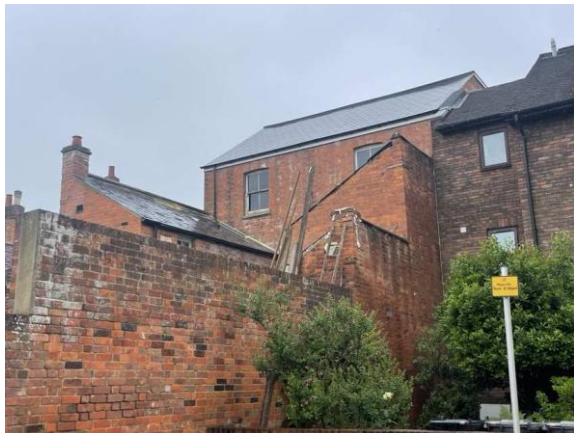
north-eastern and north-western elevations

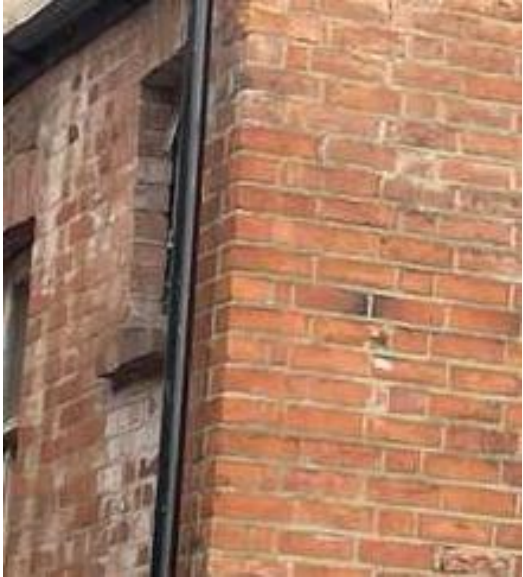
| Walls | Brick | <p><b>Condition/description</b><br/>The walls are in good condition with no defects.</p> <p><b>Suitability/access/evidence of bats</b><br/>No suitable roosting features were recorded.</p> | <p>B1 walls</p> |

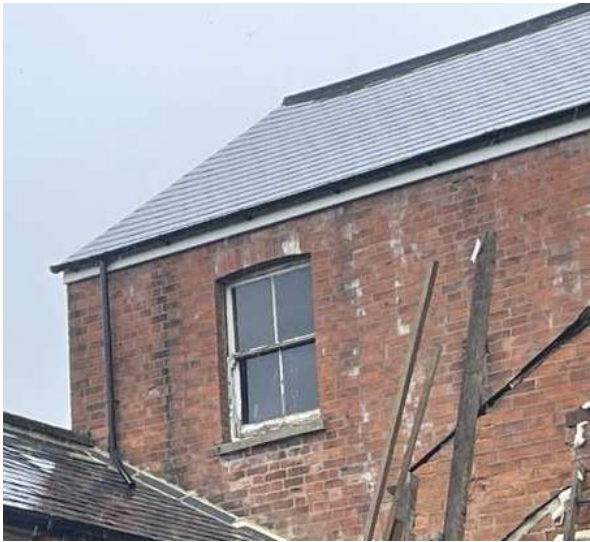
| Roof | Slate | <p><b>Condition/description</b><br/>The roof tiles are in good condition with no raised tiles under which bats could roost.</p> <p><b>Suitability/access/evidence of bats</b><br/>No suitable roosting features were recorded</p> | <p>B1 roof</p> |

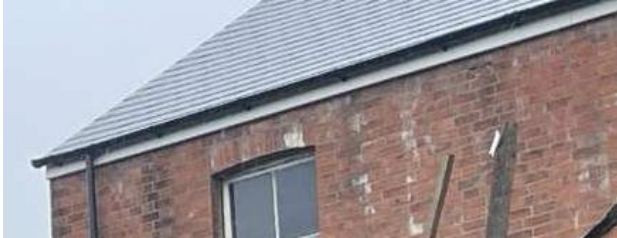
| Eaves | UPVC board | <p><b>Condition/description</b><br/>The eaves are in good condition with no defects.</p> <p><b>Suitability/access/evidence of bats</b><br/>No suitable roosting features were recorded.</p> | <p>B1 eaves</p> |

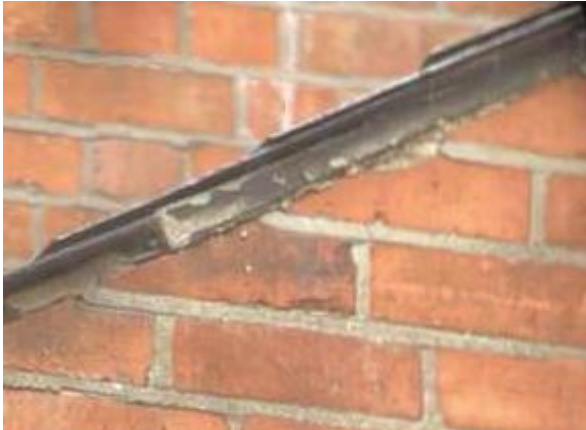
| Barge boards | uPVC | <p><b>Condition/description</b><br/>The barge boards / fascia boards are in good condition with no defects. Although, on the northern two-storey rear extension, there are no barge boards. The gable has a section of missing mortar, however, this is superficial and does not lead internally or onto the wall tops of the gable as there is still mortar within these gaps.</p> <p><b>Suitability/access/evidence of bats</b><br/>No suitable roosting features were recorded.</p> | <p>B1 barge boards / fascia boards</p> |
