## Bat Emergence and Re-Entry Surveys (BERS)

146 Southampton Street, Reading, RG1 2RD

**Project:**

A single-story rear extension, two story side extension, construction of an outbuilding and associated landscaping.

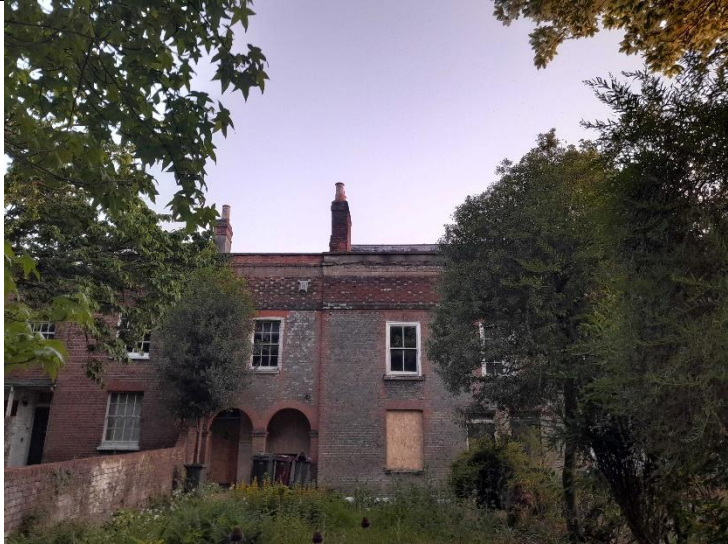
| Field Survey | | | | | |
|---|---|---|---|---|---|
| <i>Surveyor 1</i> | <b>No emergences observed.</b> | | Full elevation photo showing surveyors view. | | |
| | Key flight paths: Over B1 between the chimneys. | | | | |

| | <p>Key foraging activity: Throughout the front garden.</p> <p>Species observed: Common pipistrelle, soprano pipistrelle and noctule.</p> <p>Summary of general activity:</p> <p>The first bat activity recorded during the survey was a common pipistrelle seen commuting southeast across the garden at 21:42. Common pipistrelles were seen passing over the building, between the chimneys at 21:43, 21:57, and 22:07. From 21:44 and 21:50 a further two common pipistrelles were seen foraging in the front garden. A soprano pipistrelle was seen foraging in the front garden at 22:06. There was constant common pipistrelle heard but not seen activity between 22:44 and 22:53, followed again briefly at 23:07. A soprano pipistrelle was constantly heard but not seen from 22:56 to 23:11 and a noctule was heard but not seen at 23:03 and 23:07.</p> | |

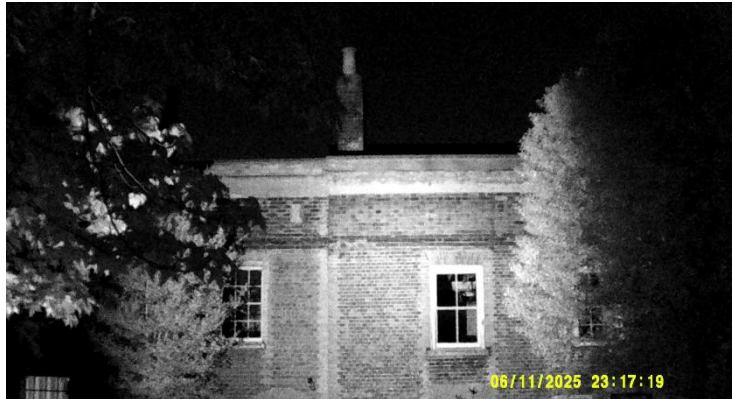
| <p><i>IR position 1</i><br/><i>Nightfox Whisker and</i><br/><i>Nightfox XB5 PRO</i></p> | <p>Camera position: observing the eastern elevation of the building.</p> <p><b>No emergences or entries into the building seen upon review.</b></p> <p>No additional observations or bat activity recorded upon review.</p> | <p>Darkest point full elevation photo showing surveyor's view.</p> |

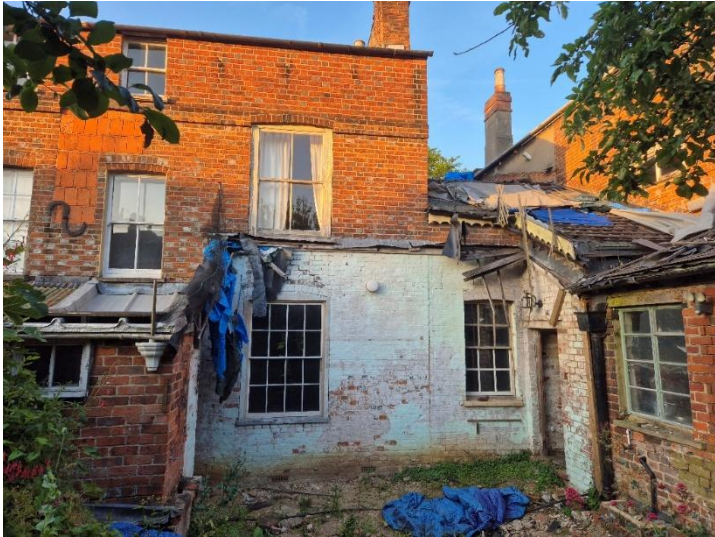
| <p><i>Surveyor 2</i></p> | <p><b>No emergencies observed.</b></p> <p>Key flight paths: west to east above B1 and west to east/ east to west above the single-storey section of B1.</p> <p>Key foraging activity: In front of the western elevation and above the single-storey section of B1.</p> <p>Species observed: Common pipistrelle and soprano pipistrelle.</p> <p>Summary of general activity:</p> <p>The first bat activity recorded during the survey was a common pipistrelle heard and not seen at 21:43, followed by another at 21:47. There was constant, intermittent common pipistrelle activity heard and not seen throughout the survey. At 21:49 a common pipistrelle was seen commuting above the single-storey section of B1 south of the site. Another common pipistrelle was seen commuting from west to east above B1 at 21:53. At 21:58 and 22:06 two common pipistrelles were seen foraging in the garden in front of the western elevation and above the single-storey section of B1. A soprano pipistrelle was heard and not seen at 23:09. The final bat activity recorded during the survey was a common pipistrelle at 23:13.</p> | <p>Full elevation photo showing surveyors view.</p> |

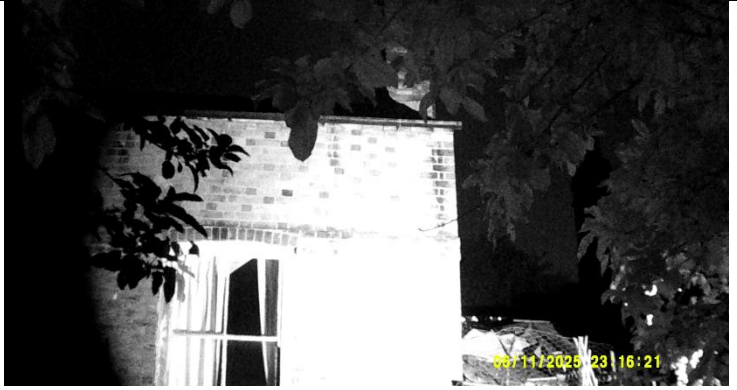
| <p><i>IR position 2</i><br/><i>Nightfox Whisker and</i><br/><i>Nightfox XB5 PRO</i></p> | <p>Camera position: observing the western elevation of the building.</p> <p><b>No emergencies or entries into the building seen upon review.</b></p> <p>A common pipistrelle can be seen flying north to south across the garden at 21:43, followed by another common pipistrelle seen foraging in front of the western elevation at 21:47.</p> | <p>Darkest point full elevation photo showing surveyor's view.</p> |

| | Identification can be confirmed through calls detected during the survey. | |

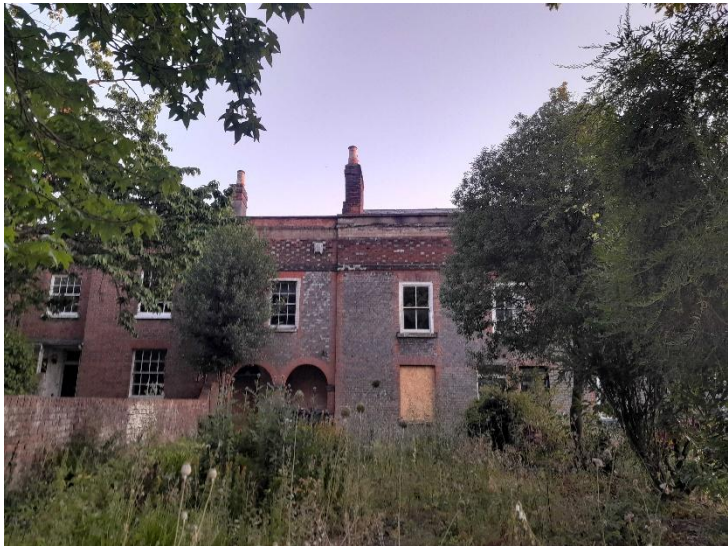
| Surveyor 1 | <p><b>No emergencies observed.</b></p> <p>Key flight paths: South to north across the front garden and east to west between the two chimneys above B1.</p> <p>Key foraging activity: Throughout the front garden, in front of the eastern elevation.</p> <p>Species observed: Common pipistrelle</p> <p>Summary of general activity:</p> <p>The first bat activity recorded during the survey was a common pipistrelle, seen passing northwards through the garden at 21:52. A common pipistrelle was observed feeding in the front garden, with constant activity from 21:53 to 22:20. Common pipistrelles were seen passing between the chimneys of the building at 21:28, 22:01, 22:07 and 22:12. Between 22:30 and 23:07 there were six occurrences of common pipistrelles heard and not seen, including the final bat activity.</p> | | <p>Full elevation photo showing surveyors view.</p> | |

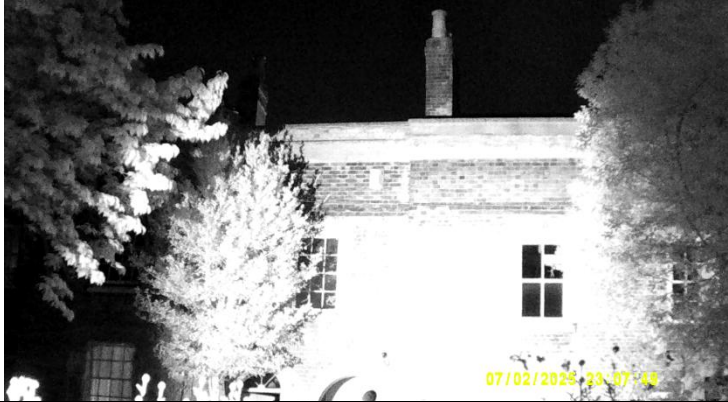
| <p><i>IR position 1</i><br/><i>Nightfox Whisker and</i><br/><i>Nightfox XB5 PRO</i></p> | <p>Camera position: observing the eastern elevation of the building.</p> <p><b>No emergencies or entries into the building seen upon review.</b></p> <p>Three common pipistrelles were seen commuting from west to east between the two chimneys above B1 at 22:04, 22:12 and 22:15. Two further common pipistrelles were seen commuting from east to west along the same flight path at 22:18 and 22:30.</p> | <p>Darkest point full elevation photo showing surveyor's view.</p> |

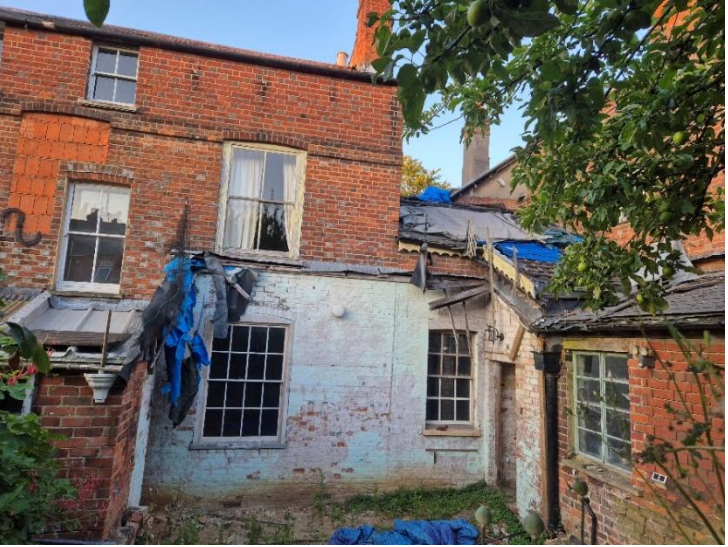
| <p><i>Surveyor 2</i></p> | <p><b>No emergencies observed.</b></p> <p>Key flight paths: Above the single-storey section between the two chimneys.<br/>Key foraging activity: N/A<br/>Species observed: Common pipistrelle.</p> <p>Summary of general activity:<br/>The first bat activity recorded during the survey was a common pipistrelle heard and not seen at 21:49. There was constant common pipistrelle heard and not seen activity from 21:56 to 22:30. Two common pipistrelles were seen commuting above the single-story section, one at 21:57 and the other at 22:01. Between 22:35 and 22:48 there were three final occurrences of common pipistrelles heard and not seen, including the final bat activity of the night.</p> | <p>Full elevation photo showing surveyors view.</p> |

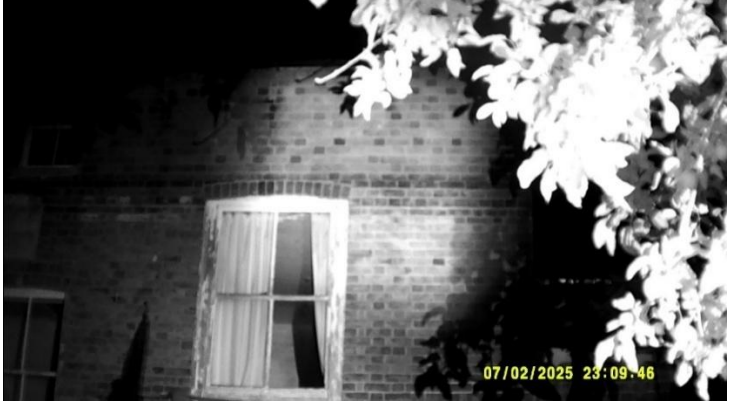
| <p><i>IR position 2</i></p> | <p>Camera position: observing the western elevation of the building.</p> | <p>Darkest point full elevation photo showing surveyor's view.</p> |

| <i>Nightfox Whisker and Nightfox XB5 PRO</i> | <p><b>No emergencies or entries into the building seen upon review.</b></p> <p>No additional observations or bat activity recorded upon review.</p> | |

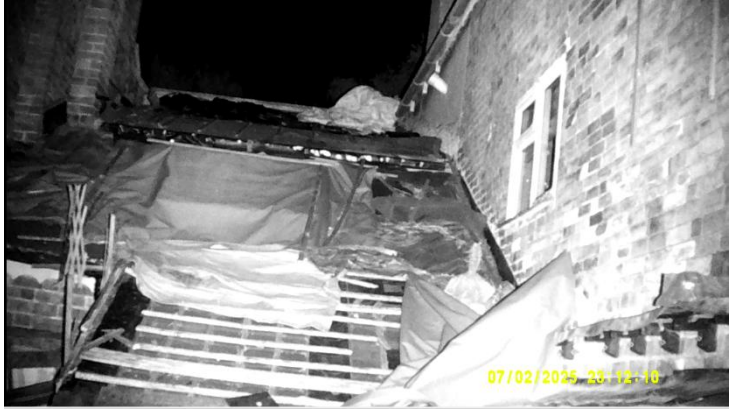
| <i>IR position 3<br/>Unmanned IR<br/>Nightfox Whisker</i> | <p>Camera position: observing the southwestern elevation of the building.</p> <p><b>No emergencies or entries into the building seen upon review.</b></p> <p>There are three occurrences of common pipistrelles commuting between the chimneys heading east towards the front garden. One common pipistrelle can be seen flying towards the front garden at 22:07 and then returning to the back garden at 22:08. The final bat activity detected on the unmanned camera were two common pipistrelles commuting west between the chimneys towards the back of the garden at 22:18 and 22:30.</p> | <p>Darkest point full elevation photo showing unmanned IR's view.</p> |

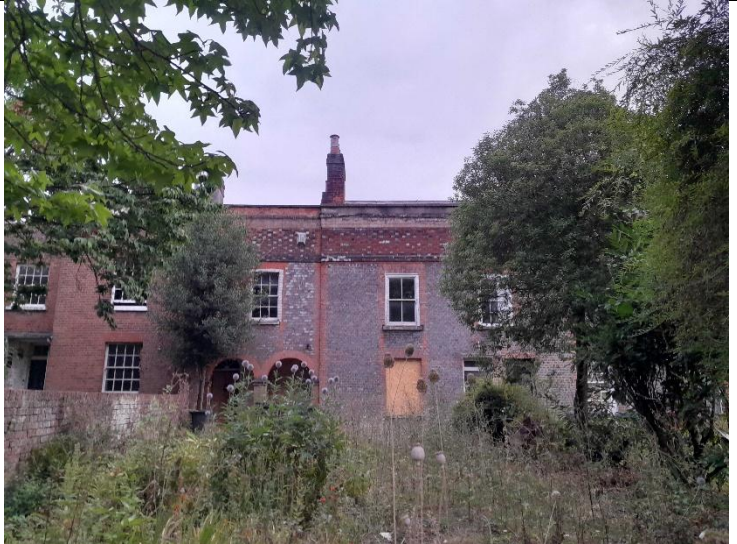
| Surveyor 1 | No emergencies observed.<br><br>Key flight paths: southeast through the front garden, west over B1 between the chimneys and northwest through the front garden.<br>Key foraging activity: Throughout the front garden<br>Species observed: Common pipistrelle and noctule<br><br>Summary of general activity:<br>The first bat was a common pipistrelle seen commuting southeast through the garden at 21:18. There was constant common pipistrelle foraging activity in the front garden | | | Full elevation photo showing surveyors view. | |

| | <p>between 21:24 and 21:38. At 21:30 a common pipistrelle was seen passing over the building between the chimneys, towards the rear garden, and again at 21:45. A common pipistrelle was seen passing through the garden heading northwest at 21:41 and again at 22:04. A common pipistrelle was heard but not seen at 22:11 and a noctule was heard but not seen at 22:34.</p> | |

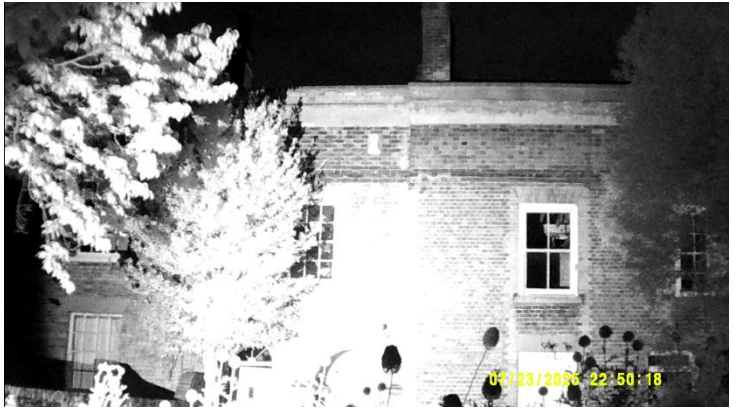
| <p><i>IR position 1</i><br/><i>Nightfox Whisker and</i><br/><i>Nightfox XB5 PRO</i></p> | <p>Camera position: observing the eastern elevation of the building.</p> <p><b>No emergences or entries into the building seen upon review.</b></p> <p>No additional observations or bat activity recorded upon review.</p> | <p>Darkest point full elevation photo showing surveyor's view.</p> |

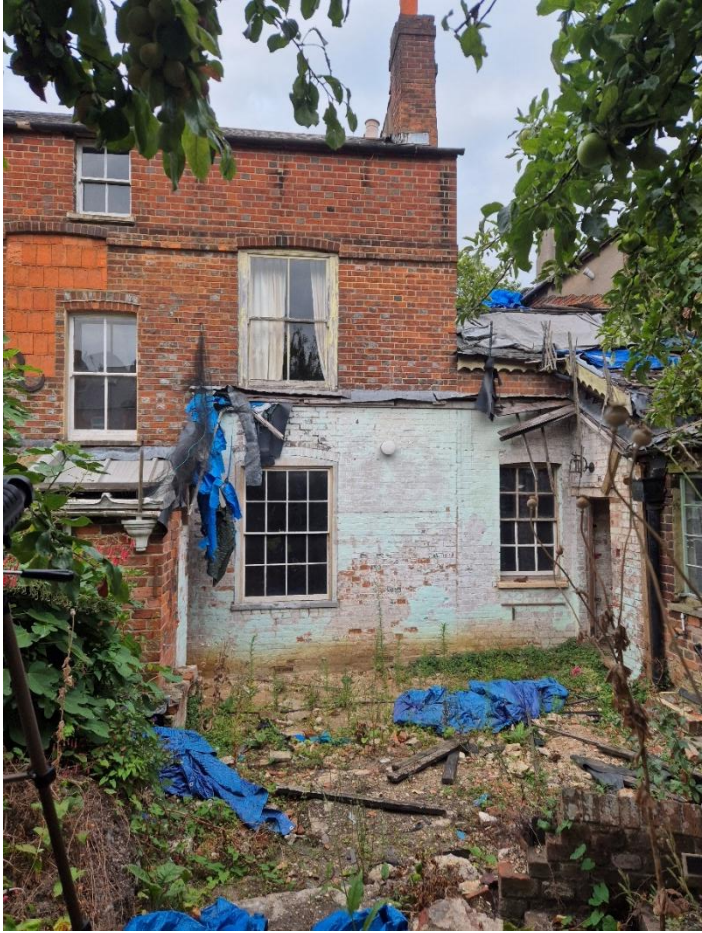
| <p><i>Surveyor 2</i></p> | <p><b>No emergences observed.</b></p> | <p>Full elevation photo showing surveyors view.</p> |

| | <p>Key flight paths: North to south across the rear garden and above the single-story section of B1.</p> <p>Key foraging activity: N/A</p> <p>Species observed: Common pipistrelle and noctule.</p> <p>Summary of general activity:</p> <p>The first activity recorded during the survey was a common pipistrelle heard but not seen at 21:28. Two common pipistrelles were seen commuting above the single-story section of B1 at 21:30 and 21:33. At 21:34 another common pipistrelle was seen flying north to south across the rear garden. Two additional individuals were heard and not seen between 21:34 and 21:44. More commuting activity was observed along the previous flight path above the single-story section of B1 at 21:45 and 21:46. Between 21:51 and 22:47 there were eight occurrences of bats being heard and not seen; five common pipistrelles and three noctules.</p> | |

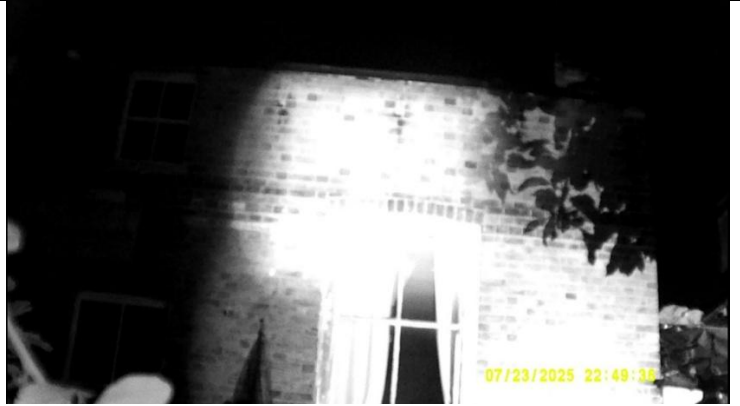
| <p><i>IR position 2</i></p> <p><i>Nightfox Whisker and</i></p> <p><i>Nightfox XB5 PRO</i></p> | <p>Camera position: observing the western elevation of the building.</p> <p><b>No emergences or entries into the building seen upon review.</b></p> <p>Six additional bats were seen within the IR footage between 21:31 and 22:40. Two were recorded commuting north to</p> | <p>Darkest point full elevation photo showing surveyor's view.</p> |

| | <p>south across the garden, three foraging throughout the garden and above the single storey.</p> | |

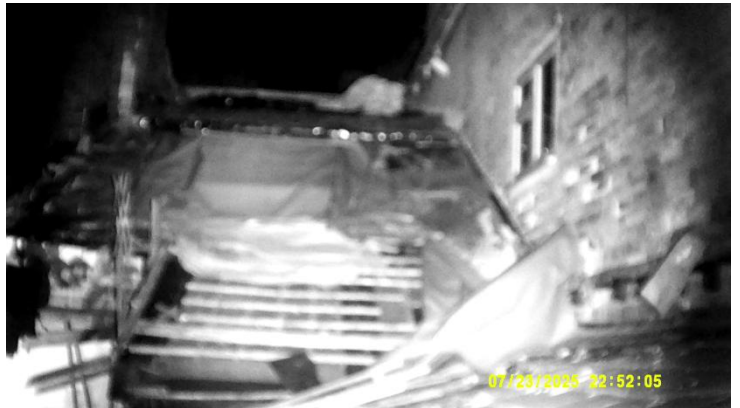
| <p><i>IR position 3</i><br/><i>Unmanned IR</i><br/><i>Nightfox Whisker</i></p> | <p>Camera position: observing the southwestern elevation of the building.</p> <p><b>No emergencies or entries into the building seen upon review.</b></p> <p>Two common pipistrelles can be seen flying west between the chimneys above B1 at 21:30 and 21:45.</p> | <p>Darkest point full elevation photo showing unmanned IR's view.</p> |
