## Preliminary Roost Assessment

Tilehurst Cobbler, School Road, Tilehurst, Reading RG31 5AR

This report is prepared to inform a planning application with Reading Borough Council. The creation of a single-person studio at the back of Tilehurst Cobbler, the creation of a dormer on the existing roof of Tilehurst Cobbler as well as internal rearrangements.

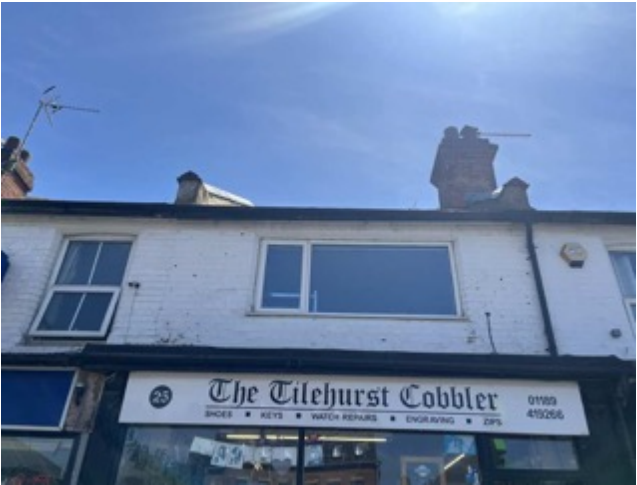
Building B1, northwestern elevation

B1 is a two-storey building, with a split commercial and residential use. Its walls are comprised of painted brick and its windows and doors are uPVC. The roof features slate roof tiles. No evidence of bats was found during the internal inspection. This building has been assessed to have negligible suitability for roosting bats due to an absence of features that can be used by crevice or void dwelling species.

In line with current development plans, B1 will undergo roof alterations and an extension to the rear. B1 has been assessed to have **negligible** suitability for roosting bats; therefore, no further surveys are recommended.

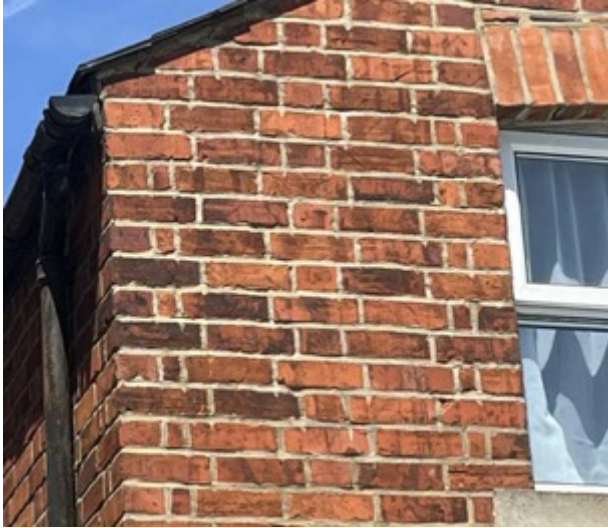
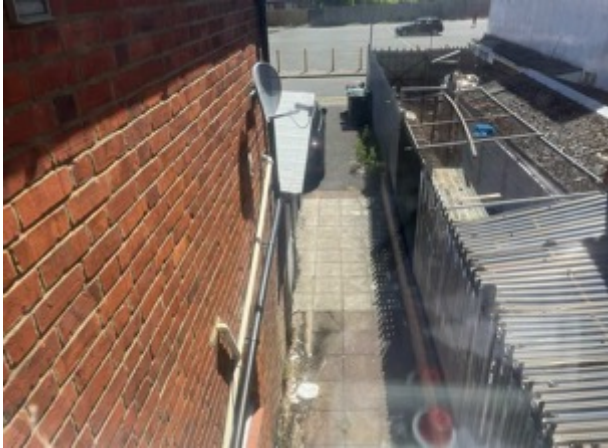
| Walls | Brick | <p><b>Condition/description</b></p> <p>The brickwork was in good condition, with no cracks, crevices or areas of missing mortar that could offer access to crevice dwelling species.</p> <p><b>Suitability/access/evidence of bats</b></p> <p>None.</p> | <p><i>B1 walls, southeastern elevation</i></p> <p><i>B1 walls, southern elevation</i></p> |

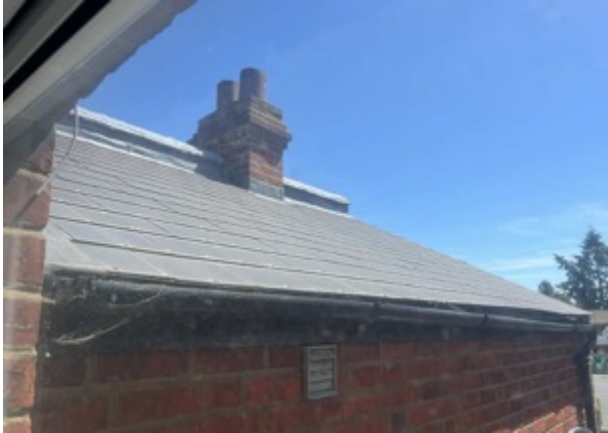
| Roof | Slate | <p><b>Condition/description</b></p> <p>The tiles were seen to be in good condition, with no lifted tiles present that could offer suitability for roosting bats.</p> <p><b>Suitability/access/evidence of bats</b></p> <p>None.</p> | <p><i>B1 roof</i></p> |

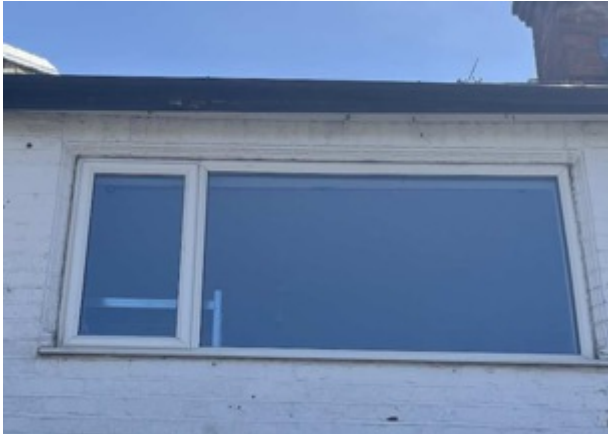
| Windows | uPVC | <p><b>Condition/description</b></p> <p>The windows and doors are in good condition, with minimal signs of wear. They are tight and well-sealed and therefore offer no suitability for roosting bats.</p> <p><b>Suitability/access/evidence of bats</b></p> | <p><i>B1 window / doors frames and lintels</i></p> |

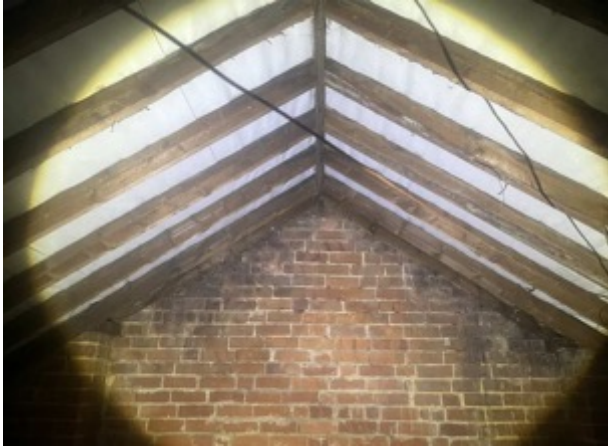
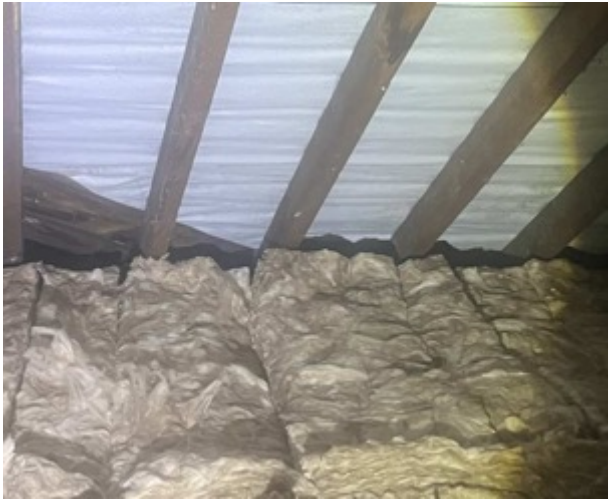
| Internal void 1 | Timber rafters.<br>Mineral wool insulation | <p><b>Condition/description</b></p> <p>The timber rafters were in good condition, with no evidence of splitting, cracking or crevices that could provide roosting opportunities. No light ingress was observed within the roof void, indicating that there were no discernible access points into the space. Furthermore, no evidence of bats, such as droppings, staining or feeding remains, was recorded during the inspection. The insulation also showed no signs of rodent activity, suggesting that the roof void is well sealed. Consequently, the roof void was assessed as providing negligible suitability for crevice-dwelling bat species.</p> <p><b>Suitability/access/evidence of bats</b></p> <p>None.</p> | <p><i>B1 internal void 1, facing southwest</i></p> <p><i>B1 internal void 1, floor, facing west</i></p> |

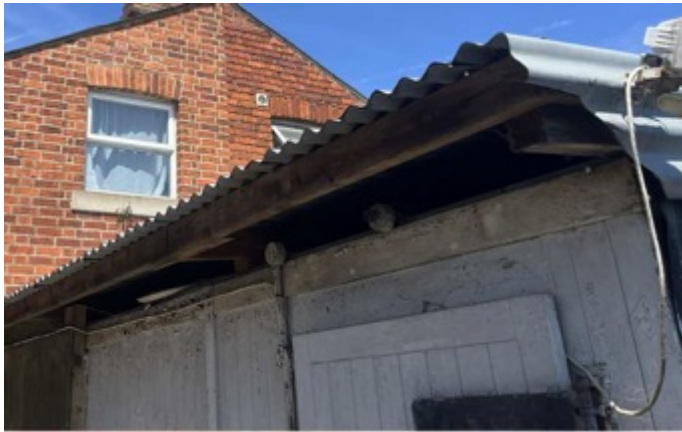
Building B2, southwestern elevation

B2 is a shed with a corrugated iron sheet flat roof. It has brick walls to the west and north and is block built to the east. Internally, it has two voids; however, these voids join at the centre. B2 has been assessed to have **negligible** suitability for roosting bats.

B2 will be demolished in line with development plans. B2 has been assessed to have **negligible** suitability for roosting bats.

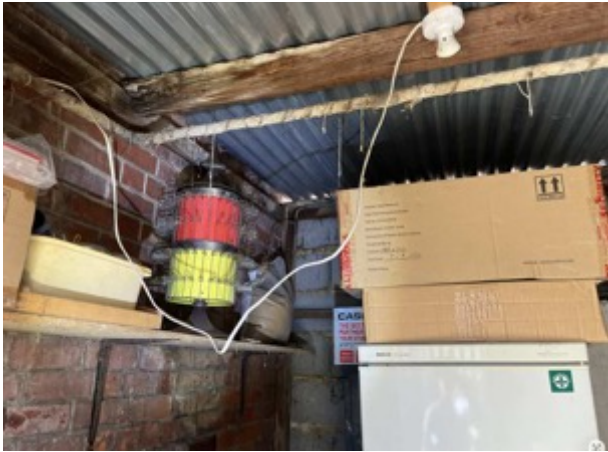
| Feature | Materials/Details | Condition / description / suitability | Photograph |
|---|---|---|---|
| Internal void | Internally, the outbuilding's use is split between a shed (NW) and disused meat refrigerator (NE). The two voids join at the centre (see photo facing north) and have therefore been assessed as one. | <p><b>Condition/description</b><br/>N/A</p> <p><b>Suitability/access/evidence of bats</b><br/>Several gaps were identified at the wall tops on the north-west (NW) and south-west (SW) elevations, providing direct access into the roof void. Although these gaps could potentially allow bats to enter the void, no evidence of bats was identified internally or externally, and no suitable crevice roosting features were present.</p> | <p>B2 internal void, facing northwest, featuring gaps into the building</p> |

While the gaps above the ridge beam provide limited access to the roof void for void-dwelling species, each void offers a maximum of approximately 1.5 m of uninterrupted flight space. This is considered insufficient to facilitate warm-up flights typically undertaken by such species within roosts.

Furthermore, the building is likely to experience significant temperature fluctuations due to the nature of its construction materials, resulting in an unstable thermal environment that is unlikely to support roosting bats. The gaps on the south-west elevation also permit substantial light ingress into the roof void. Taking these factors into account, together with the regular disturbance associated with use of the space for storage, Building B2 is assessed as having negligible suitability for roosting bats.
