## Preliminary Roost Assessment

Highfields, Routh Lane, Tilehurst, Reading, RG30 4JY

This report is prepared to inform a planning application with the Reading Borough Council. The proposed development is described as:  
*Double storey side extension over garage and single-storey rear extension across the full width of the house.*

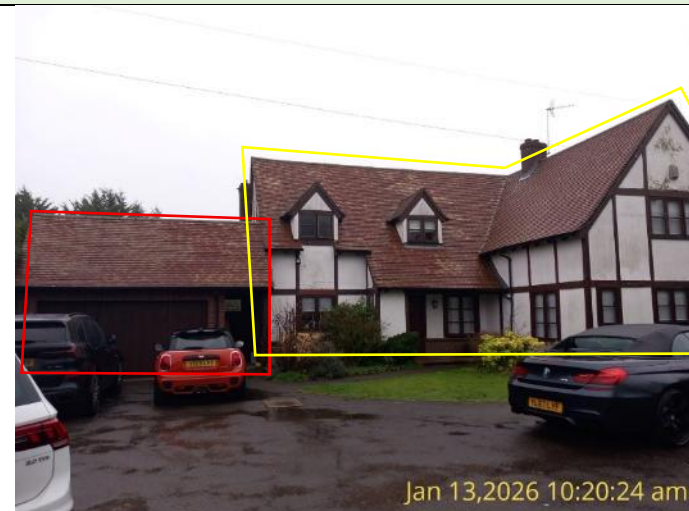
Figure 1: B1 – Northwest elevation.

B1 is a detached dwelling with a pitched and gabled roof clad in clay tiles. B1a (yellow) is the main residential building, and B1b (red), is the garage.

There are dormer windows on the front and rear of B1a.

Both B1a and B1b will be affected by the proposed development. B1 is assessed as **moderate** for bat roosting suitability.

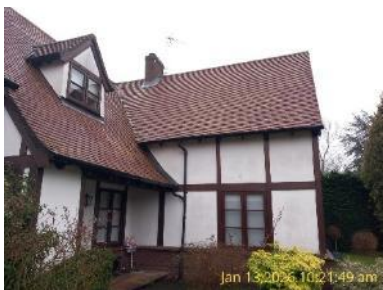
| Feature | Materials | Condition/description | Suitability/access/evidence of bats |
|---|---|---|---|
| Walls | Brick, rendered and painted<br> | Good condition, no visible gaps or cracks. | There are no opportunities for crevice dwelling bats to roost in the brickwork.<br>No evidence of bat use found. |

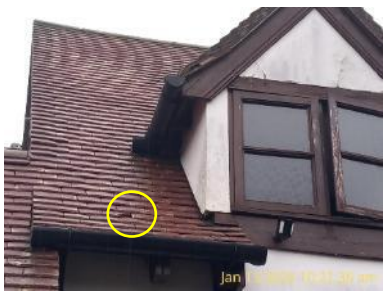
| Roof | Clay<br> | Clay tiles are mostly flush and in good condition. There are a few examples of broken tiles (<10). Mortar all intact along verges. | Small gaps under ridge and roof tiles on the roof could present some limited and low value roosting opportunities for individual bats, please refer to Appendix 4 for additional photos. |

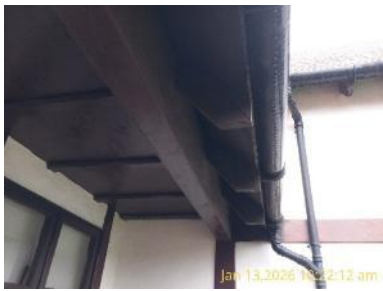
| Eaves | Timber soffit boxes<br> | Tight fitting | N/A |

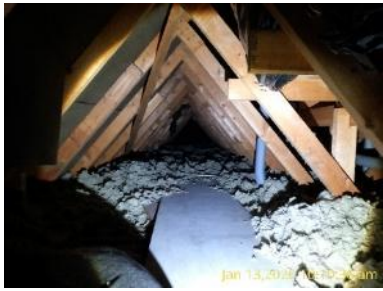
| Internal voids | One loft space<br> | Roof is lined internally with bitumen. The floor of the loft is not boarded and is lined with mineral wool insulation. The loft was recorded at 16.4°C and 75.9% relative humidity at the time of survey. | No bat evidence or access points noted. |

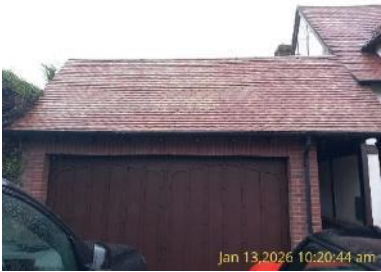
| Walls | Brick and mortar<br> A photograph showing a red brick wall and a dark brown garage door. The roof is made of red tiles. A timestamp 'Jan 13, 2026 10:20:44 am' is visible at the bottom right of the photo. | Good condition. | There are no opportunities for crevice dwelling bats to roost in the brickwork.<br>No evidence of bat use found. |

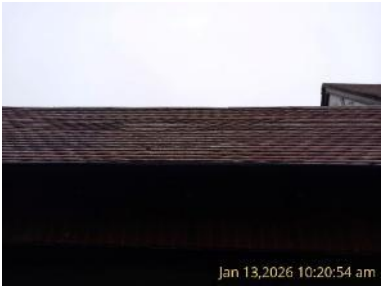
| Roof | Clay<br> A photograph showing a close-up of dark brown clay roof tiles. A timestamp 'Jan 13, 2026 10:20:54 am' is visible at the bottom right of the photo. | Clay tiles are mostly flush and in good condition. There are a few examples of broken tiles (<5). Mortar all intact along verges. | Small gaps under ridge and roof tiles on the roof could present some limited and low value roosting opportunities for individual bats, please refer to Appendix 4 for additional photos. |

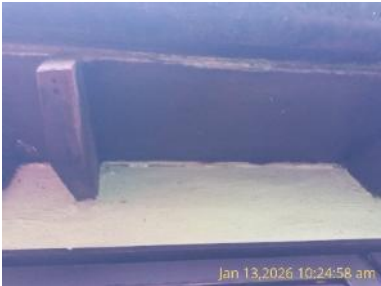
| Eaves | Timber soffit boxes<br> A photograph showing a close-up of a wooden soffit box. A timestamp 'Jan 13, 2026 10:24:58 am' is visible at the bottom right of the photo. | Tight fitting | N/A |

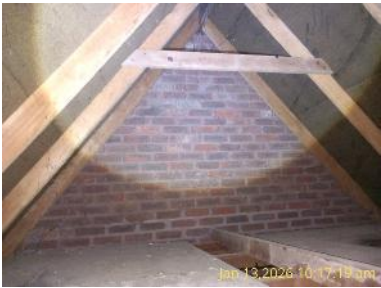
| Internal voids | One loft space<br> | Roof is lined internally with bitumen. The floor of the loft is boarded. The loft was recorded at 14.8°C and 70.3% relative humidity at the time of survey. | No bat evidence or access points noted. Heavily dust laden cobwebs were present at the apex of the roof, indicating a lack of activity within the void. |

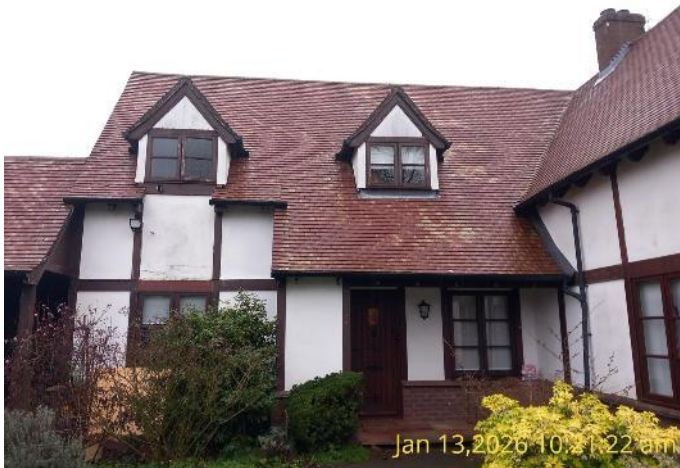
Figure 2: B1a – West elevation

There are two dormer windows on the western elevation of B1a.

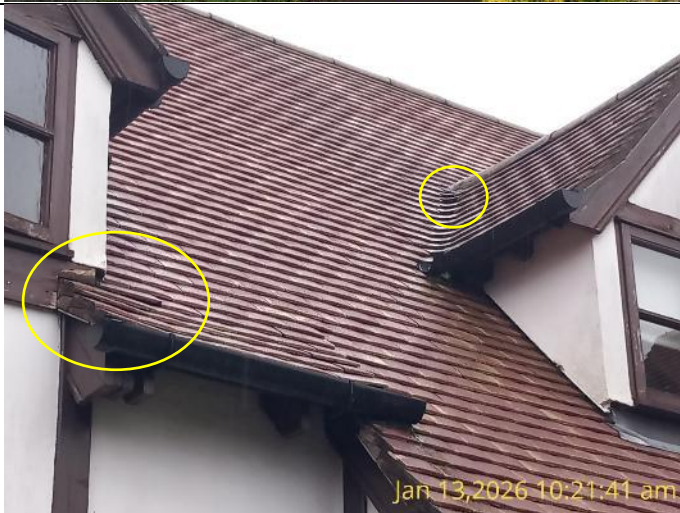
Figure 3: B1a – West elevation

There are raised tiles in areas which could accommodate roosting crevice dwelling bats, such as pipistrelles.

| <i>Recommendations</i> | <p>No works to the property that may block or remove potential roosting features should be carried out until the required surveys have been completed. Undertaking such work beforehand could unlawfully affect bats if present and may compromise the validity of the surveys and hinder the planning application process.</p> <p><b>Two</b> bat emergence and re-entry surveys are required during the active bat season (optimal May to August, suboptimal September) to confirm presence or likely absence of a bat roost in the building. Both of the surveys should be completed during the optimal survey period mid-May to August inclusive.</p> <p>Infra-red cameras should be used as an aid. Surveys should be a minimum of three weeks apart.</p> <p><b>Four</b> surveyors are required to provide full coverage of the building.</p> |

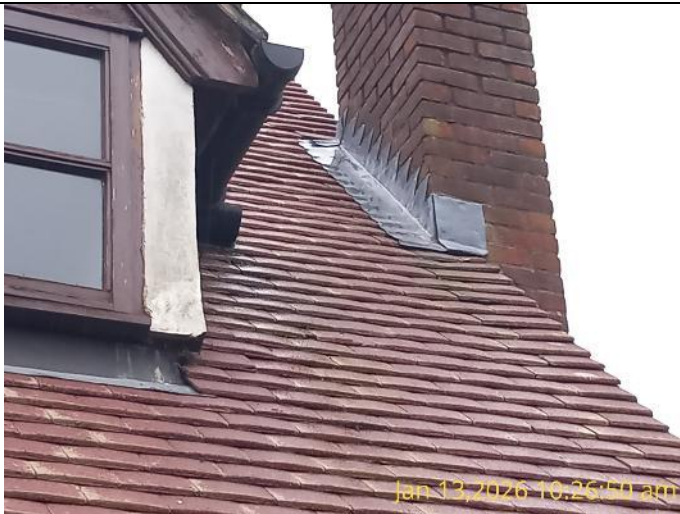
Figure 4: B1a – Lead flashing  
There are areas of raised lead flashing along the base of the chimney, as well as at the base of the dormer windows. Bats are known to utilise lead flashing for roosting.

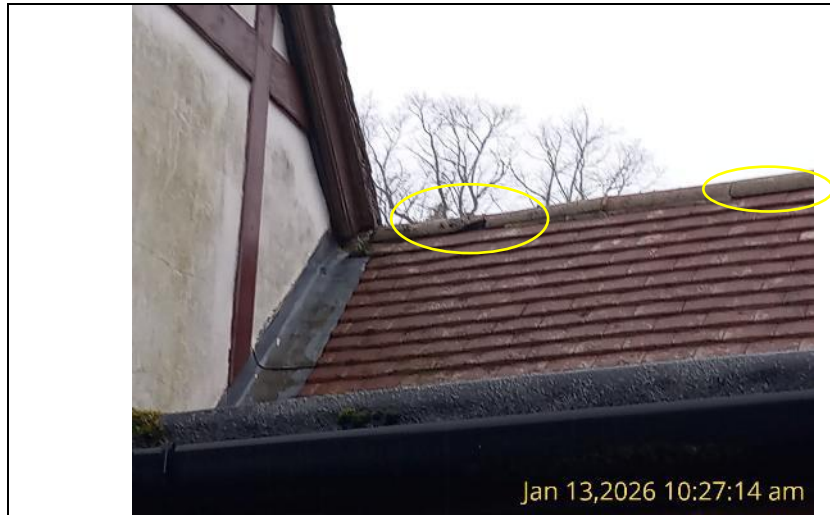
Figure 6: B1b – East elevation  
Areas of broken/raised tiles suitable for roosting bats.
