# 86 London Street

## HERITAGE STATEMENT

### Proposed windows and Ground Floor structural strengthening

Document No: 1347-HR-A-HS-XX-03  
Rev 03

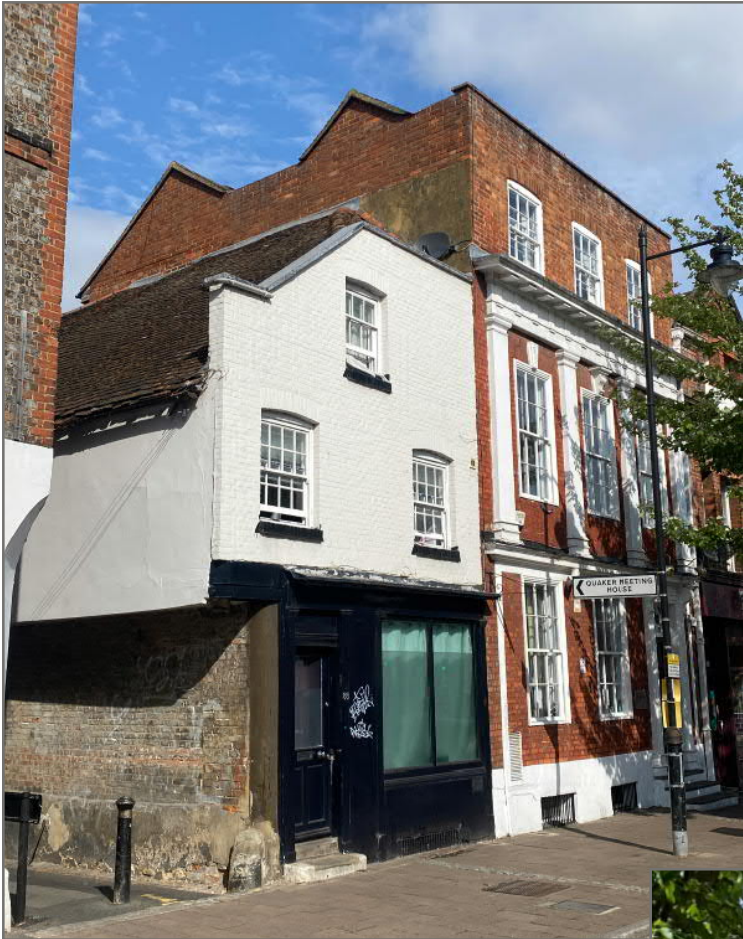
The east elevation is clearly the 'facade' of the property in its purest sense. The elevation can be read as a 'squat' Palladian town house whose architectural features reflect a Greek temple: the 'base' level at the Ground Floor, separated from the First Floor by a string course, the First Floor as the 'piano nobile', however, rather than a 'typical' two storeys of larger town houses in the Georgian era, the second floor is the 'attic' floor, separated by a large entablature.

Social hierarchy of the interior is reflected in decoration, or lack thereof: the main reception floor includes pilasters to frame the three windows bays and central 'keystones' to the window heads. The main entrance is reached via three steps up to the door, flanked by brackets

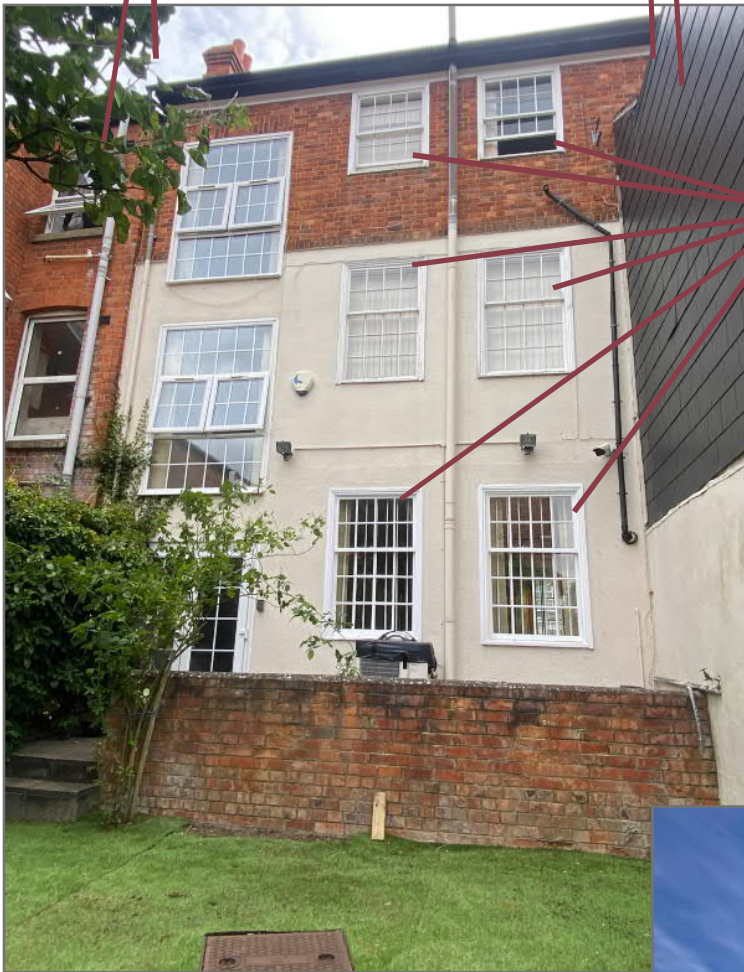
Image 20: Rear west elevation

Sash windows replaced in the 1990s with modern spiral balanced windows

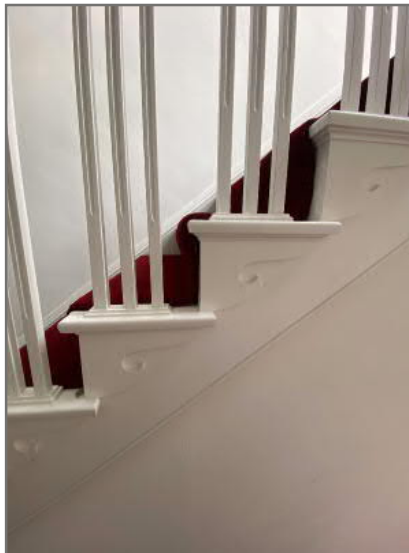
Image 25: open-string staircase: detail of treads with trio of square profile balusters with inset detail, set into a raised block

Floor grille for air conditioning - void that connects with the Basement

Staircase design with deep treads and two curtail steps (curved at the bottom of the flight)

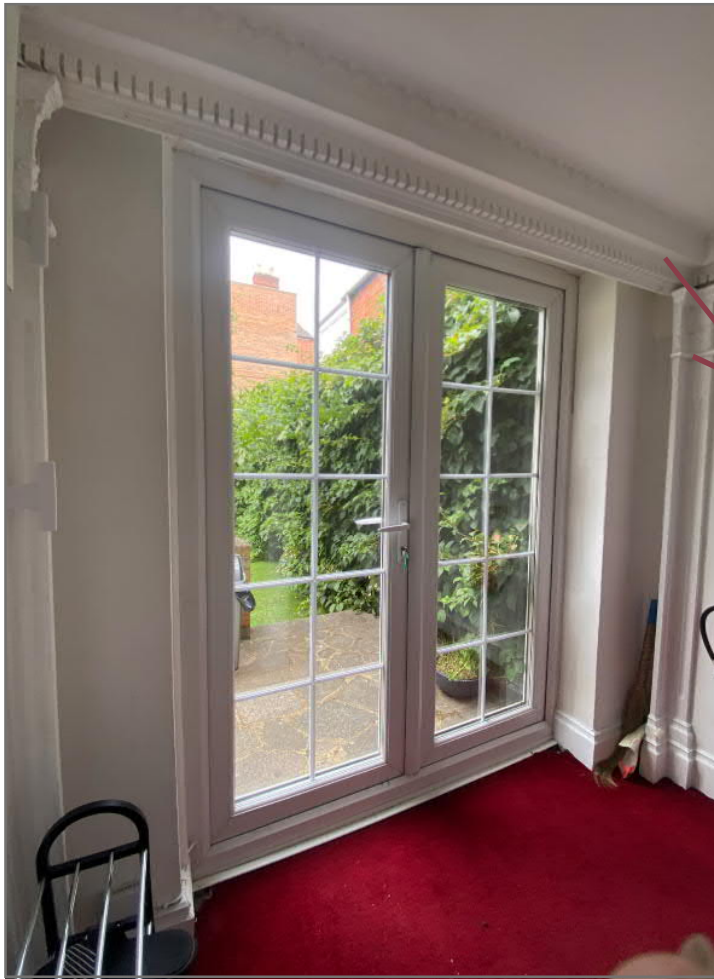
Image 29: Ground Floor door to garden

Elaborate fibrous plaster cornice to window head - investigated and advised by Locker and Riley as likely between 20-30 years' old

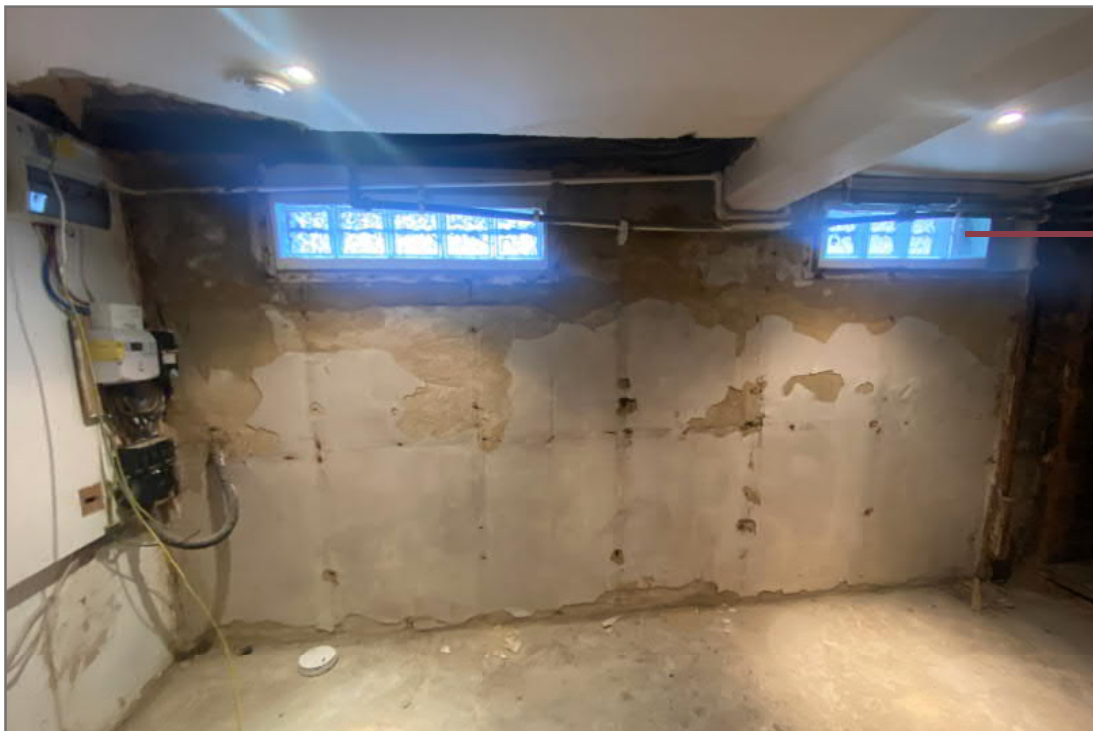
Image 30: Basement - windows 'W3' and 'W4' onto London Street

Glass blocks

- 4.3.1 The proposed replacement windows are of white painted timber frame double glazed units with opening vents to improve the ability of the windows to 'purge' ventilate the Basement. The kitchen and shower rooms produce high-humidity spaces which require humid air to be removed to minimise the risk of condensation occurring on the surfaces which could deteriorate the fabric. The existing windows onto London Street are glass blocks which are not openable and are not thermally efficient. These are not the original windows, and do not align with the windows above (also not original). The proposed windows would be of more appropriate materials - of white painted timber frame - and are proposed to be doubled glazed for improved thermal efficiency. There would be an openable vent to allow the air to be changed. The existing railings would be retained to provide security from the street, as currently provided.

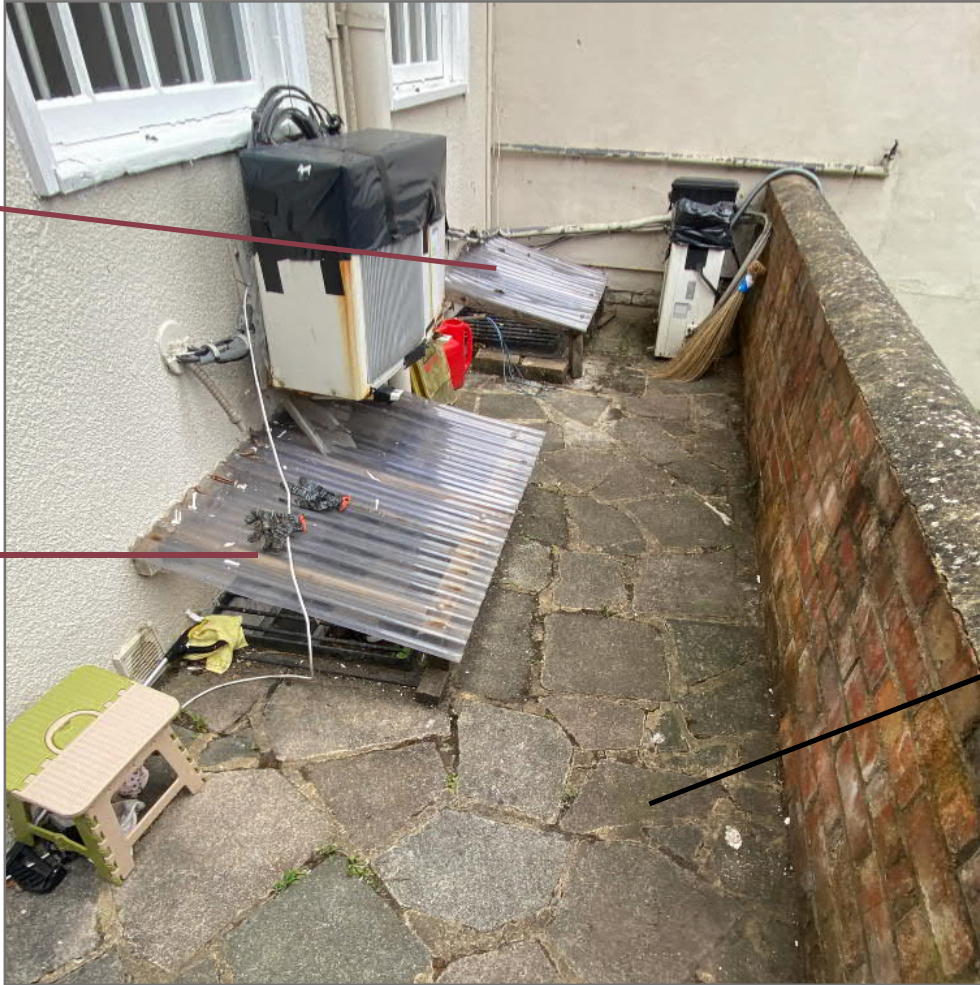
Image 33: Patio to rear of property and Basement windows 'W1' and 'W2'

Patio described by conditions' surveyor as requiring to be relaid to fall away from the house to reduce water being driven towards the Basement wall

- The windows to the rear of the property are of uPVC and are proposed to be replaced with doubled glazed timber windows with openable vents. Similarly, these are not the original windows, or the original window openings. The windows are relatively obscured visually as they are protected from water ingress with transparent canopies (refer to Images 33 and 34).

The perimeter wall locations are particularly challenging areas to manage moisture as water ingress is largely outwith the control of the owner of No.86. Where control is possible, the rear patio shall be relaid to move the water away from the property. The structural proposals allow the existing timber to be retained, whilst being carefully supplemented to conserve the structure and retain this historic fabric for a greater understanding of the building's construction. The repair of the structure and improved moisture management will arrest further decline of the original fabric in the interests of the long term survival of the building and is therefore a positive intervention.

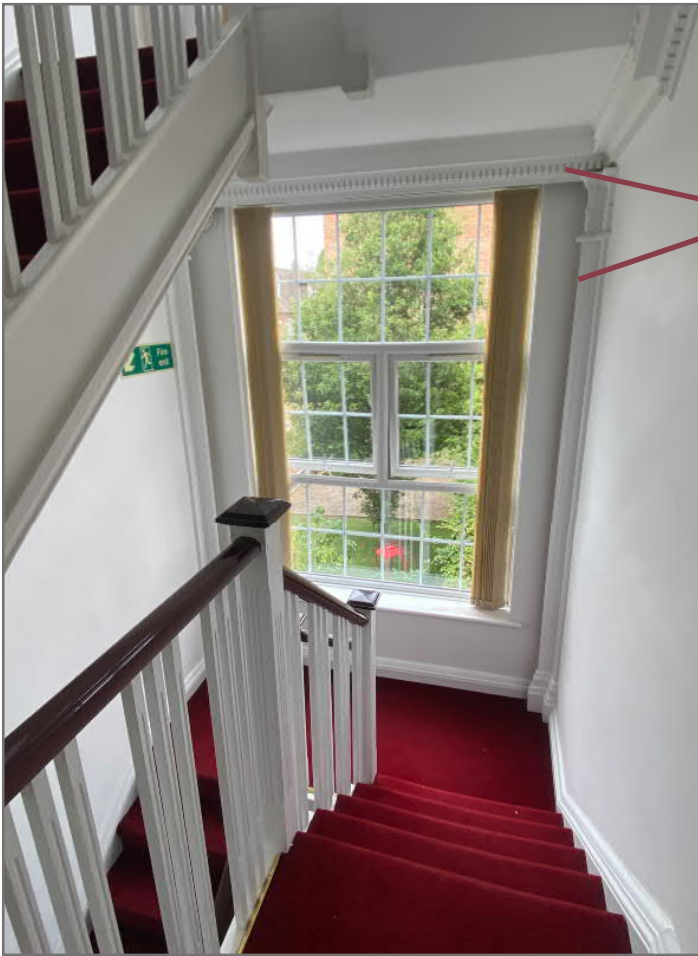
Image 35: View of landing between Ground and First Floors

Fibrous plaster cornice and pilasters to staircase window opening - these have been examined by 'All Things Lime' and 'Locker and Riley' and advised a likely between 20-30 years' old.

Modern door openings

Original line of wall anchored by staircase

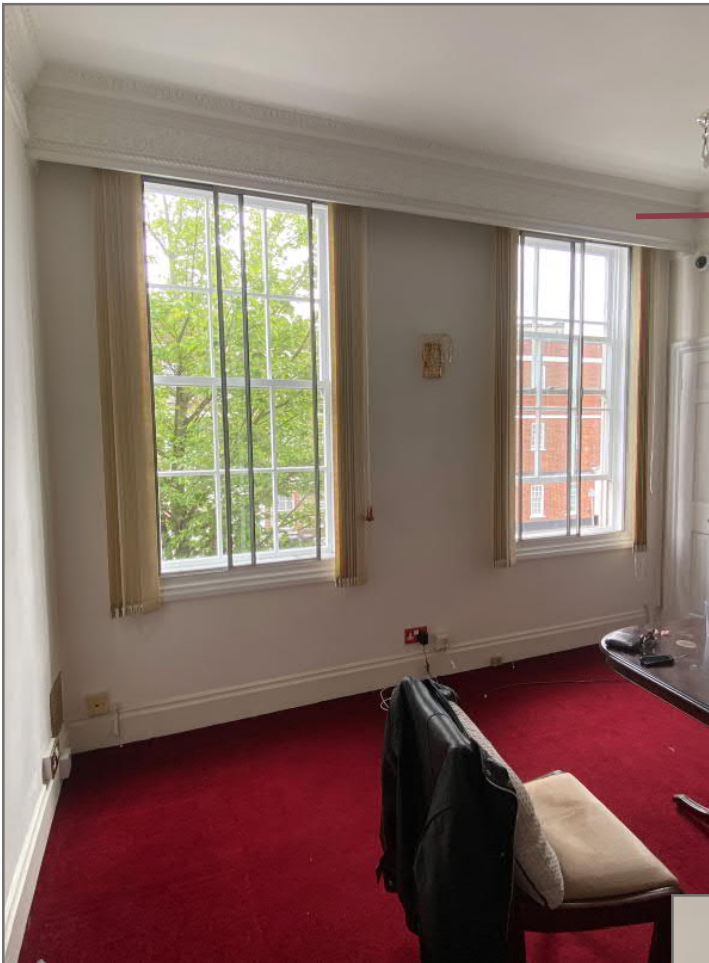
Image 37: First Floor southeast room

Deep decorative cornice  
between 20-30 years' old

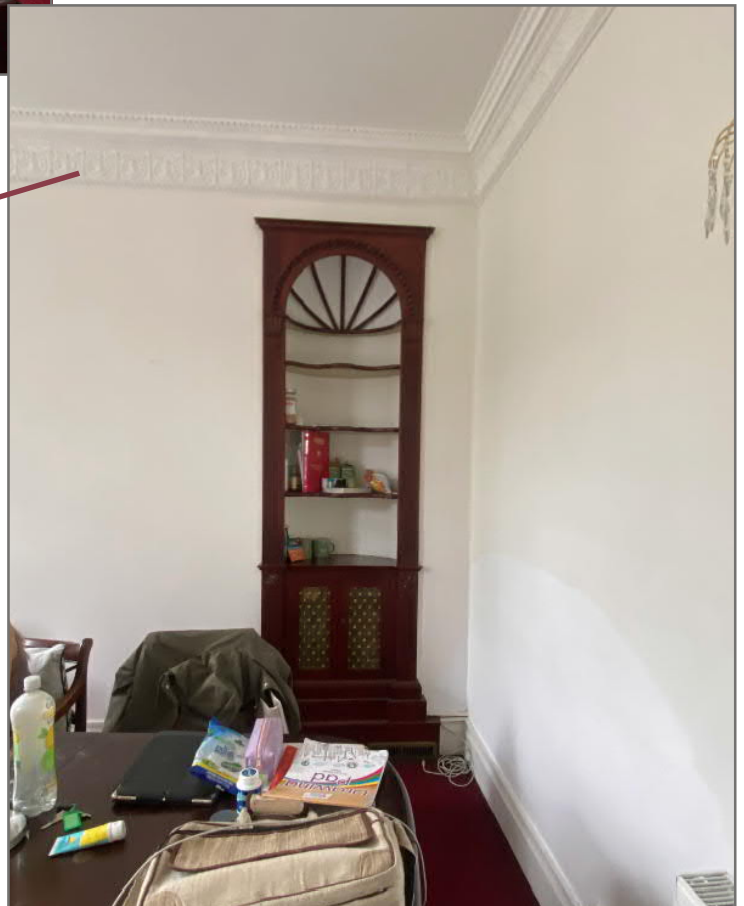
Image 38: Niche to First Floor southeast room  
86 London Street, Reading

Fibrous plaster cornice -  
between 20-30 years' old.

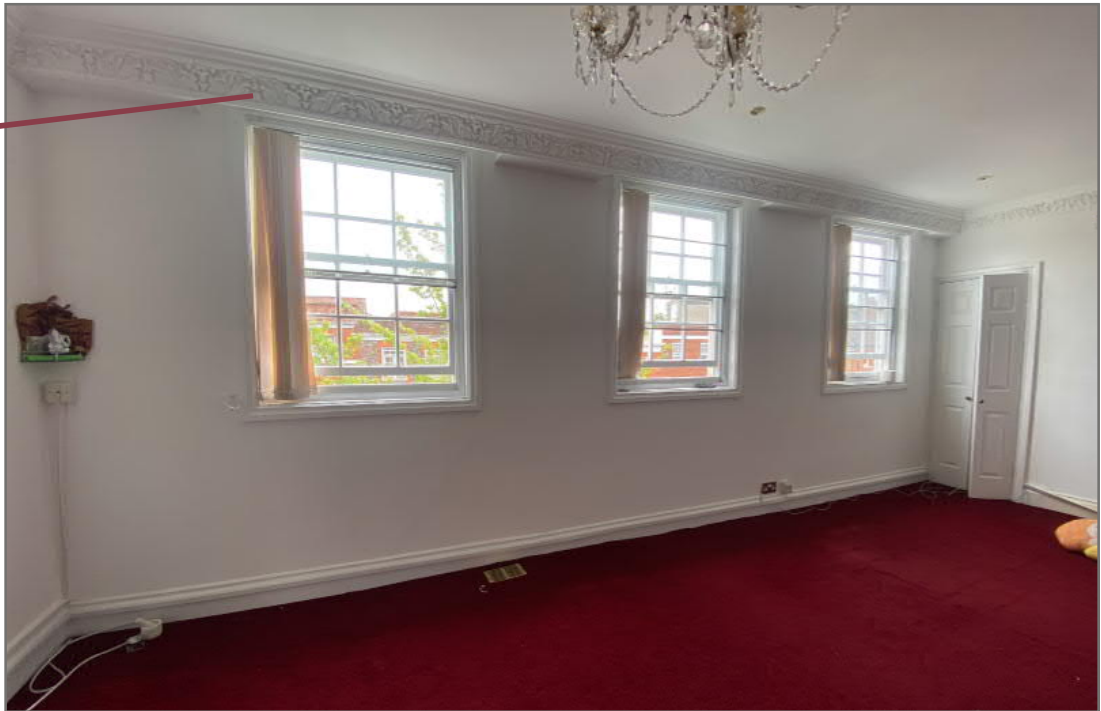
Fibrous plaster  
cornice - between  
20-30 years' old

Image 43: Second Floor east room - the 'attic' floor, is likely to have originally been three rooms and would not have had a decorative cornice - reserved only for the most important reception room

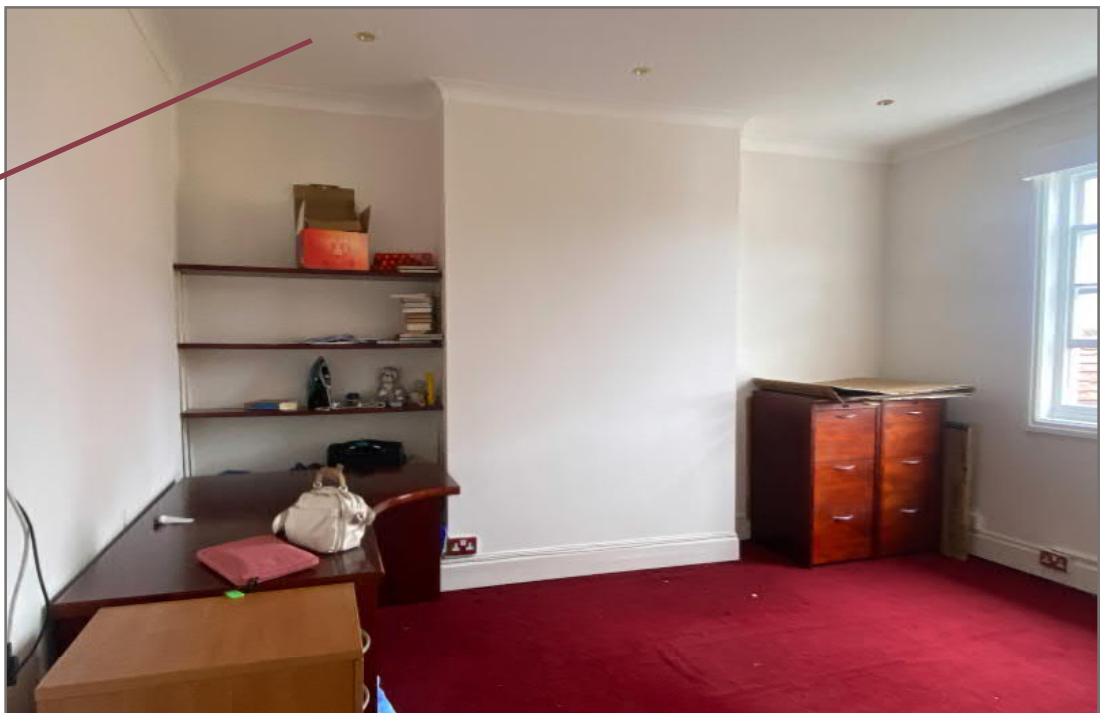
Spot lights indicate a  
modern plasterboard  
ceiling installation and  
modern cornice

Image 44: Second Floor west room - the chimney breast remains

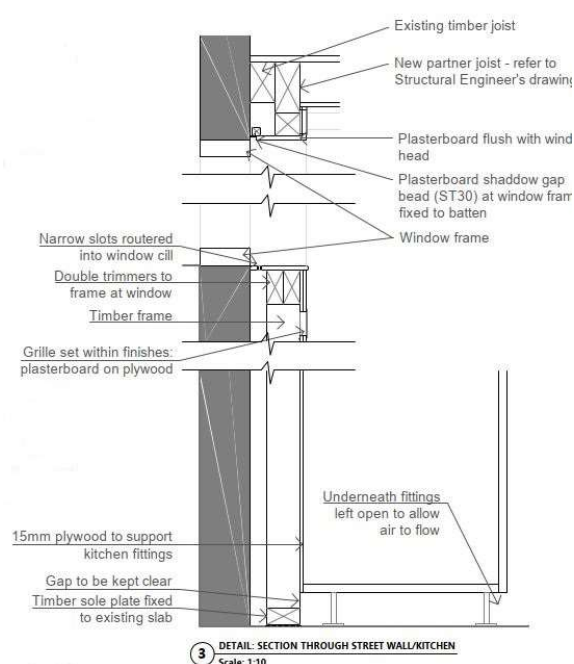
Refer to the diagram below extracted from 1347-HR-A-DE-0302 Rev03:

An air gap must be maintained below the fittings and remain open where possible. This creates a continuous air gap behind the cavity wall with ventilation grilles installed at the top of the wall finish – either at the window cill level horizontally, or an open gap at the top to allow air to freely pass.

Below the kitchen fittings a 'plinth' (skirting) board must not be fitted - to allow as much ventilation as possible to flow below the units.

This gap must be kept clear: it must not be used for storage of any items and must be regularly cleaned to remove debris.

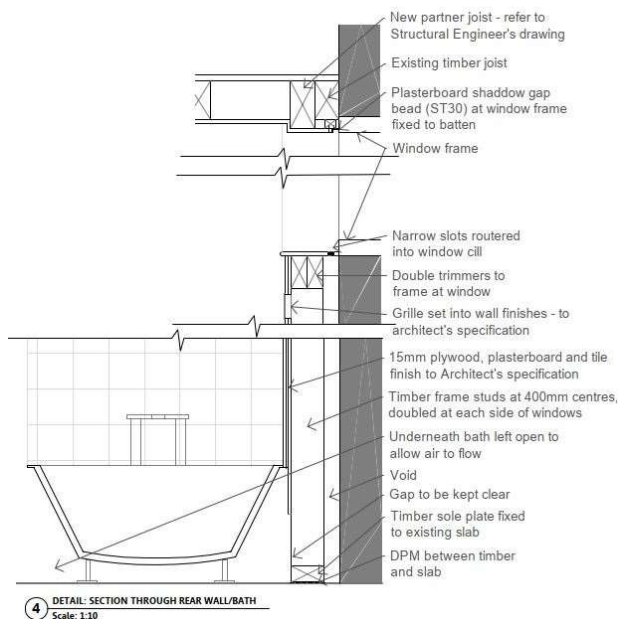
Refer to the diagram below extracted from 1347-HR-A-DE-0303 Rev01:

Where the cavity wall is full height the inlet grilles at the bottom of the wall must not be covered over with furniture or other items.
