# UPDATE BAT SURVEY RESULTS REPORT

10 Gun Street, Reading, RG1 2JR

May 2026 | FN22-024C | VERSION 3 | KH

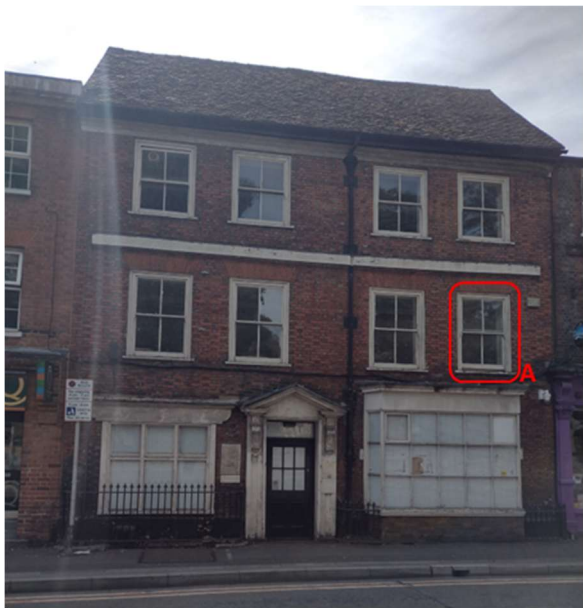
| Northern elevation | |

The northern elevation is in good overall condition with no apparent gaps or crevices within the brickwork. However, the age and style of the property means there is potential for small gaps and crevices around lintels and window frames that could have the potential to support small roosts suitable for individual or low numbers of bats.

The same is true of the roof tiles, which appear to be in overall good condition but are of an age and style that they are irregularly shaped and therefore provide small gaps that have the potential to support small roosts suitable for individual or low numbers of bats.

| Various locations - <b>Potential small gaps and crevices around lintels and window frames and beneath roof tiles.</b> | Potential roost space for individual or small numbers of crevice dwelling bats. |
| A - <b>Slightly ajar windows.</b> | Access into the interior of the building. |

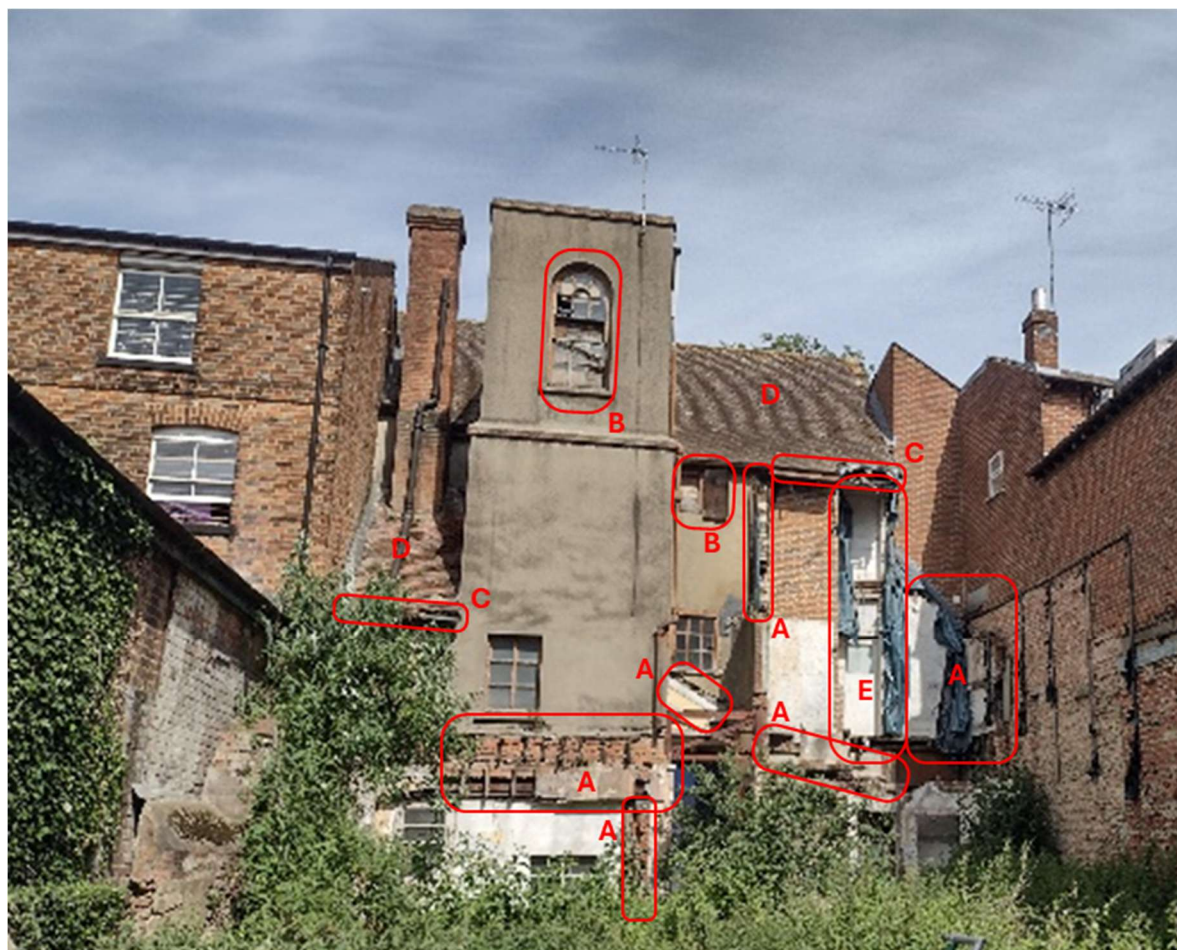
#### Southern elevation

The southern elevation provides a number of PRF's and access points into the building. The sections of tiled roof are similar to the northern elevation and provide a number of small gaps suitable for individual or small numbers of bats. The damaged section of roof provides access into the roof void and potentially into a void between the loft floor (which is boarded) and the ceiling below.

The damaged sections of wall provide small roosting opportunities within small gaps and cracks but also provide potential access points into larger voids and into the interior of the building. The broken windows also provide potential access into the interior of the building where boarding behind is either missing or in poor condition.

| Feature | Potential value to bats |
|---|---|
| A - Damaged walls/brickwork resulting from removal of extensions. | <p>Potential roost space for individual or small numbers of crevice dwelling bats.</p> <p>Potential access to larger voids behind brickwork/ created by damage</p> <p>Access into the interior of the building.</p> |
| B - Broken or missing window panes. | Access into the interior of the building. |

| C - Damage to roof in SE corner. | Potential roost space for individual or small numbers of crevice dwelling bats.<br><br>Access into the interior of the building. |
| E – Interior doors exposed | Access into the interior of the building. |

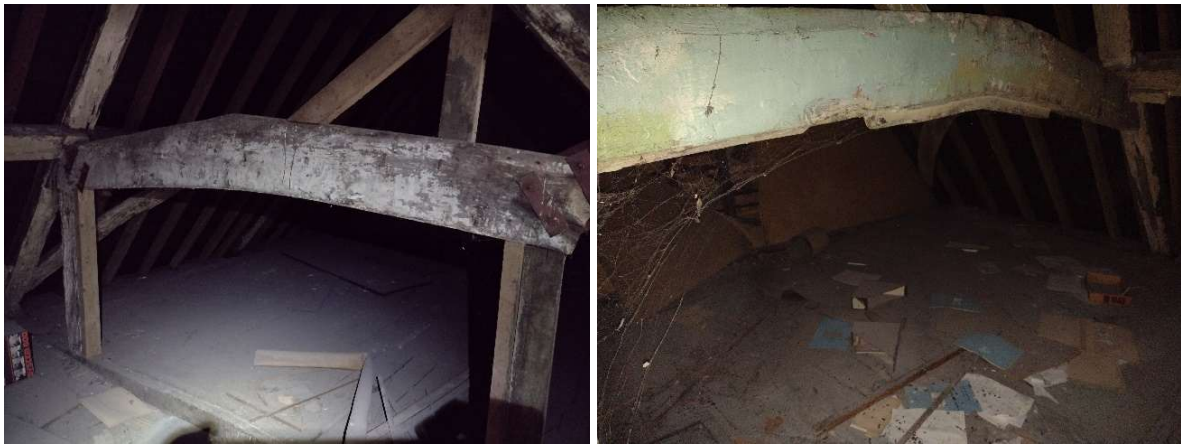
| C - Damage to roof in SE corner. | Potential roost space for individual or small numbers of crevice dwelling bats.<br><br>Access into the interior of the building. |
|---|---|
| <b>Loft space</b> | |

The loft is accessible by the main staircase and the floor is fully boarded but the space is currently unused. It is constructed by a timber 'A' frame which is lined behind and generally in good condition. Brick walls make up the gable ends and large gaps are present at the top at each end of the loft providing connectivity to the adjoining properties.

The damage identified to the exterior provides a large access point in the south east corner of the roof and a further, small, access point was identified on the southern side, further west. This gap was full of cobwebs and unlikely to have been recently used by bats.

The loft void itself provided a suitable feature for large numbers of bats to roost. The wooden frame appeared to be in good condition and well connected so provided limited gaps or crevices for bats to roost within.

The floor and vertical beams were thoroughly searched and no bat droppings or bat feeding remains were found to be present. Rat droppings were present throughout.

| C - Damage to roof in SE corner. | Potential roost space for individual or small numbers of crevice dwelling bats.<br><br>Access into the interior of the building. |
|---|---|
| <b>Loft void</b> | Potential roost space for large numbers of bats. No signs of bats present. |
| <b>Wooden frame</b> | Potential roost space for individual or small numbers of crevice dwelling bats. No signs of bats present. |

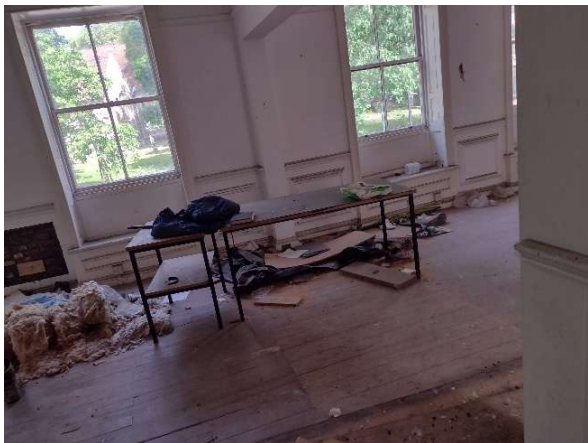
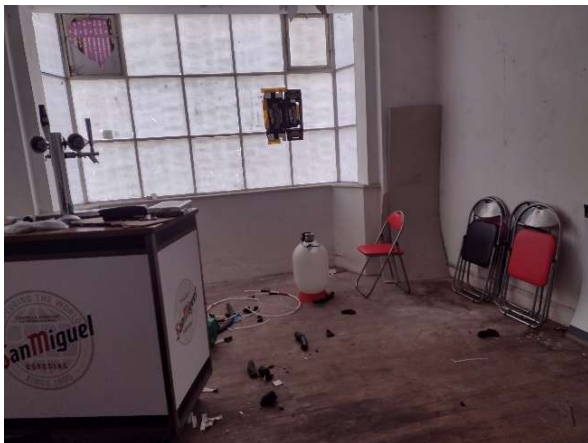
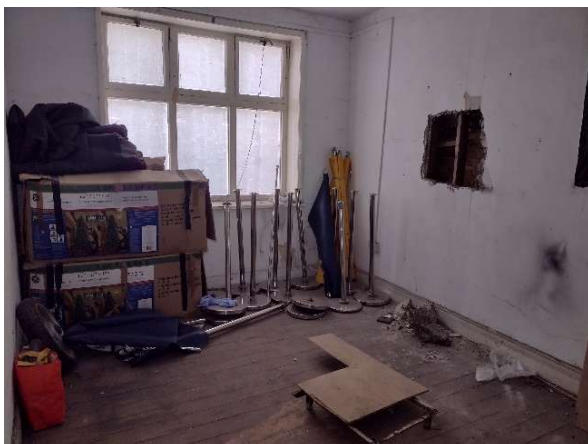
| C - Damage to roof in SE corner. | Potential roost space for individual or small numbers of crevice dwelling bats.<br><br>Access into the interior of the building. |
|---|---|
| <b>Ground floor, first floor and second floor</b> | |

The majority of the interior walls and ceilings were intact and where there was damage this was superficial. The exception to this was the areas of damage already noted on the southern exterior where a number of gaps were present which opened up into the interior of the building. There were also a small number of inspection hatches that had been created in the ceiling which provided access to the space above the ceiling.

The overall suitability of the interior as a roost space was low due to it being well lit and having relatively few voids, cracks or crevices for bats to utilise. However, a single bat dropping was identified behind a board leaning against a door on the ground floor during the previous PRA of the Site, in 2022. The dropping was old and was characteristic of a pipistrelle bat dropping. The board was considered a sub-optimal roosting location and the absence of other signs of bat presence suggested its use had been minimal.

No signs of bat presence were identified in 2025 despite all floors and surfaces being thoroughly checked. Rat droppings were present. There is potential for other stored materials within the interior to provide similar sub-optimal roosting conditions to the board, although no signs of bats using other materials were identified.

| | |
|---|---|
| Limited shelter behind stored materials, such as the board on the ground floor. | Limited potential for individual or small numbers of bats. A single bat dropping was found attached to one board in 2022. |
| Inspection hatches. | Potential roost space for small to medium numbers of bats. No signs of bat use were identified. |

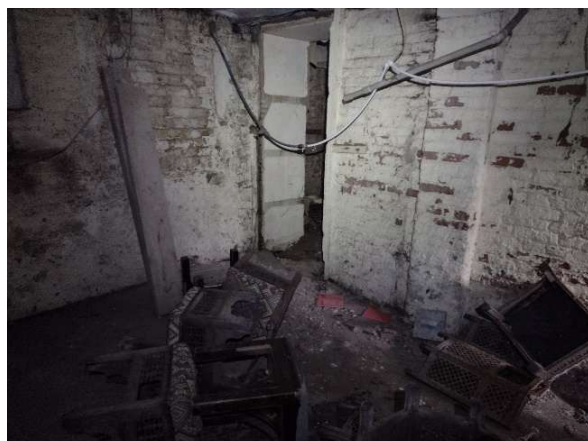
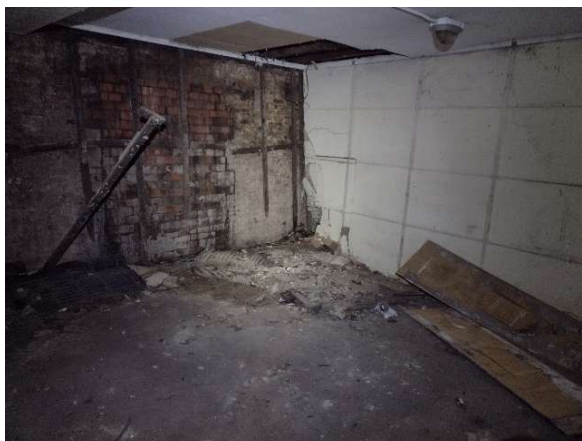
| | |
|---|---|
| Basement | |

All surfaces were thoroughly searched for signs of bat activity and none were found. Rat droppings were present throughout. The basement is a suitable location for a hibernation roost although no signs to suggest its use as such were identified.

Potential roost space for small to medium numbers of bats. No signs of bat use were identified. No signs of bats present.

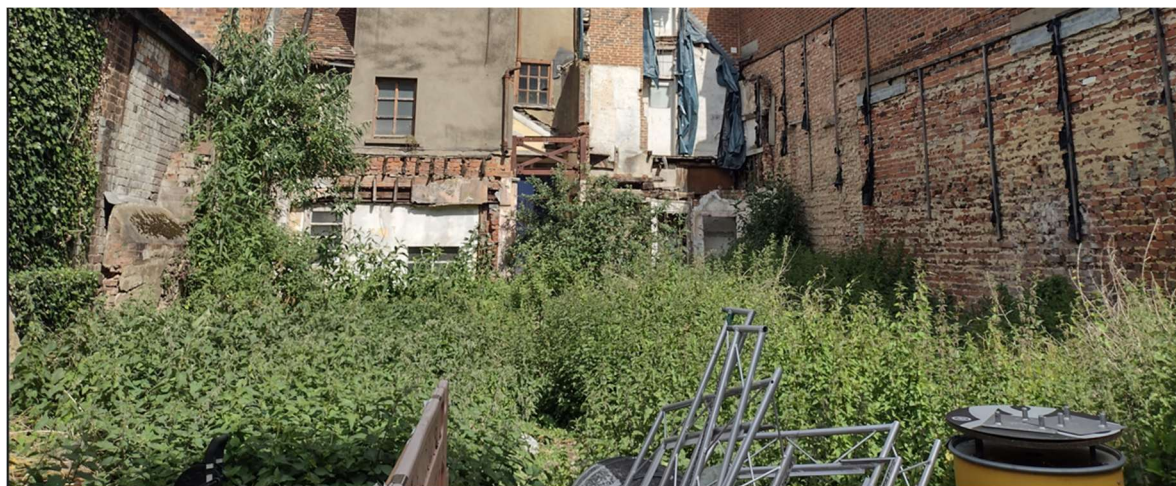
### Yard

No roost potential but provides some opportunity for foraging bats.

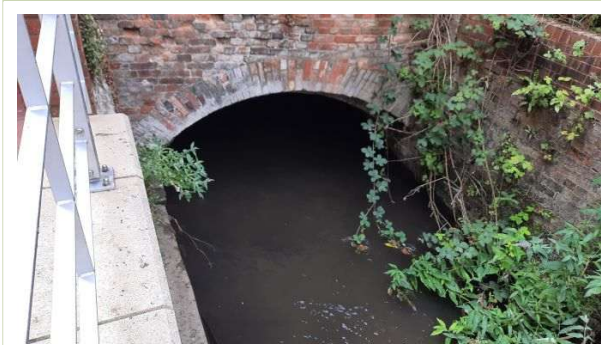
### Culvert

The culvert that runs beneath the site was assessed from the point it exits the culvert immediately east of the site boundary. The culvert is constructed from brick and is believed to have been first culverted in the 19<sup>th</sup> Century. The brickwork around the culvert exit and the brick walls that formed the channel sides after the culvert appeared old but were generally intact and well rendered. No obvious gaps or cracks that could provide bat roost potential were evident. The full length of the culvert below the site could not be accessed so it is unknown what the condition of the brickwork is for the full length.

| | |
|---|---|
| <i>Photo from 2022 visit</i> | |

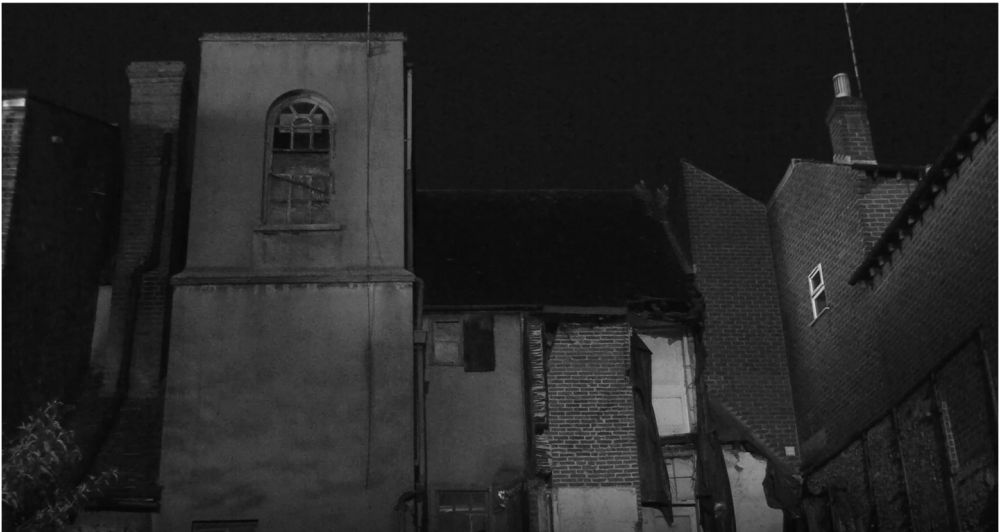
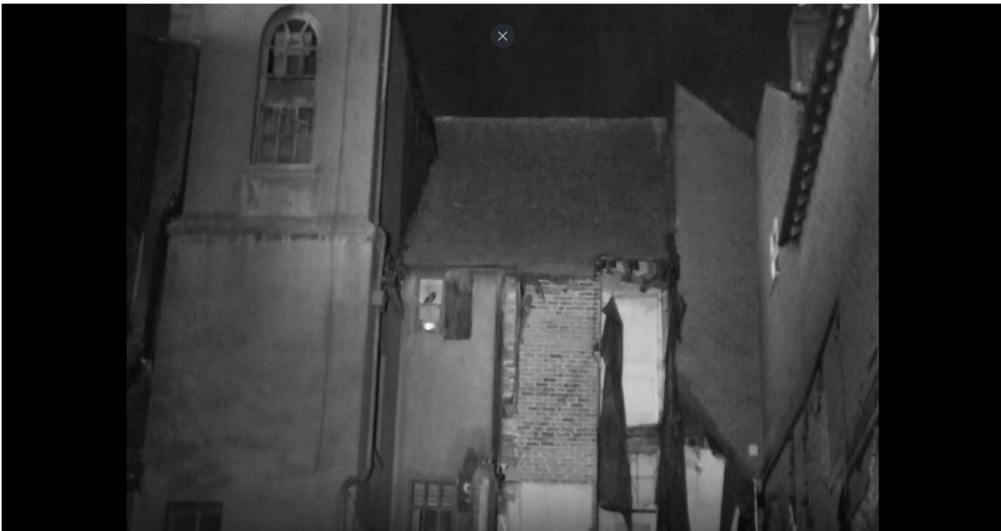
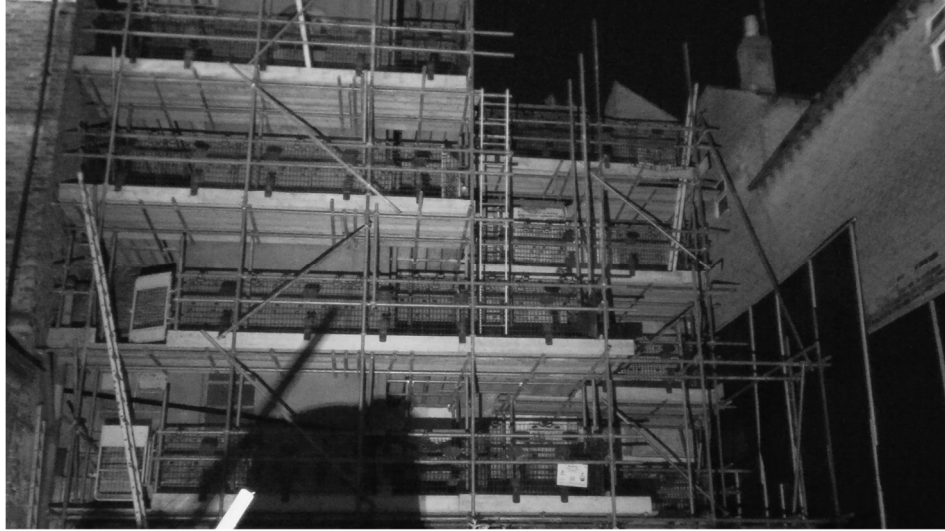
**Table 3.4: Screenshots of infra-red cameras at position 2 for all surveys**

During the emergence survey in May 2026 it was observed that scaffolding had been erected to rear of the building on the southern elevation (see Table 3.4). It is understood from client communications that this was done in order carry out essential repair works to the listed building, preventing further decay and rainwater ingress and to block the holes where pigeons were entering the building. There was a significant pigeon and rat infestation which was exacerbating decay and causing health and safety issues internally.

| <p><b>Emergence<br/>survey 1:<br/>05/06/25<br/>at 22:45</b></p> | |
| <p><b>Emergence<br/>survey 2:<br/>07/07/25<br/>at 22:51</b></p> | |

**Emergence  
survey 3:  
11/05/26  
at 22:21**

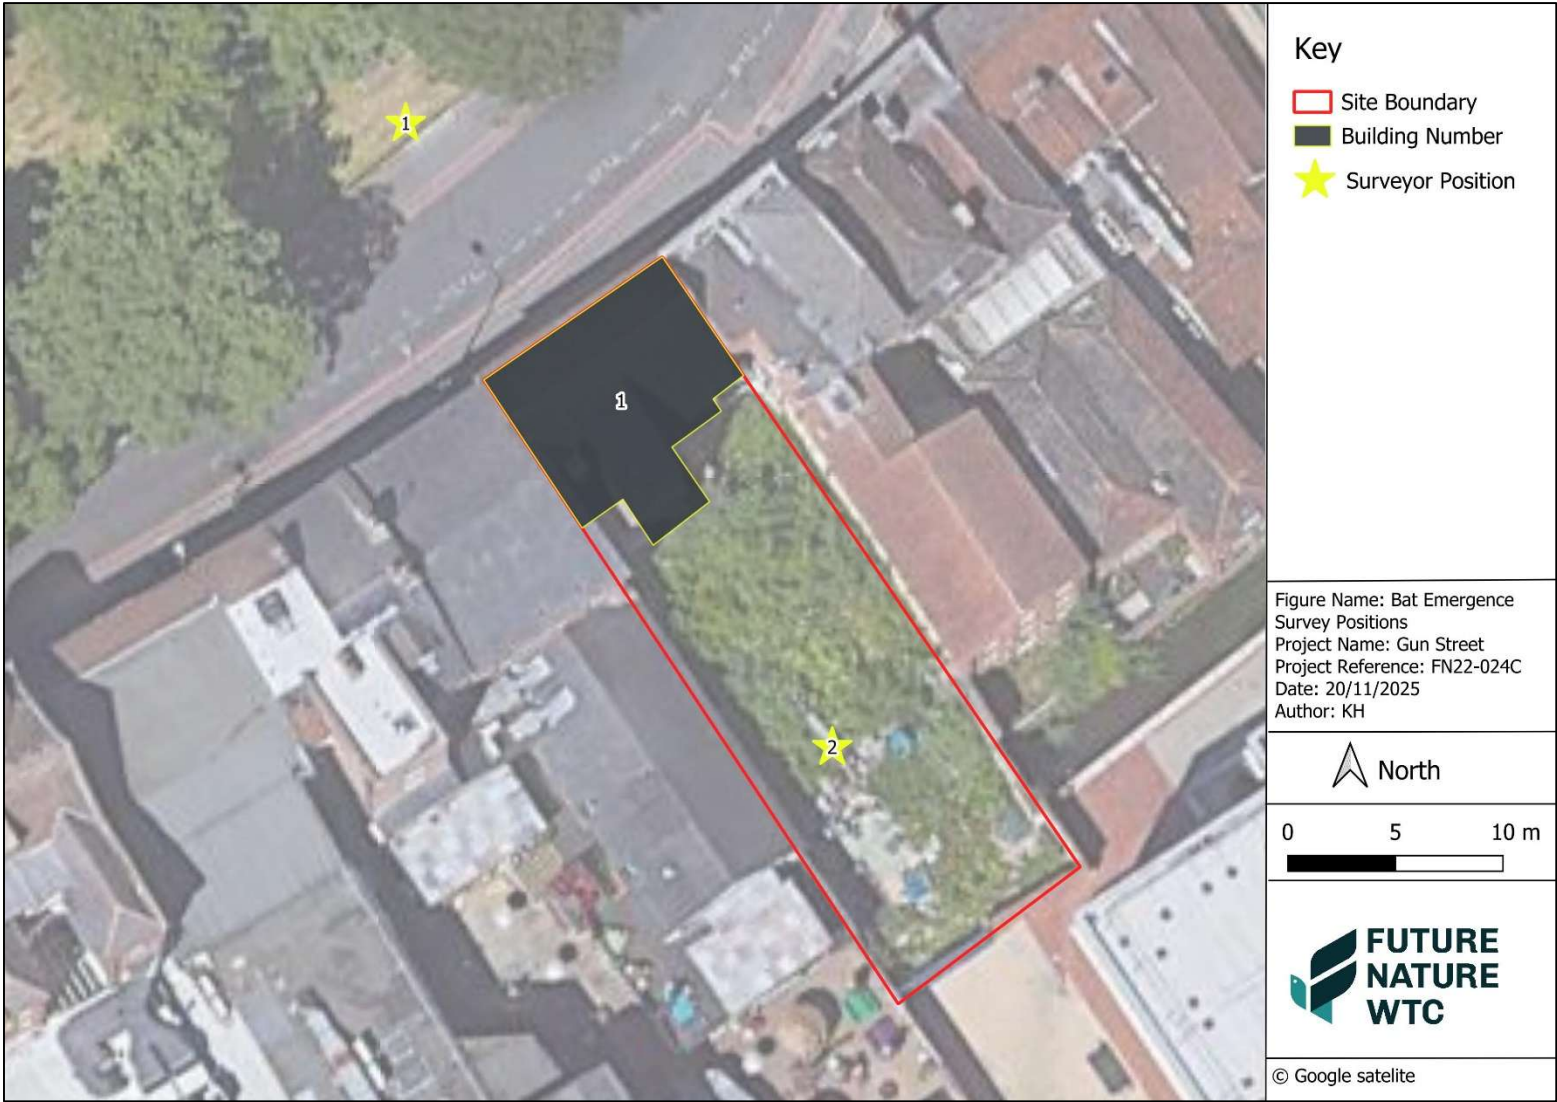
Figure 3.1: Bat Emergence Survey Positions

The results of the emergence surveys are summarised in Table 3.3, and the surveyor positions are shown on Figure 3.1. Screen shots of the infra-red camera for position 2 at the darkest point of the survey for both surveys is shown in Table 3.4.

The surveyor positioned to the south of the building recorded one noctule contact at 21:53, 37 minutes after sunset. The bat was heard but not seen. No other bat activity was recorded during the survey and no bats were observed foraging or commuting on the site.

The surveyor positioned to the south of the building recorded two periods of common pipistrelle activity, the first from 21:53, 32 minutes after sunset, until 22:08 and again from 22:18 until 22:21. During each period one common pipistrelle was observed foraging around
