47 Rotherfield Way  
Emmer Green

**Report for:**  
Mr & Mrs P Williams  
47 Rotherfield Way  
Emmer Green  
Reading  
RG4 8PJ

In accordance with your instructions, AA Environmental Limited (AAe) carried out a Preliminary Roost Assessment (PRA) at the above site on Monday 3 August 2026. The purpose of the survey was to assess the presence or likely absence of bats utilising the house and provide appropriate mitigation measures, as necessary. A series of photographs has been attached for reference.

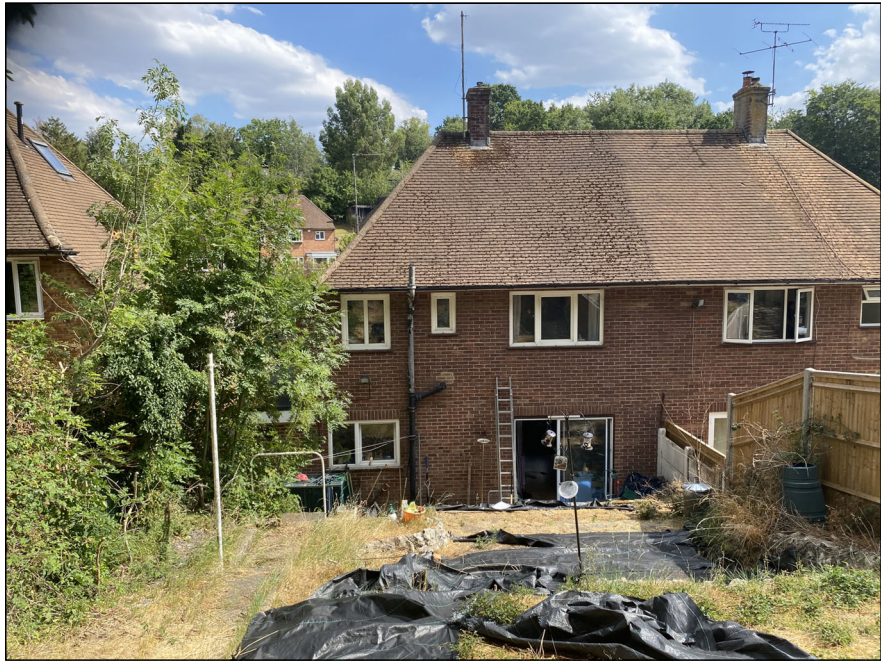
Photograph 1: Showing the rear elevation of the house.

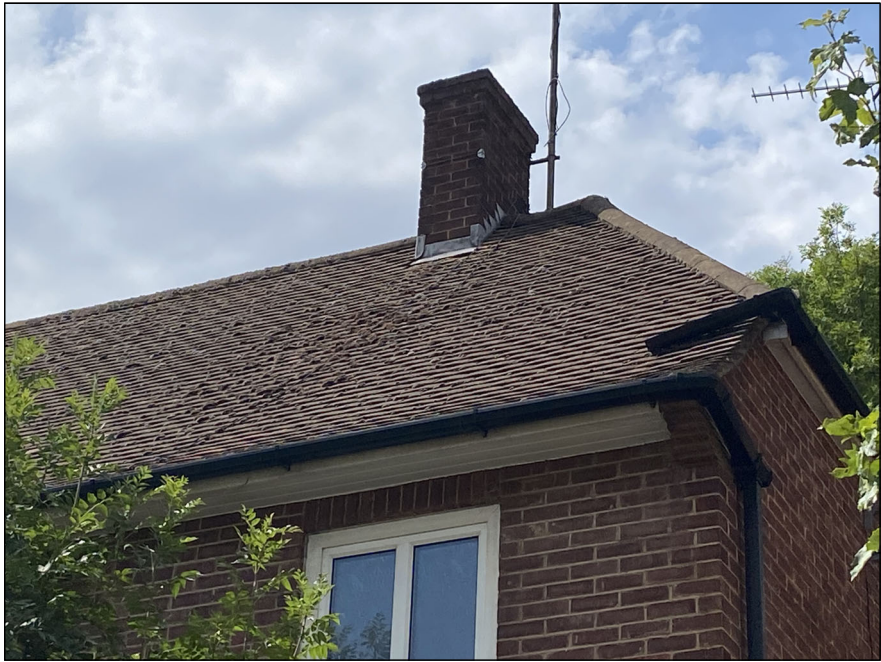
Photograph 2: Showing the front elevation of the house.

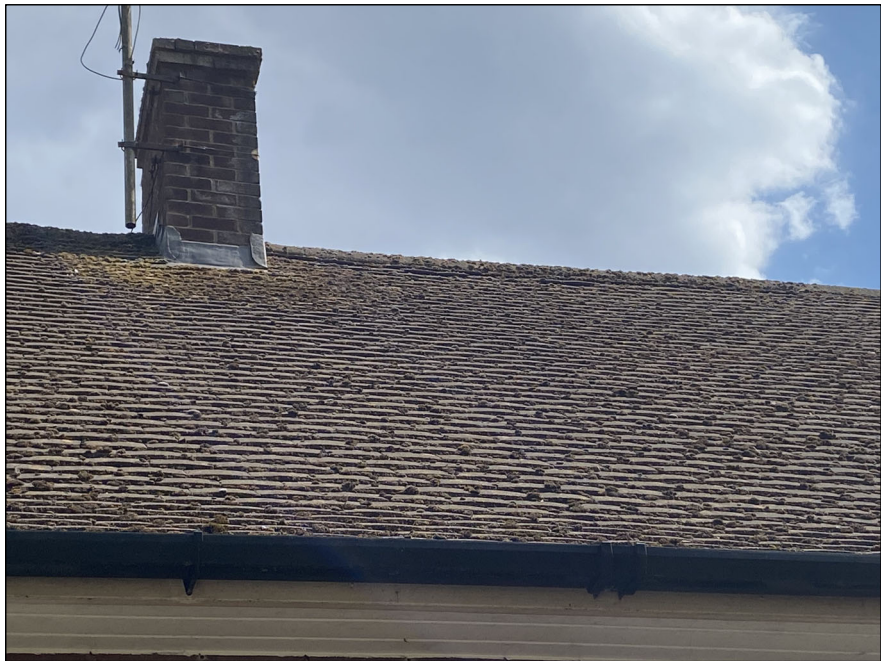
No evidence of bats was recorded during the careful internal and external inspection of the house, which was well-maintained, with no potential access gaps for bats recorded. The roof tiles and lead flashing were closely fitted and the soffits/fascia well-sealed. Internally the roof space/attic was fully accessed and not complex allowing a thorough inspection to be completed and found to be in cobwebbed condition. Overall the house was assessed to provide **negligible** roosting opportunities for bats.

Photograph 3: Showing the roof which was in good condition and well-sealed.

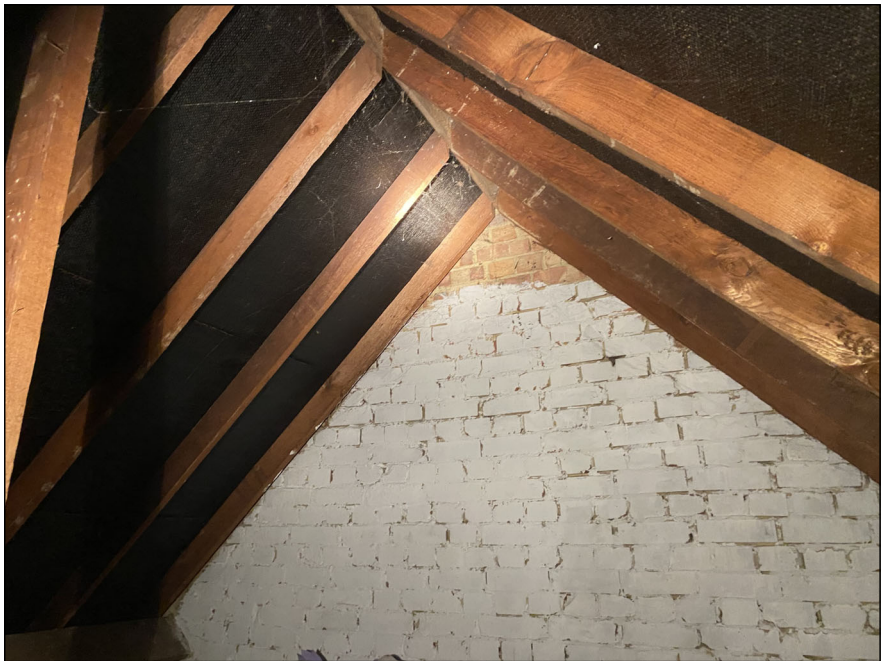
The two-storey masonry constructed semi-detached house had a pitched, engineered tiled roof that was in good condition. There was a single chimney stack with lead flashing at its base. There was a single-storey extension to the side, with a flat solid concrete roof. The uPVC soffits/fascias were in good condition and well-sealed with mastic/silicone. Internally there was a single roof space/attic that was lined with a bitumen based felt, insulated with mineral wool and in a cobwebbed condition.

Photograph 4: Showing the cobwebbed roof space.
