# Preliminary Bat Roost Assessment

110 Severn Way,  
Tilehurst,  
Reading,  
RG30 4HH

**Project Reference:** 0826\_4HH

This report sets out the findings of a Preliminary Roost Assessment undertaken on 07 August 2026.

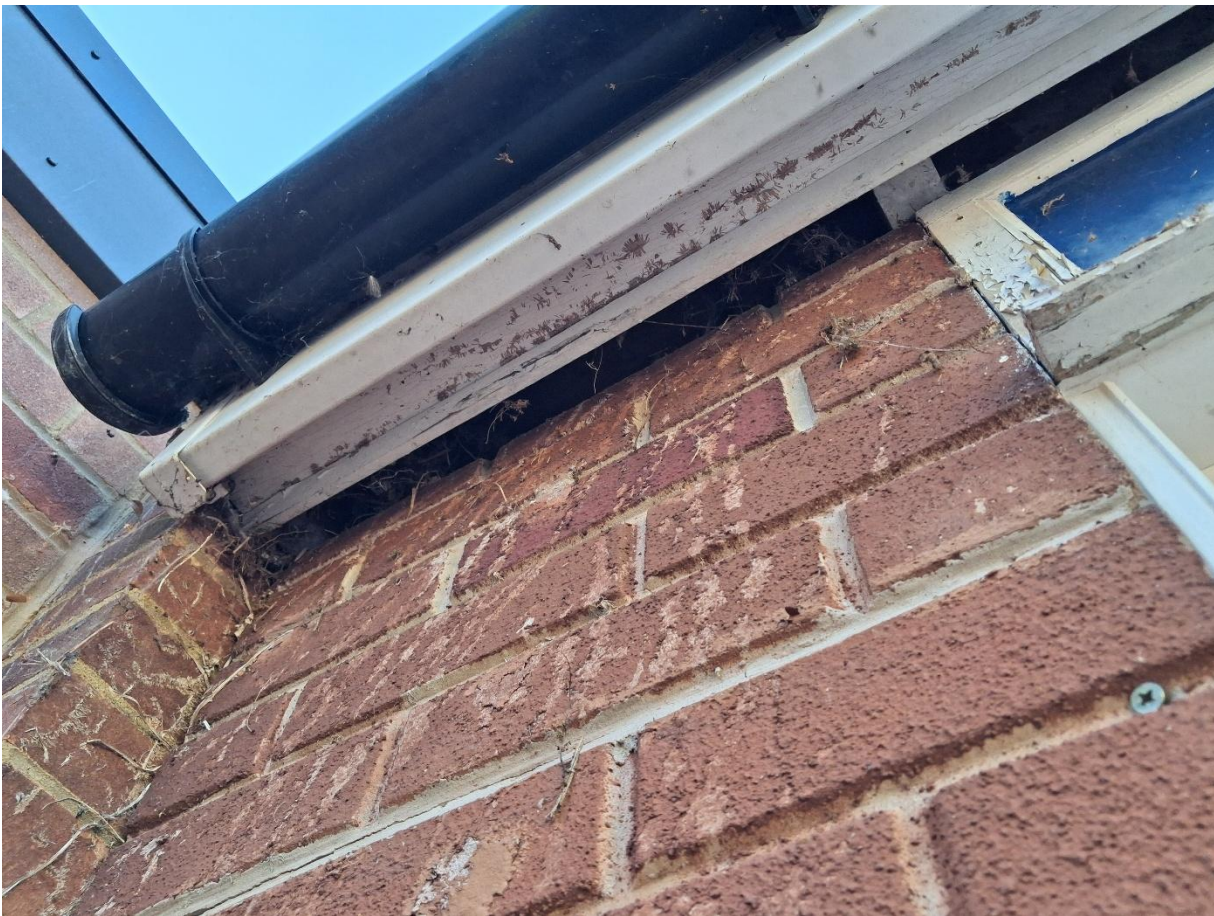
***Figure 4: Gaps beneath the single-storey fascia might lead into further PRFs***

The rear extension, which is proposed for demolition, comprises a single-storey structure with a flat roof and uPVC fascias. A high-powered torch was used to inspect along the full length of the fascia, where a substantial continuous gap was identified.

The exposed gap itself was considered unsuitable for crevice-roosting bats due to its width and open nature. However, it could not be determined from the external inspection whether the gap provides access to narrower, concealed crevices beneath the roof covering that may offer suitable roosting opportunities.

Prior to demolition of the rear extension, a suitably licenced bat worker should inspect the accessible gaps beneath the flat-roof fascia and associated potential roosting features, using an endoscope where appropriate. The fascia, roof covering and any associated features with bat roosting potential should subsequently be carefully removed by hand under the supervision of the bat worker.
