**BAT ACTIVITY SURVEY REPORT  
FOR:**

**SAINT PETER'S CHURCH  
THE WARREN  
CAVERSHAM  
READING RG4 7TH**

A report to:  
Caversham Thameside & Mapledurham Parish

July 2026

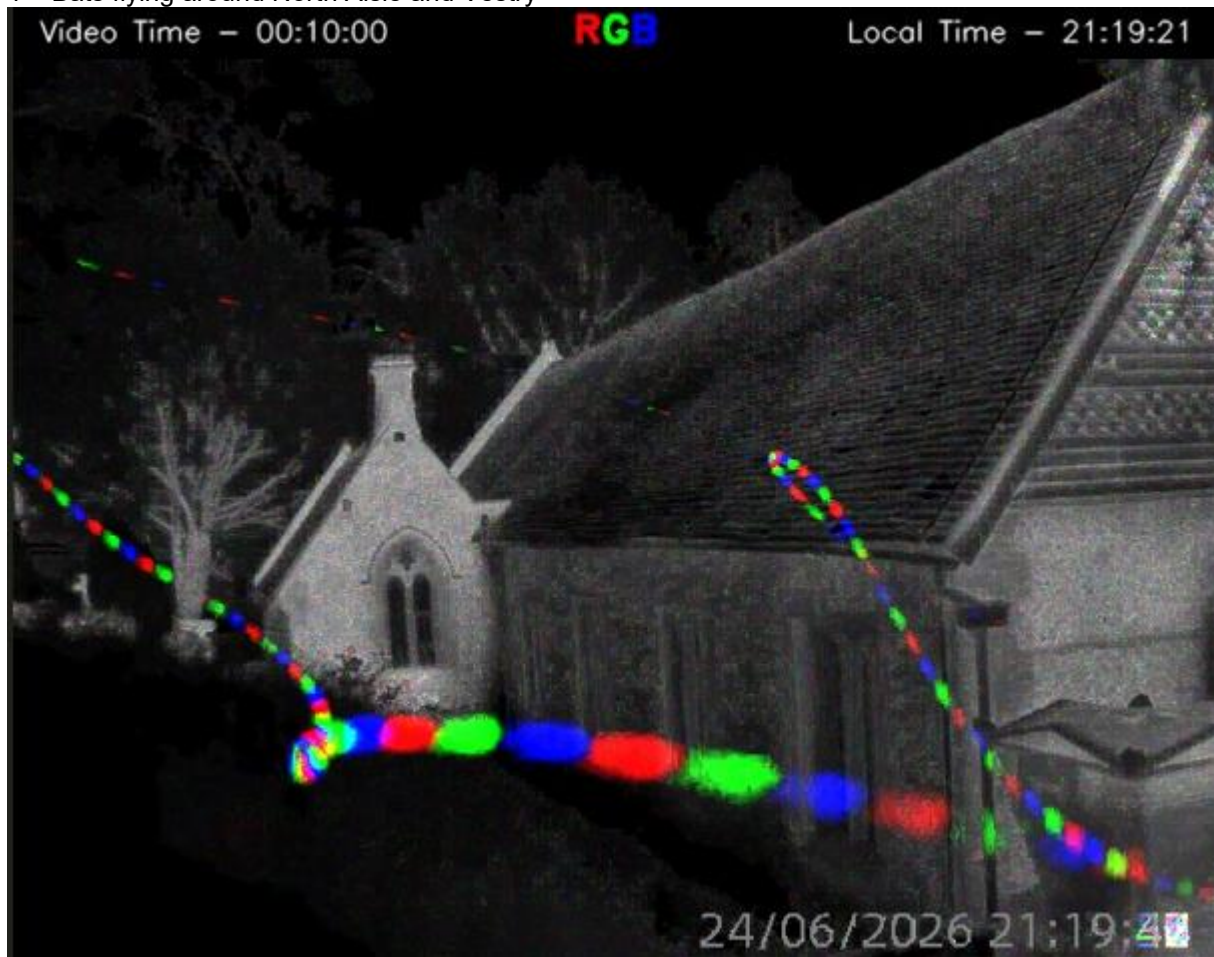
#### 1 – Bats flying around North Aisle and Vestry

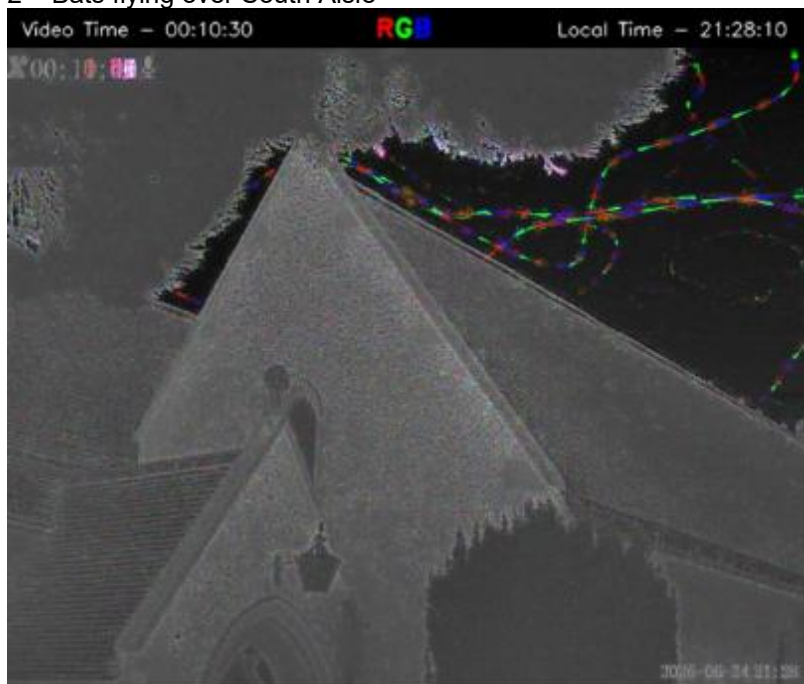
#### 2 – Bats flying over South Aisle

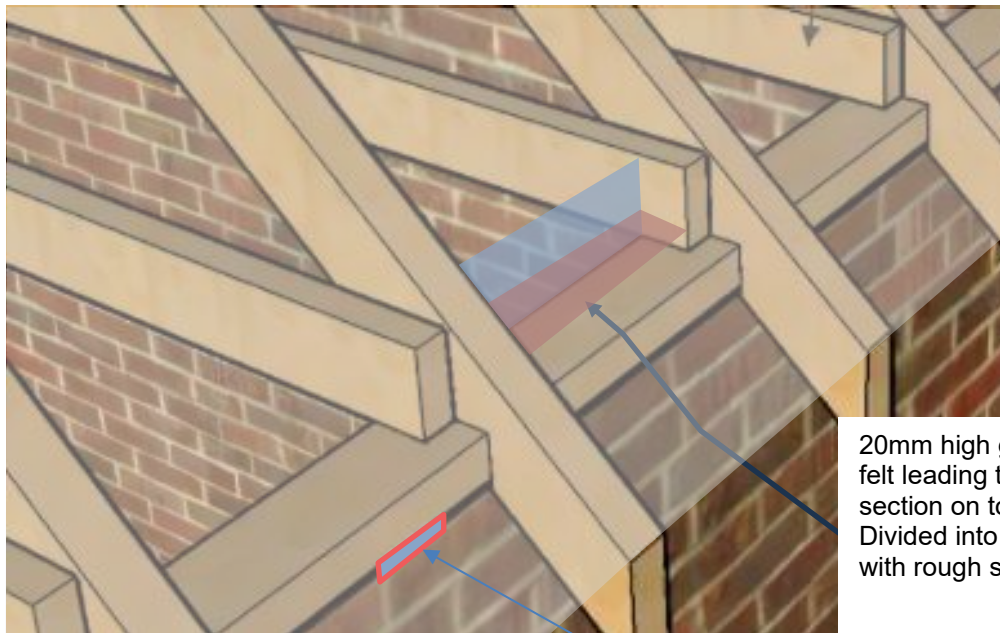
#### 2. Wall-top crevice examples (exact design to be confirmed by inspection by site ecologist)

20mm high gap under bitumen felt leading to a boxed off section on top of the wall plate. Divided into smaller sections with rough sawn timber.

20mm high gap under wall plate.

- Access to wall tops on gable ends by retaining existing gaps and/or omitting mortar from small sections. Of all the measures recommended, this is the most important because such gaps provide direct access to potential hibernation roosts that could not be confirmed by the surveys carried out to date;

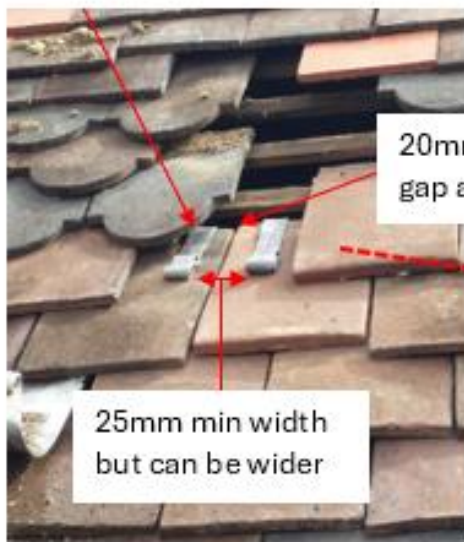
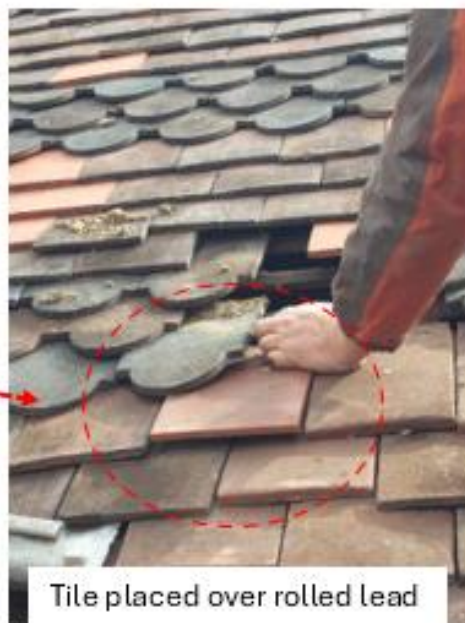
#### 3a - Bespoke feature

Lead strips rolled to create 20mm high

- Crevice features under re-seated ridge tiles. A means of achieving this is set out in Appendix 2;
  - Roof pitch access points using purpose-made tiles or by lifting tiles;
