**59 Gloucester Road, Reading, RG30 2TH**

**Remediation Validation Report**

**P26-231rv**

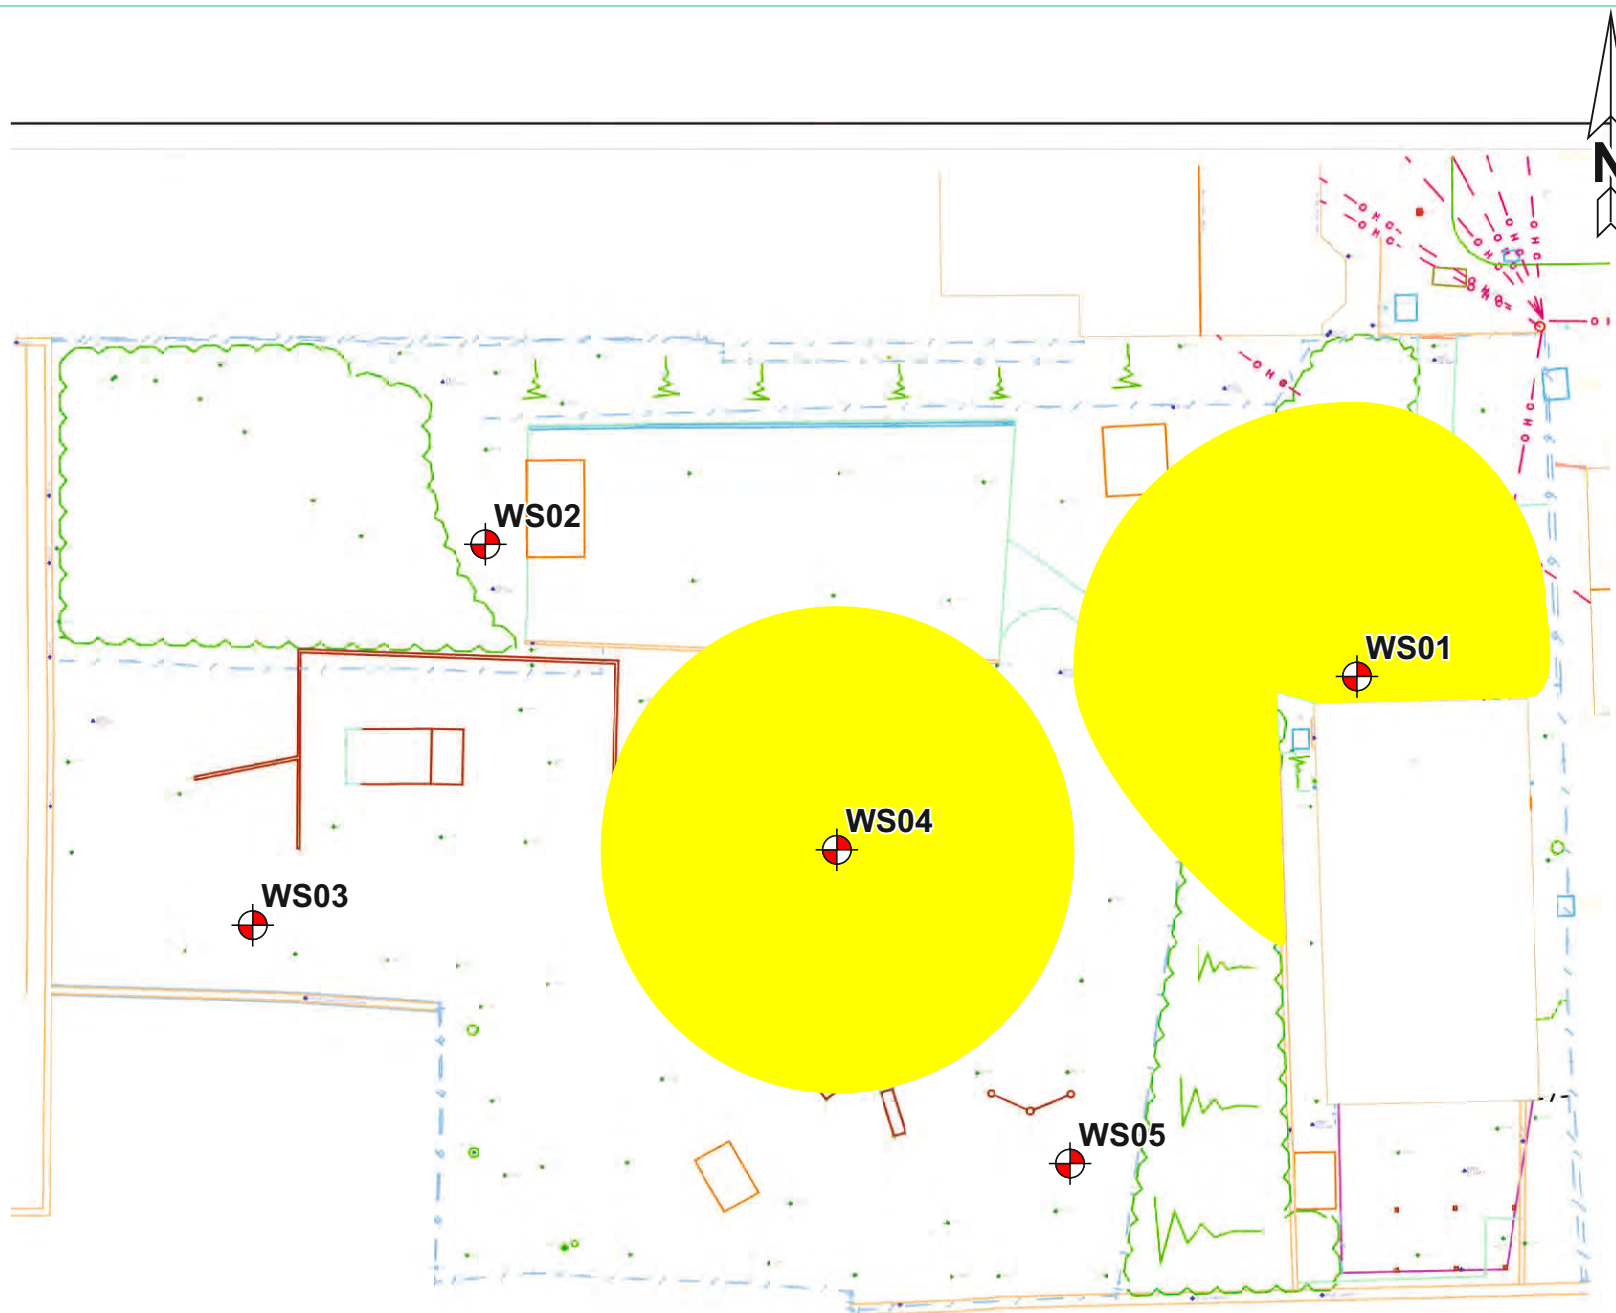
A Remediation Plan of the approximate remediation area is presented in Appendix B.

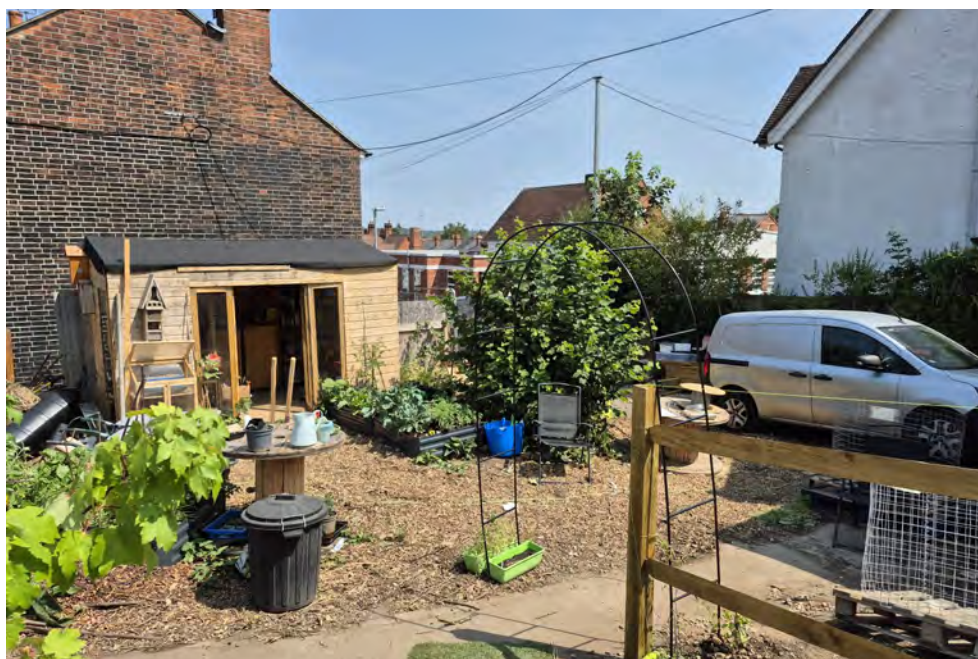
**Photo of the investigated area facing northeast**

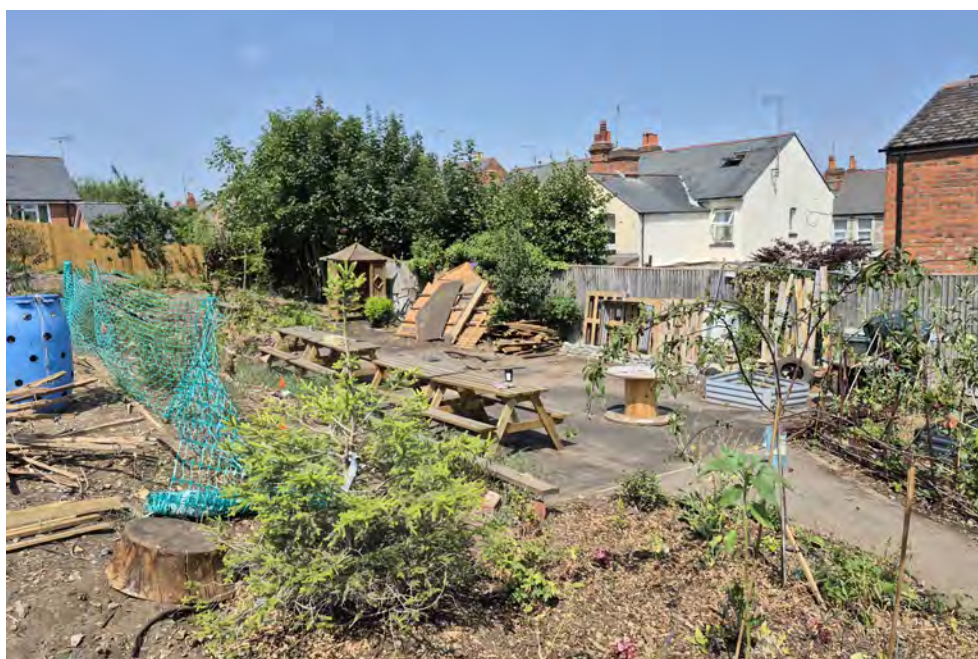
**Photo of the investigated area facing northwest**

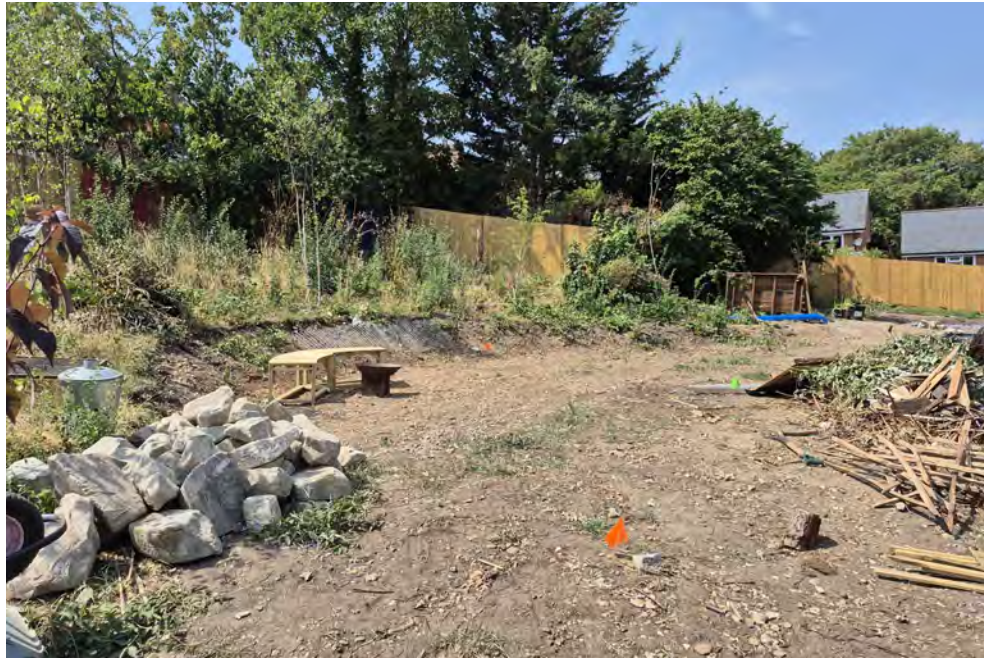
**Photo of the investigated area facing southwest**

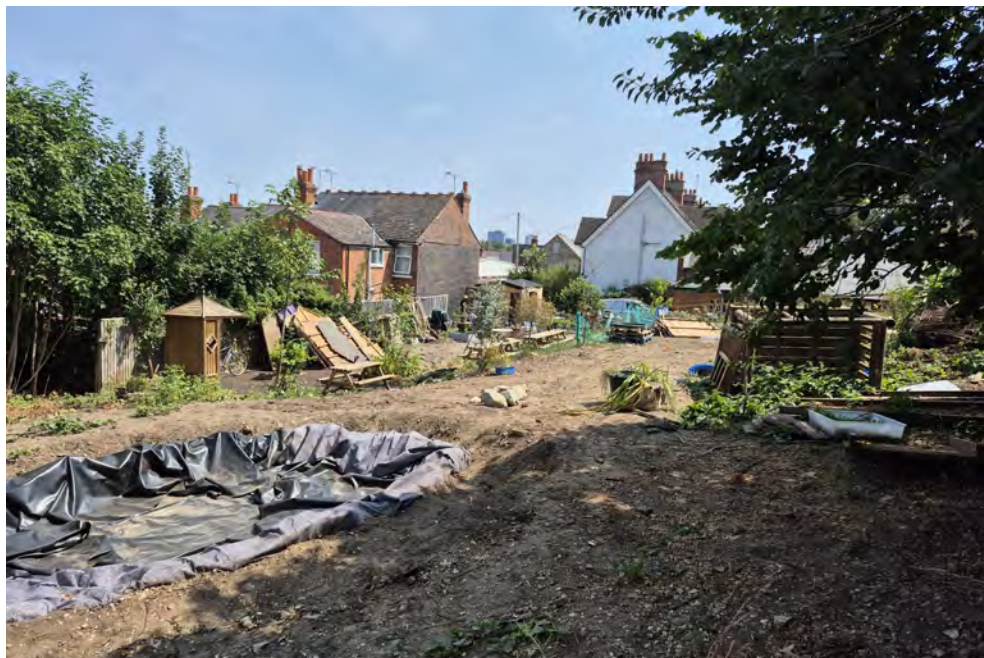
**Photo of the investigated area facing east**
