Topsoil Verification Report – Blocks C, D & H and Plots 9-12

Site: Former Elvian School, Southcote Lane, Reading

Client: Taylor Wimpey West London

Project Reference: V0774

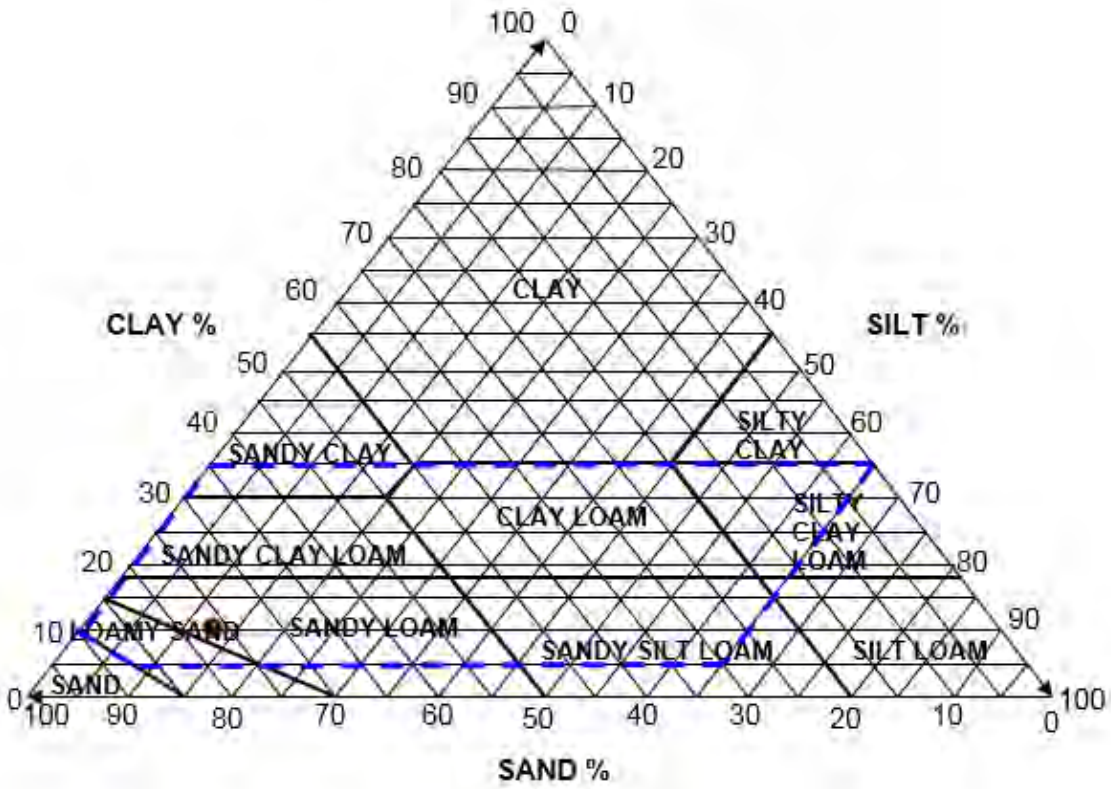
Soil Texture Triangle 665090

The results of the analysis indicate that the soils fell into the sandy loam texture class and meets and therefore compliant with multipurpose use. The results however, indicate high stone content which is not compliant with multipurpose use. The results also indicate that the soil is deficient in nutrients.
The non-compliance relating to high stone content and nutrient deficiencies can be addressed by screening the soil to remove the stones and also by application of suitable fertilizer.
