READING CENTRAL CLUB MURAL

CONSERVATION ASSESSMENT  
NOVEMBER 2017

# Reading Central Club Mural

## Condition Survey and Conservation Assessment

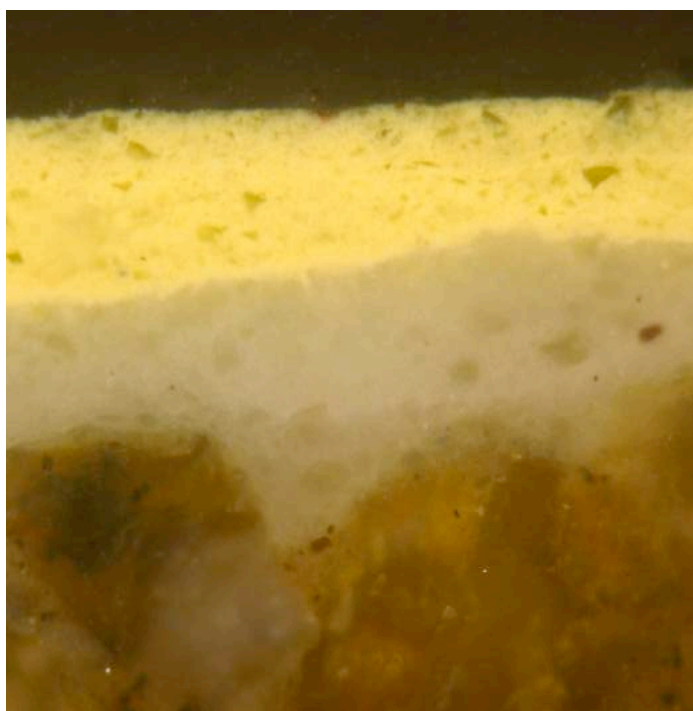
**SAMPLE 6**

Area 2 yellow from top of wall above  
turban figure.

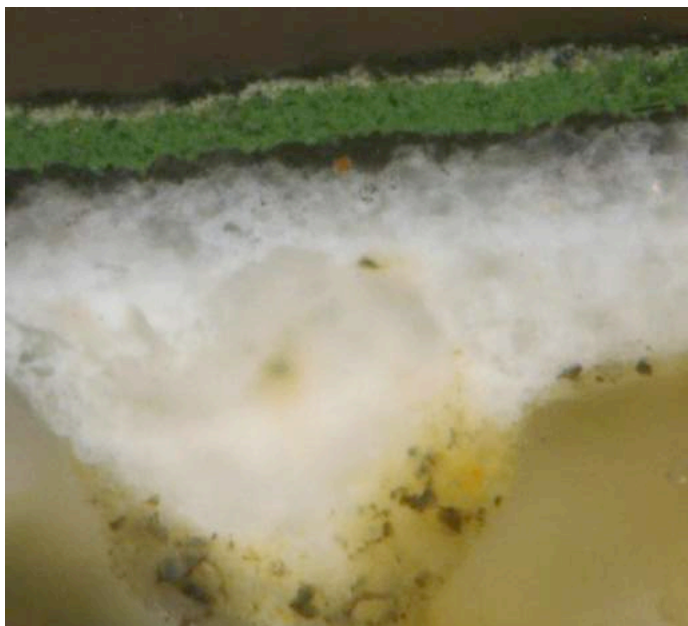
**SAMPLE 7**

Green from trees above zone 4

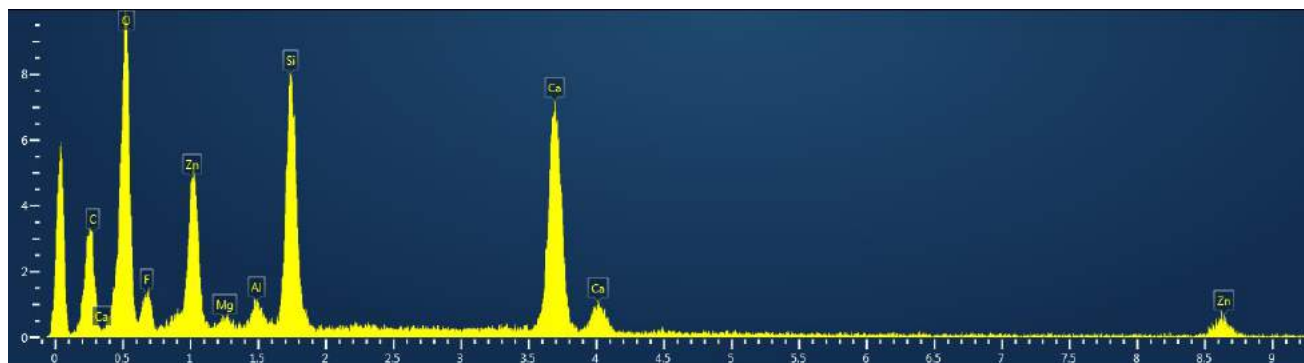
### EDX analysis of the white ground

Showing features for calcium [Ca] from chalk, zinc [Zn] from zinc oxide and silicon [Si] from silicates

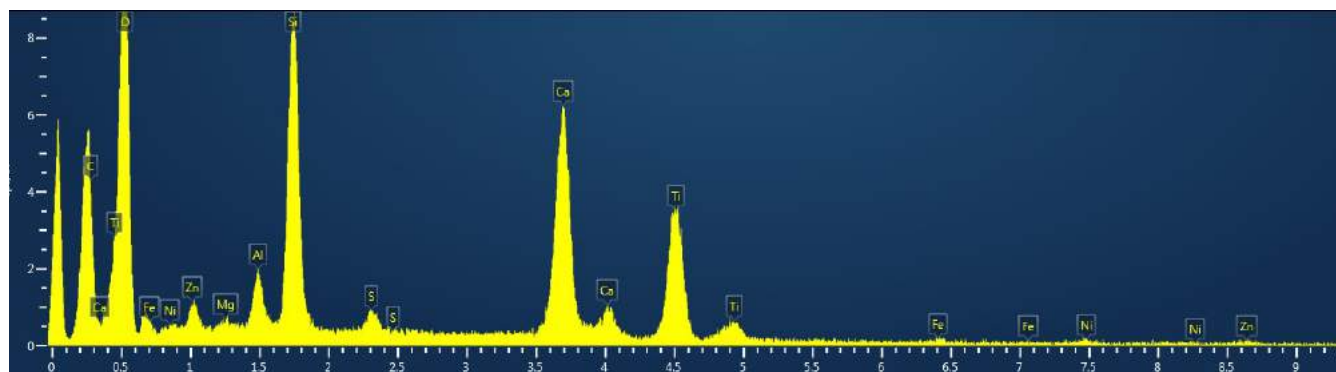
### EDX analysis of the yellow in Sample 6

Showing features for calcium [Ca] from chalk, titanium [Ti] for titanium dioxide, and silicon [Si] from silicates, and small features for zinc [Zn] from zinc oxide, and iron [Fe] from iron oxide.

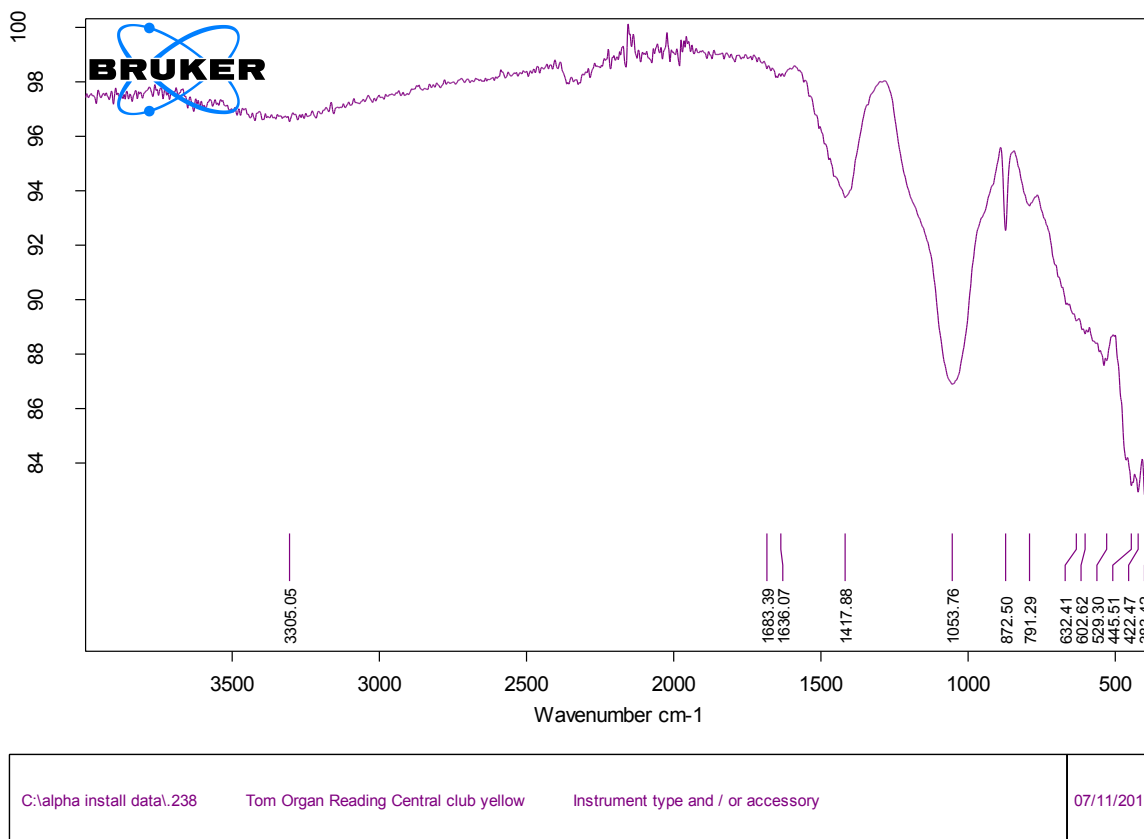
**Figure 1 FTIR Spectrum of sample 1 yellow paint**

The spectrum (figure 1) indicates the presence of:

- Some anatase (broad peak at  $422\text{ cm}^{-1}$ ) (cf. Figure 2).
- Some calcite (chalk) (peaks at 1418, 872 and  $712\text{ cm}^{-1}$  (shoulder)) (cf. Figure 3).
- Some sulphate (peak at  $1052\text{ cm}^{-1}$ .)
- No obvious peaks were seen for binders

Hence the yellow paint, sample 1, from the FTIR alone, seems to contain: titanium dioxide (anatase) calcite and a sulphate, possibly lead sulphate. Calcite is the main component of chalk. Anatase is a modern pigment dating from around the 1920's onwards but is less common than rutile, the other form of titanium dioxide. There were little clues as to the binder which must be present in very small proportions relative to the pigments and extenders.

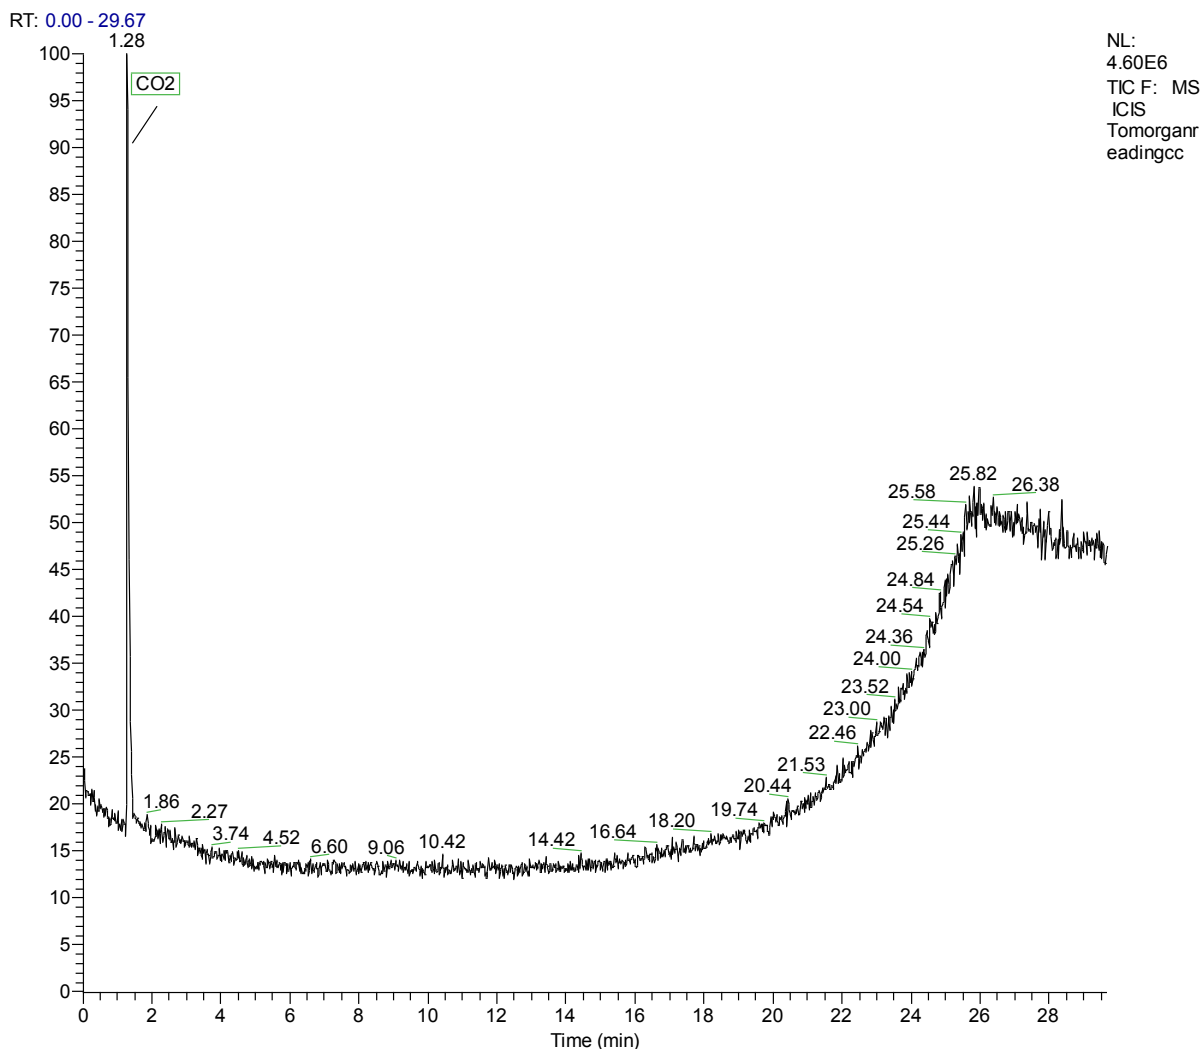
**Figure 4** Pyrogram of sample 1, yellow paint

Initially this method was chosen to look for modern binders such as acrylic, vinyl or other modern resins. However the chromatogram (Figure 4) yielded only carbon dioxide presumably from decomposition of the calcium carbonate (chalk) present.

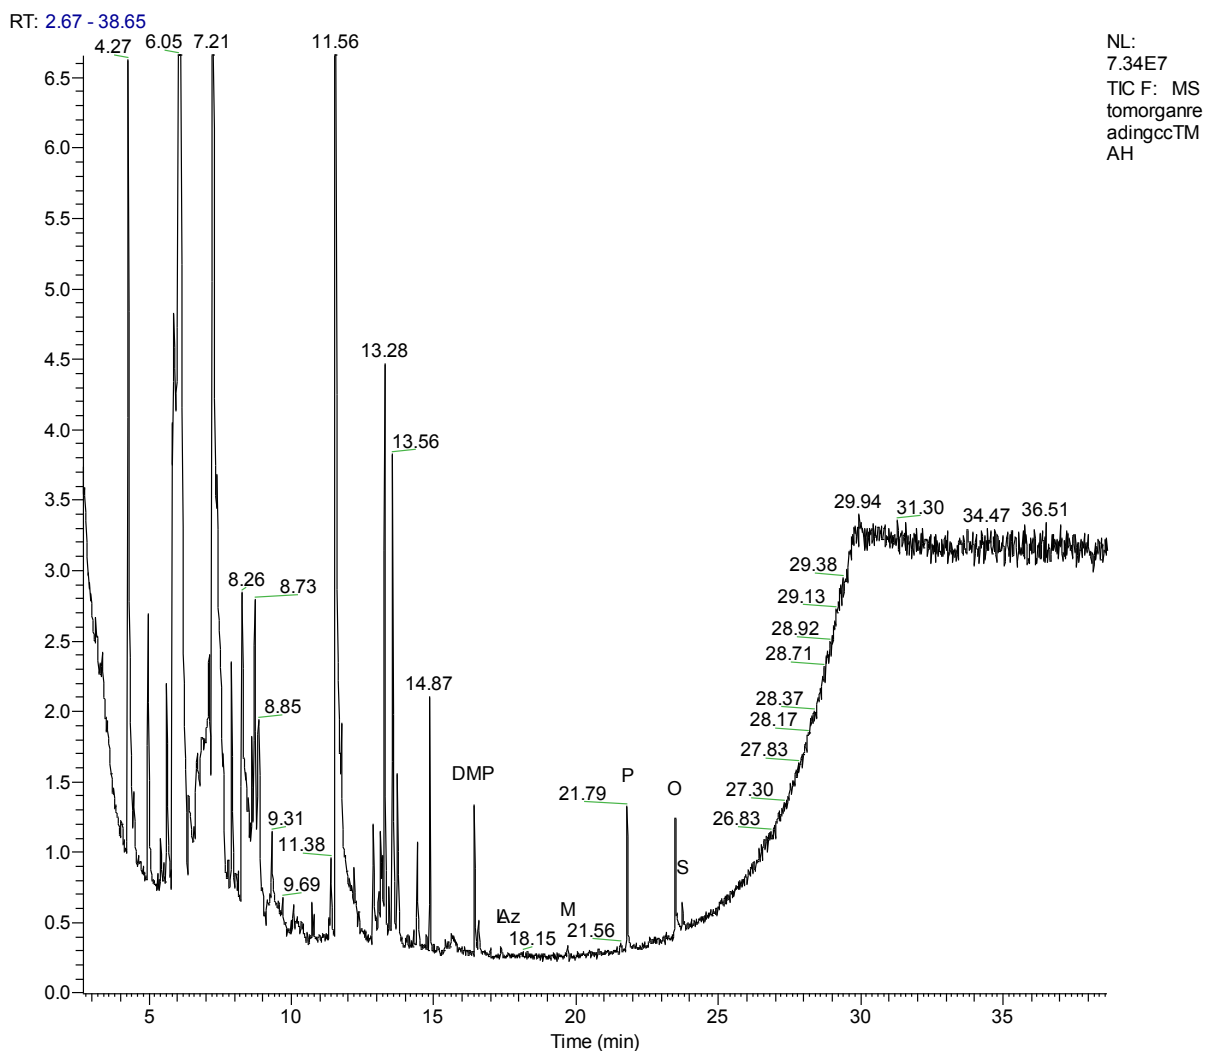
**Figure 5** Py-GC-MS pyrogram of sample 1, detail 2-38 mins. (DMP = dimethyl *o*-phthlate, L = methyl laurate; Az = dimethyl azelate, M = methyl myristate P= methyl palmitate, O = methyl oleate, S= methyl Stearate).

This on line methylation method was chosen as oil or alkyds were now suspected here. A portion of the sample 1 gave a pyrogram (Figure 5) in which the derivatised components were recognised by mass spectroscopy as various fatty acids including : azelic acid, lauric acid, myristic acid, palmitic acid, oleic acid and stearic acid as their methyl esters. This is the typical output of a lipid such as a fat or drying oil but there is also a very large peak for dimethyl phthalate indicating an ortho-phthalate alkyd, one formed from an oil and phthalic anhydride. The ratios of one acid to another were measured (Figure 6, Table 2). The azelate to palmitate ratio is 0.1 which indicates that very little drying oil is present and that the sample may contain some fats. The palmitate to stearate ratio is 3.2 (cf. Table 3). The

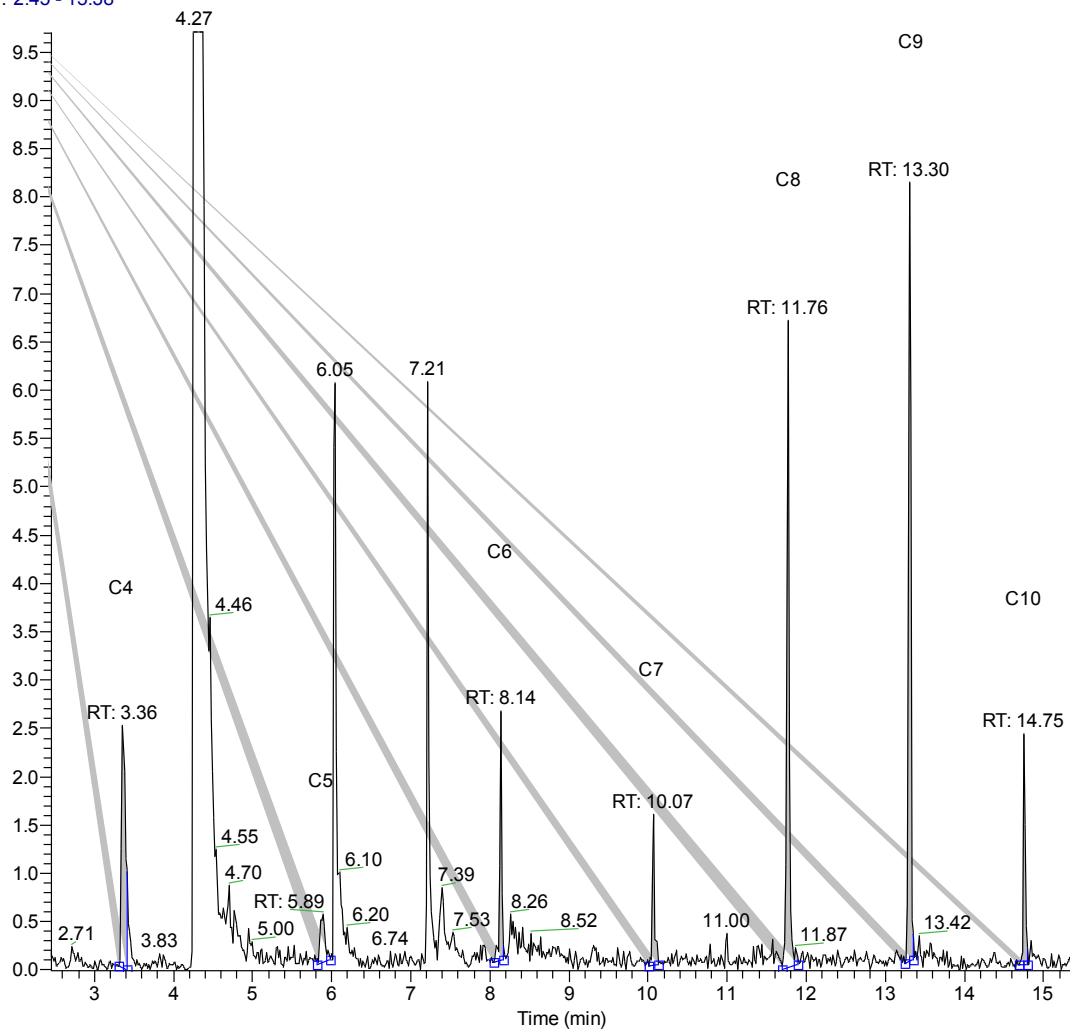
**Figure 7 Py-GC-MS pyrogram of sample 1, detail 2-15 mins.,74 ion count (C4=methyl butanoate, C5 =methyl pentanoate, C6 = methyl hexanoate, C7 = methyl heptanoate, C8 = Methyl octanoate, C9 = methyl nonanoate, C10 = methyl decanoate)**

In order to characterise the oil further the chromatogram was view in a 74 ion count (Figure 6). The low molecular mass carboxylic acid, methyl esters peak at the C8/9 acids (table 4), which is typical of linseed oil which peaks at C8<sup>5,9</sup> and animal fats which peak at C9<sup>5</sup> perhaps mixed with a little Coconut oil which peaks at C10, within this range.
