# Ground Investigation Report

Brunel Retail Park, Kiln Lane, Reading, RG2 0HS

Issue Date: 27 February 2020

REFERENCE: 19.1247/CB/LC

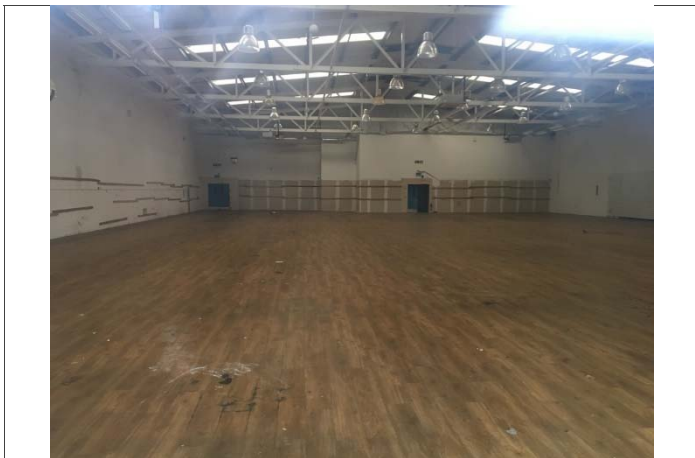
11: Internal Photograph of Unit 4

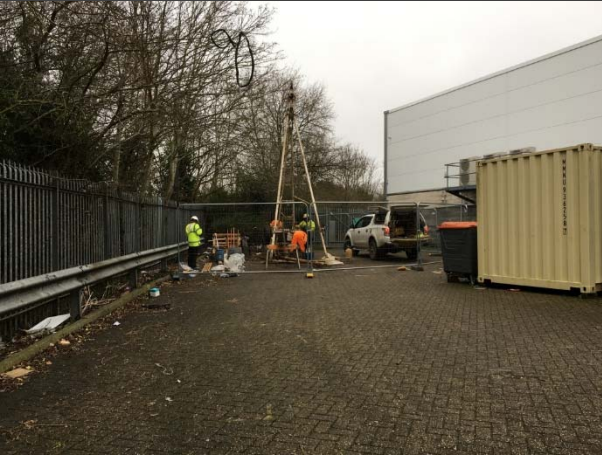
17: Cable percussive rig set up

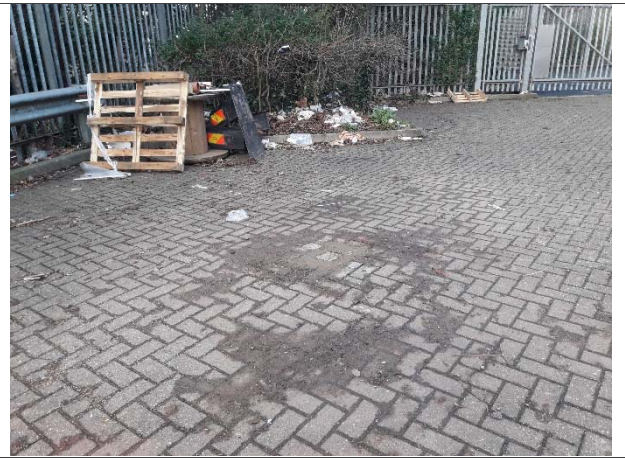
20: Example of reinstated position
