## Condition overview of 75-77 London Street Reading

This report looks at the condition of the building as it stands today.

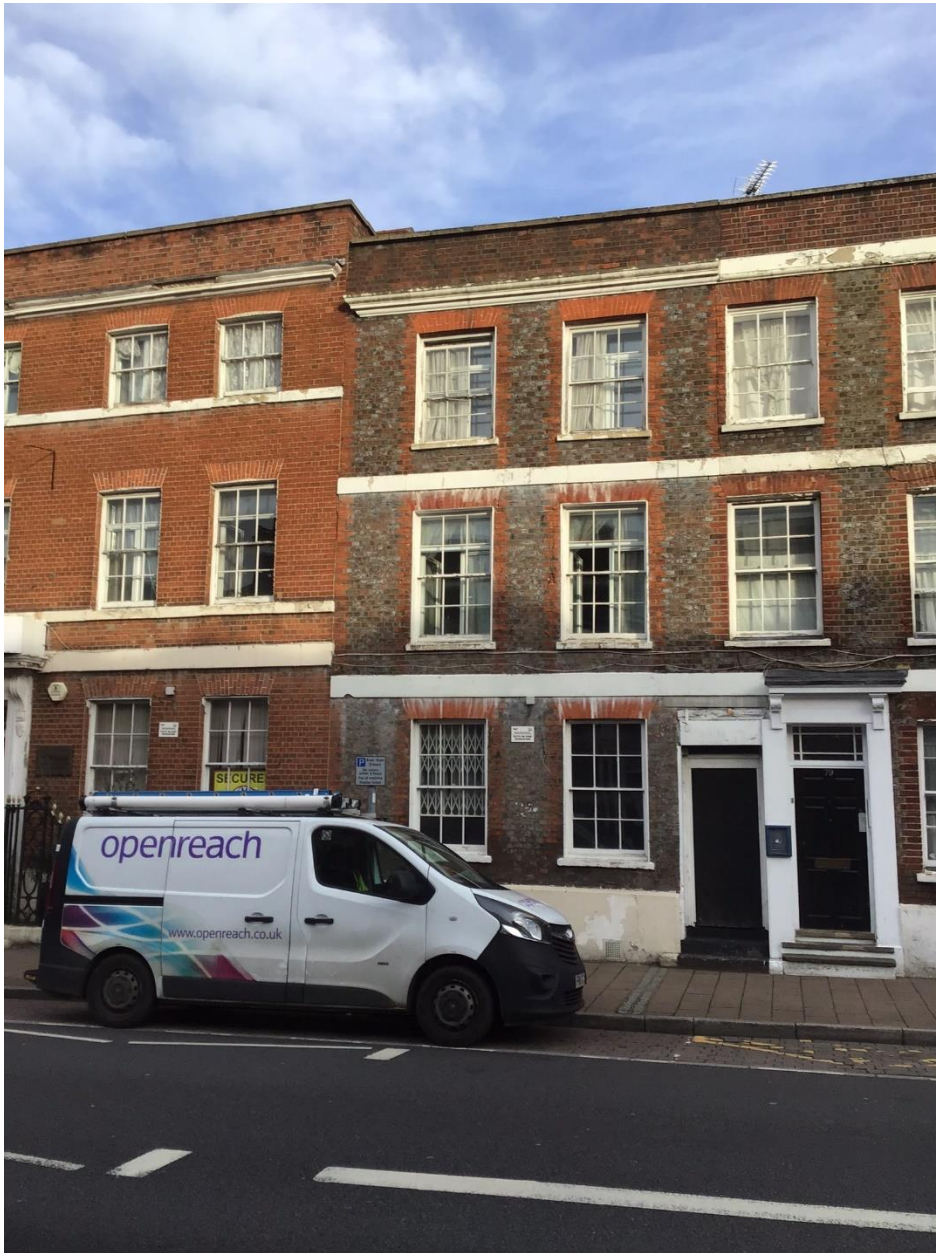
77 London Street

Rotten sash to second floor window, vertical fracturing of brickwork & string course to left of frames.

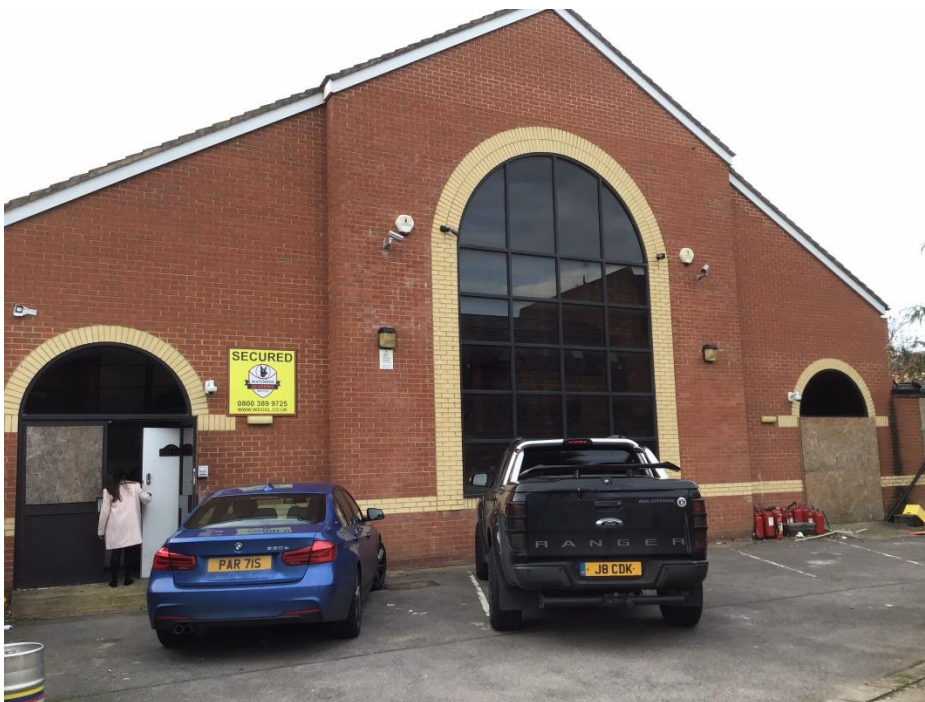
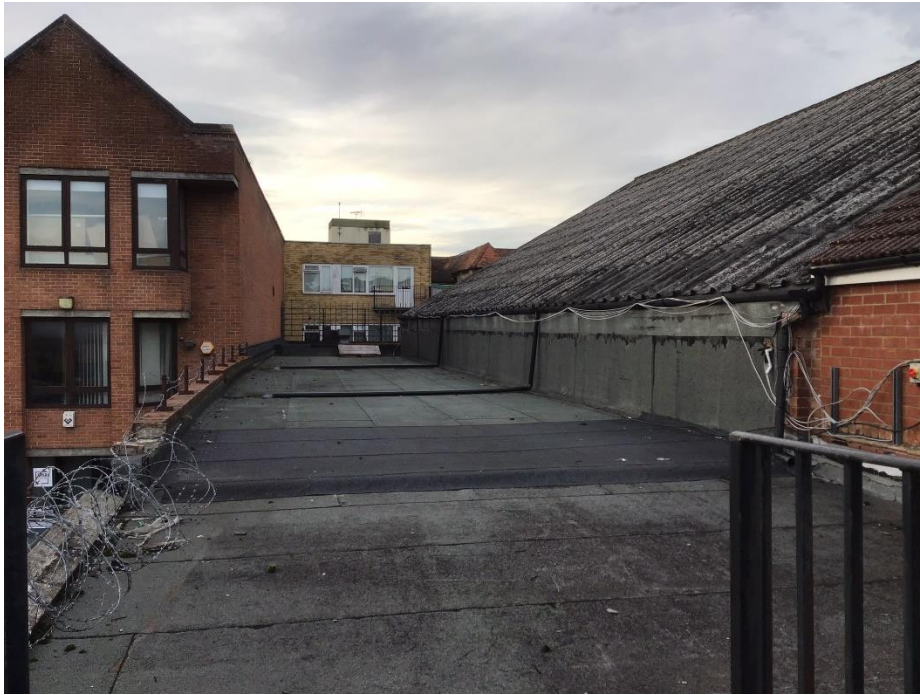
Rear elevation of 2007 extension

View of the left hand flat roof section looking from the rear showing repaired sections.

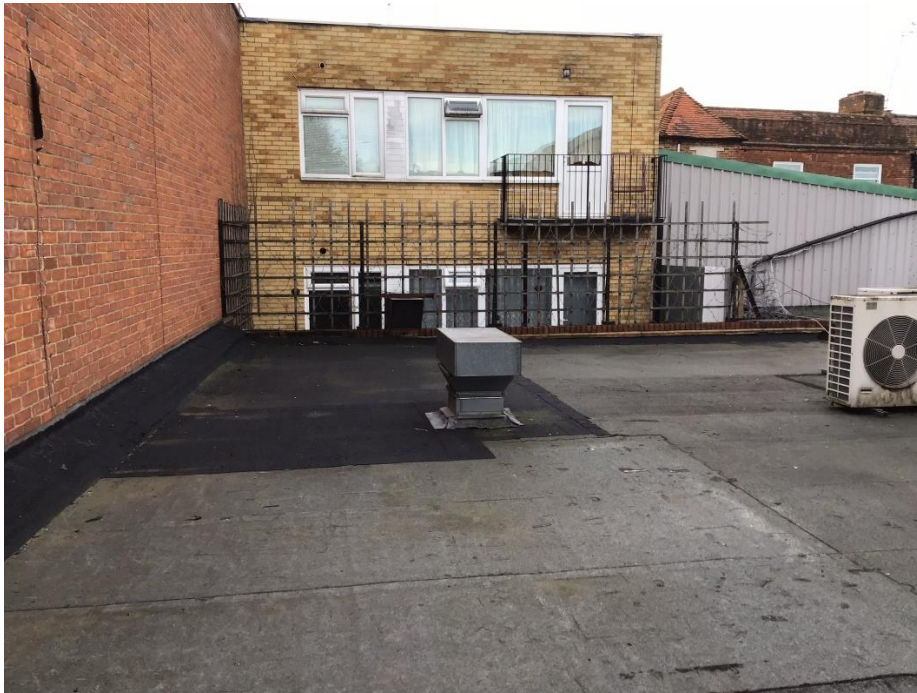
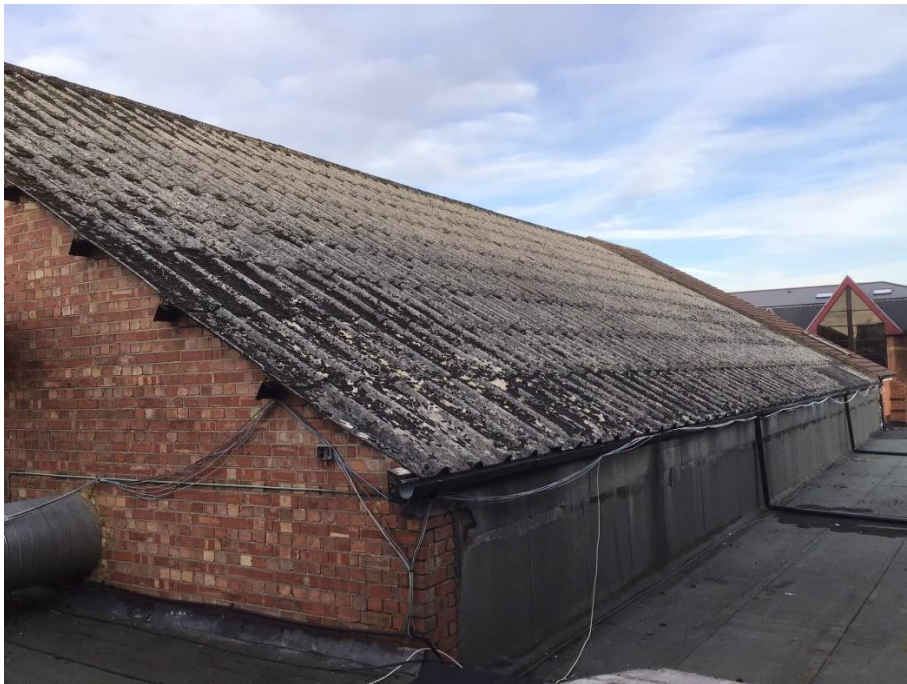
View of corrugated cement, possibility asbestos based roof sheeting.
