| BUILDING NUMBER, STREET | | 34 St Mary's Butts / Vacant | |
| PROPERTY DETAILS | | | |
| Date of Survey | 08/04/2021 | | |

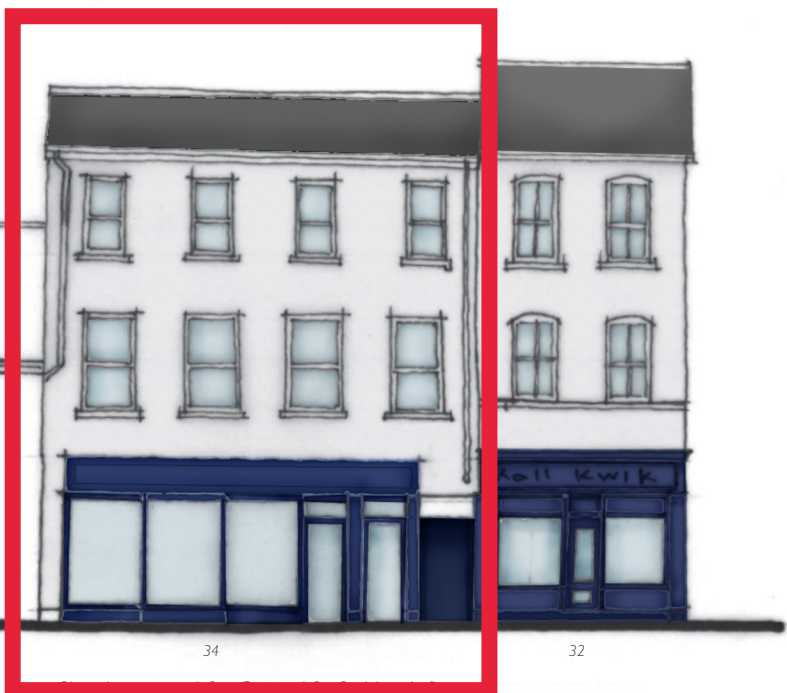
Photograph of Group 10 : 32-34 St Mary's Butt

| New sash windows in frist floor / Level across to be maintained / Metal RWP in right side of façade / Flat panel door as entrance to first floor / Window cills need repairing / Gutters to be cleared / Some loose slates in roof / Historically central door / Original under carriage passage / Modern infill to be removed | | | |

| GROUP 9 - 34 St. Mary's Butt | | | | | | | |
|---|---|---|---|---|---|---|---|
| F | Upper floors – repairs to high level joinery, reinstating lost features | Redecorate centre bargeboard and fascia/soffit behind gutter before replacement. Front elevation only. | 10 | m | £45.00 | £450.00 | |
| H1 | Rainwater goods | Existing pipe looks undersized and does not reach the ground. Replace with new 110mm min diameter cast iron pipes | 9 | m | £200.00 | £1,800.00 | |

| K | Replace ground floor door to floor above with new insulated timber door and top light as per sketch | Existing flat panel door not in keeping. Recommend replace in accordance with sketch | 1 | nr | £4,200.00 | C | £4,200.00 |
| N | Stone repairs to copings or cills | Install new timber cills as part of window replacement | 8 | m | £800.00 | C | £6,400.00 |
