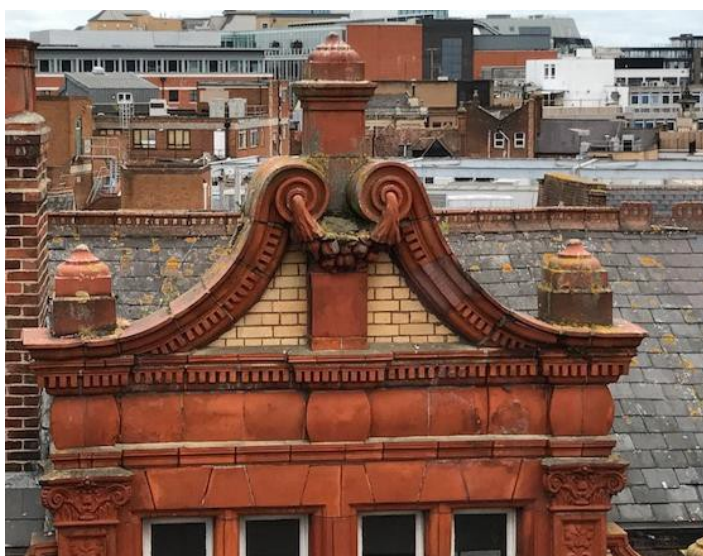
Large gable

The high level gables can be divided in to two distinct shapes, one almost twice as large as the other. It was difficult to closely examine these gables due to the protective mesh that has been mechanically fixed over the entire gable to protect pedestrians from falling masonry. So for indicative purposes I have photographed the gables that match from the other side of Queen Victoria Street, which appear to be the same construction.

**Large Gables** : The majority of these have been compromised by the failure of the joints/pointing and in some the actual units have spalled and split. We may be able to salvage these with resin and stainless steel pins, if the terracotta has not become too friable and weak, but if this is not possible we can either cast new ones in our yard or construct new ones on site from coloured mortars. If there are numerous failed units that are the same it is more economic to cast new ones in the yard, so this is something we cannot determine until the gables are properly accessible.

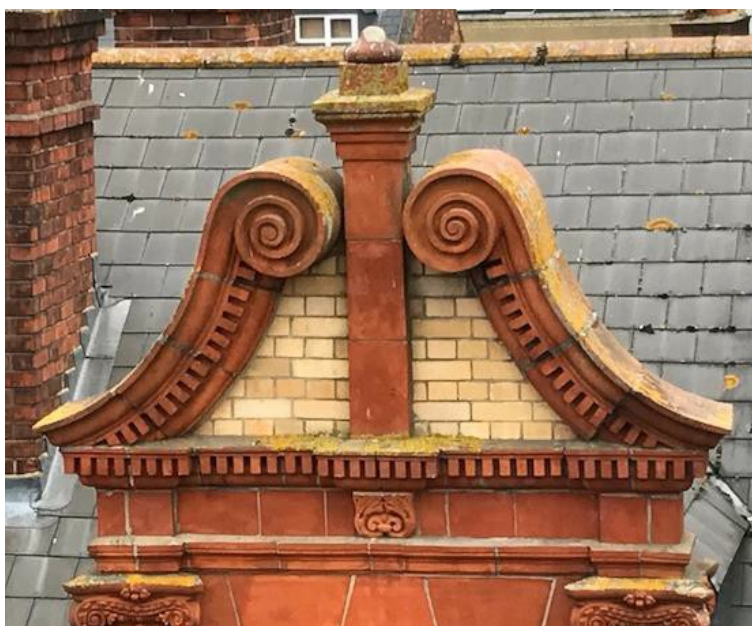
Small Gable

**Small Gables** : These gables have the same problems as the larger gables, but because they contain less detail and scroll work they have been less vulnerable to the problems of damp penetration. The face brickwork within these gables has been reasonably well protected, but there are numerous splits and cracks that are allowing water and damp penetration.
