**23 Woodcote Road  
Caversham  
Reading  
Berkshire  
RG4 7BA**

# **Preliminary Bat Roost Assessment**

**Ref: R3034/a**

**February 2022**

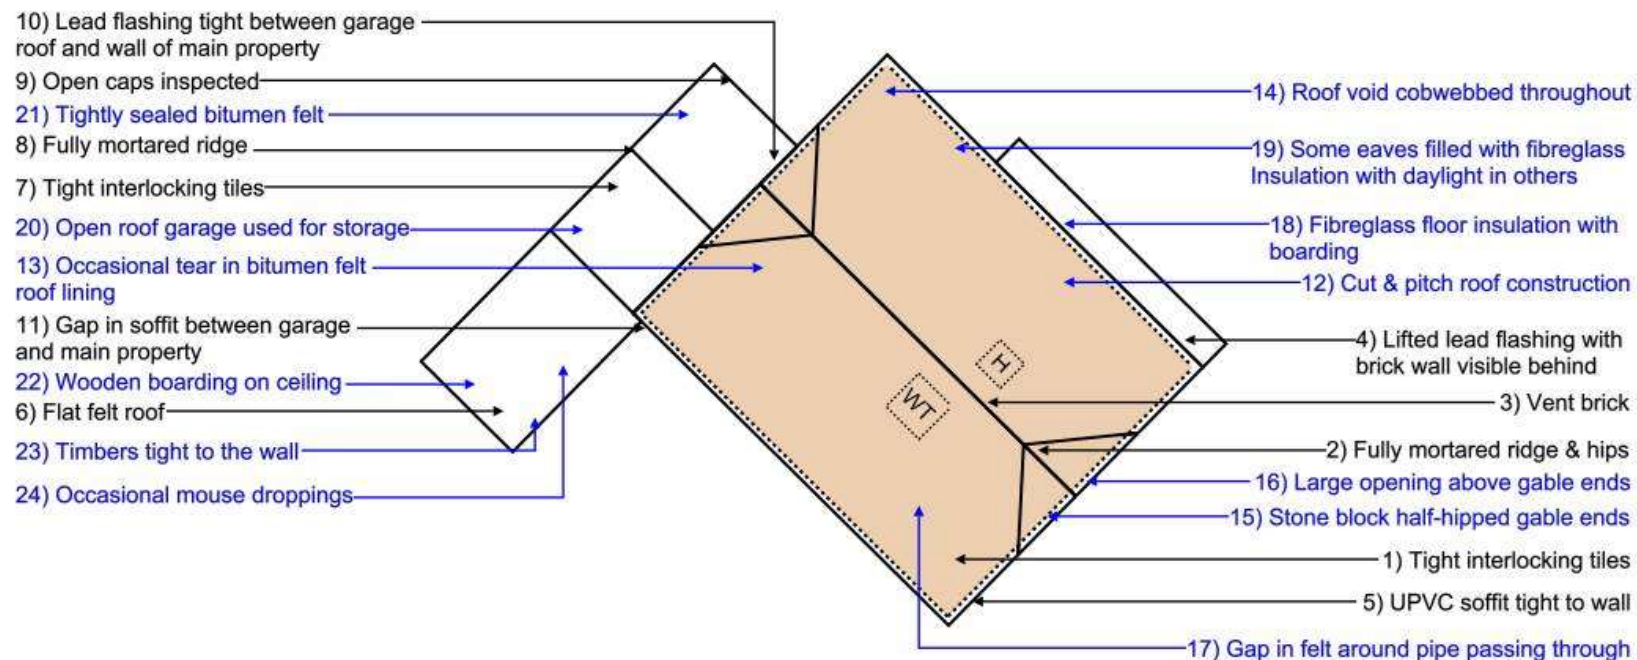
## APPENDIX 2 – PRELIMINARY BAT ROOST ASSESSMENT PLAN

- 4.2.2** No evidence of roosting bats was observed at the time of the external inspection of the house.
- 4.2.3** The garage was partly attached to the eastern wall of the house with the northern section being a flat roof and the southern section having a pitched, tiled roof (**Photographs 9 & 10**). The northern flat roofed section was tight to the soffit with no visible gaps; the southern section was covered with tight interlocking tiles and had a fully mortared ridge (**Photographs 11 & 12; Target notes 6, 7 & 8**). The tiles had capped end and occasionally these had moved leaving the tile end open, they were closely inspected and unsuitable for bats (**Photograph 13; Target note 9**). The lead flashing between the garage and the main house was fitted closely to the wall with no gaps observed (**Photograph 14; Target note 10**). The UPVC soffit was generally tight to the brick wall of the garage; however, the soffit on the flat roof section did not fully connect to the main property (**Photograph 15; Target note 11**).

- 4.3.2** No signs of roosting bats were observed during the internal inspection of the house.
- 4.3.3** The garage had an open roof and was used for storage, accessible via a large, up and over door to the front, and a smaller rear door to the garden (**Photograph 22; Target note 20**). The roof was lined with a mixture of tightly sealed bitumen felt on the northern tiled section and wooden boarding on the southern flat roof section (**Photograph 23; Target note 21 & 22**). The garage was cobwebbed throughout, and timbers were tight to the wall with occasionally mouse droppings present throughout (**Photograph 24; Target note 23 & 24**). Daylight was however observed through the timbers where the external soffit did not fully connect to the main property (**Photograph 25**).
