# Site Investigation Report

121420.1.USI

| Client | Sedgwick |
| Visit date | 11/05/2021 |

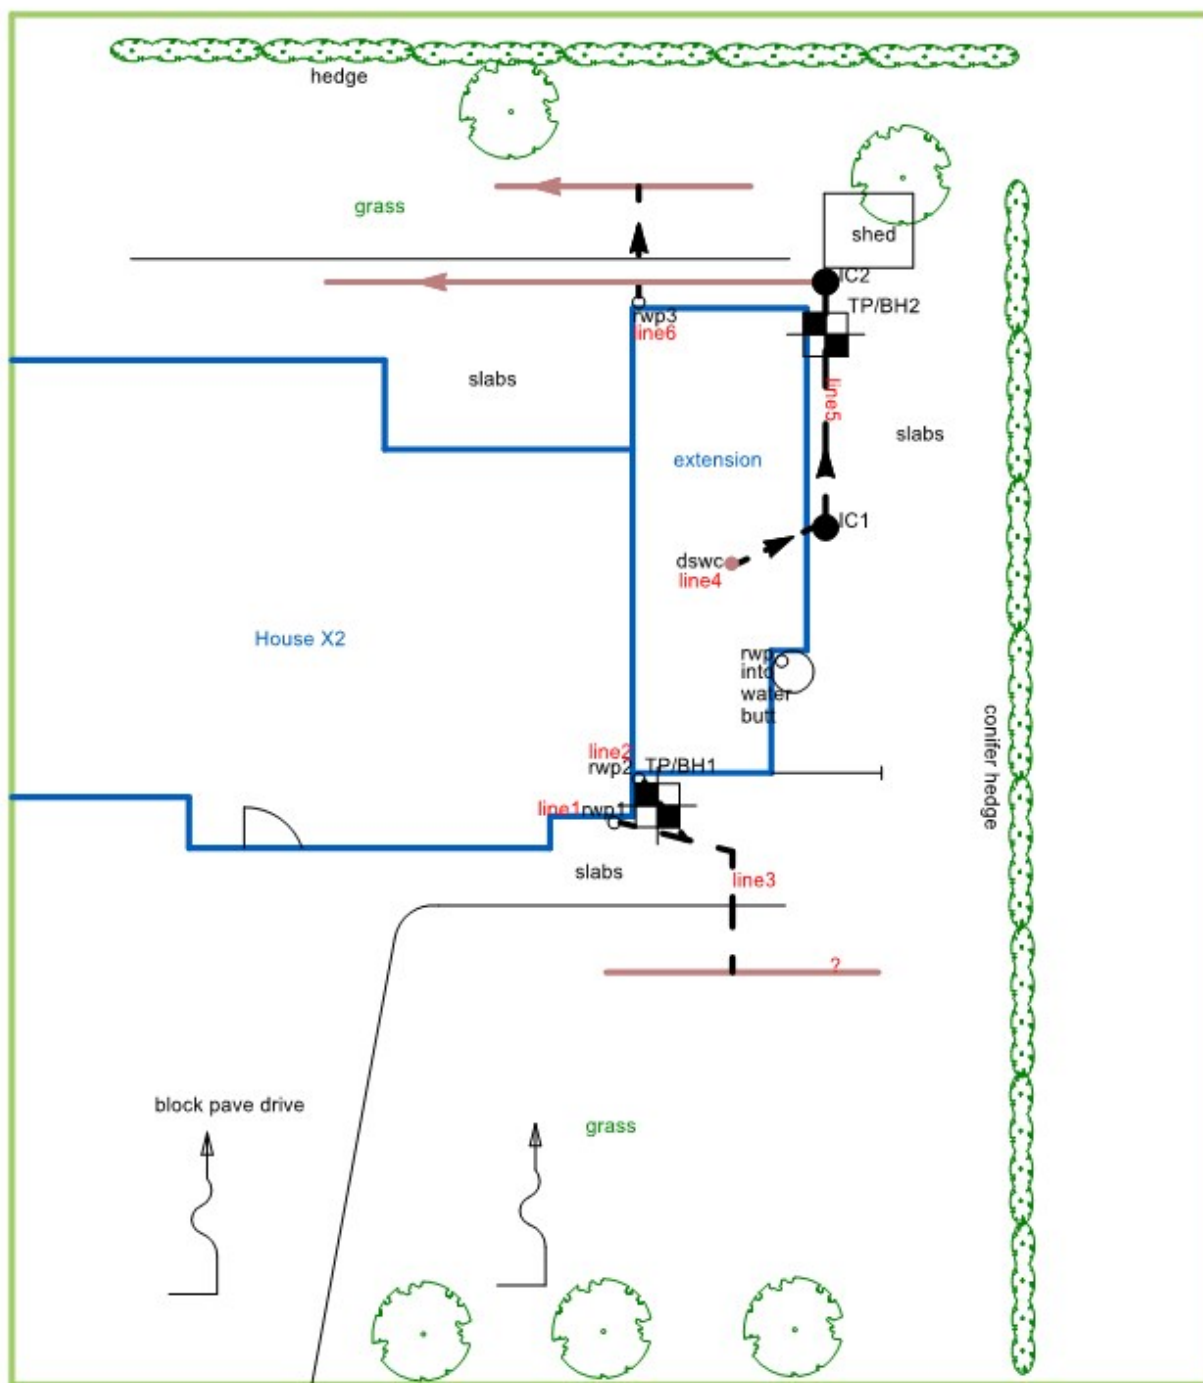
FRONT OF PROPERTY

| Findings | |
|---|---|
| Drain Survey | The CCTV survey revealed no significant defects to the plastic drainage system which could be allowing an escape of water. |
| | <p>We were unable to survey downstream from IC2 due to water holding within the line, however, we discovered that this pipework was of plastic construction.</p> <p>Our survey revealed that the guttering for RWP1 and 2 leaks when water flows through it and the guttering for RWP3 was found to be defective allowing a large escape of water.</p> |
