# CAPITAL STONE

Site : Queen Victoria Street,  
Reading,  
RG1 1TG

### **METHOD STATEMENT FOR THE REPAIRS OR REBUILDING OF THE HIGH LEVEL GABLES.**

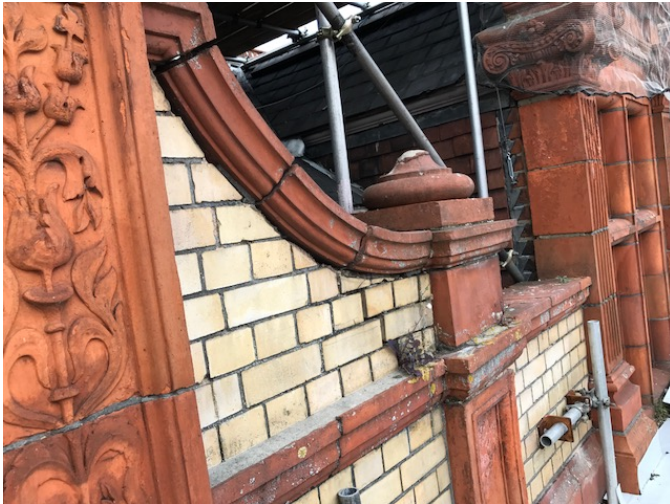
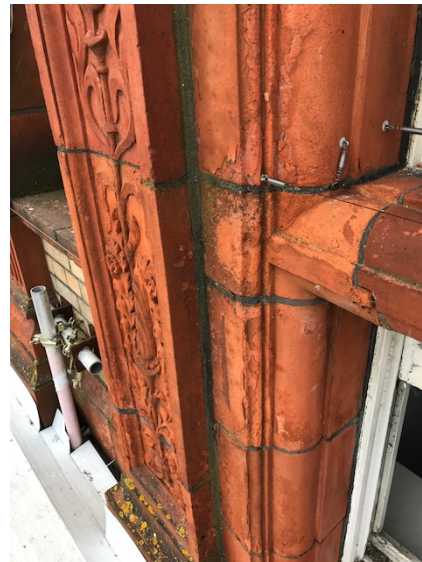
The high level gables are constructed of imperial red stock bricks, over clad with ornate terracotta units and faced to the front elevations with imperial yellow/white gaunt bricks. The terracotta units are in poor condition having suffered general weathering decay and spalling due to movement and modern cement mortar splitting the arrises. Several of the gables have moved from the vertical and the cause of this is not immediately obvious. All the ornate exposed finial or urn toppings to the gables and their shoulders have been previously removed (presumably for safety reasons).

The mortar joints have failed generally as has most of the lead flashing and mortar flaunching.

4. Any damaged terracotta items that are salvageable will be carefully removed and repaired using reconstituted terracotta mortar with stainless steel wire re-inforcing resin fixed in position. An example of these repairs will be presented to the Conservation Officer for approval.

5. Any terracotta units that are beyond repair will be carefully recorded prior to removal and then we will manufacture a mould and re-cast a new unit. A sample of the replacement units will be presented for approval prior to manufacture.
