9548: 43a CHURCH ROAD, CAVERSHAM, BERKSHIRE

## **BRIEFING NOTE: BAT BUILDING ASSESSMENT**

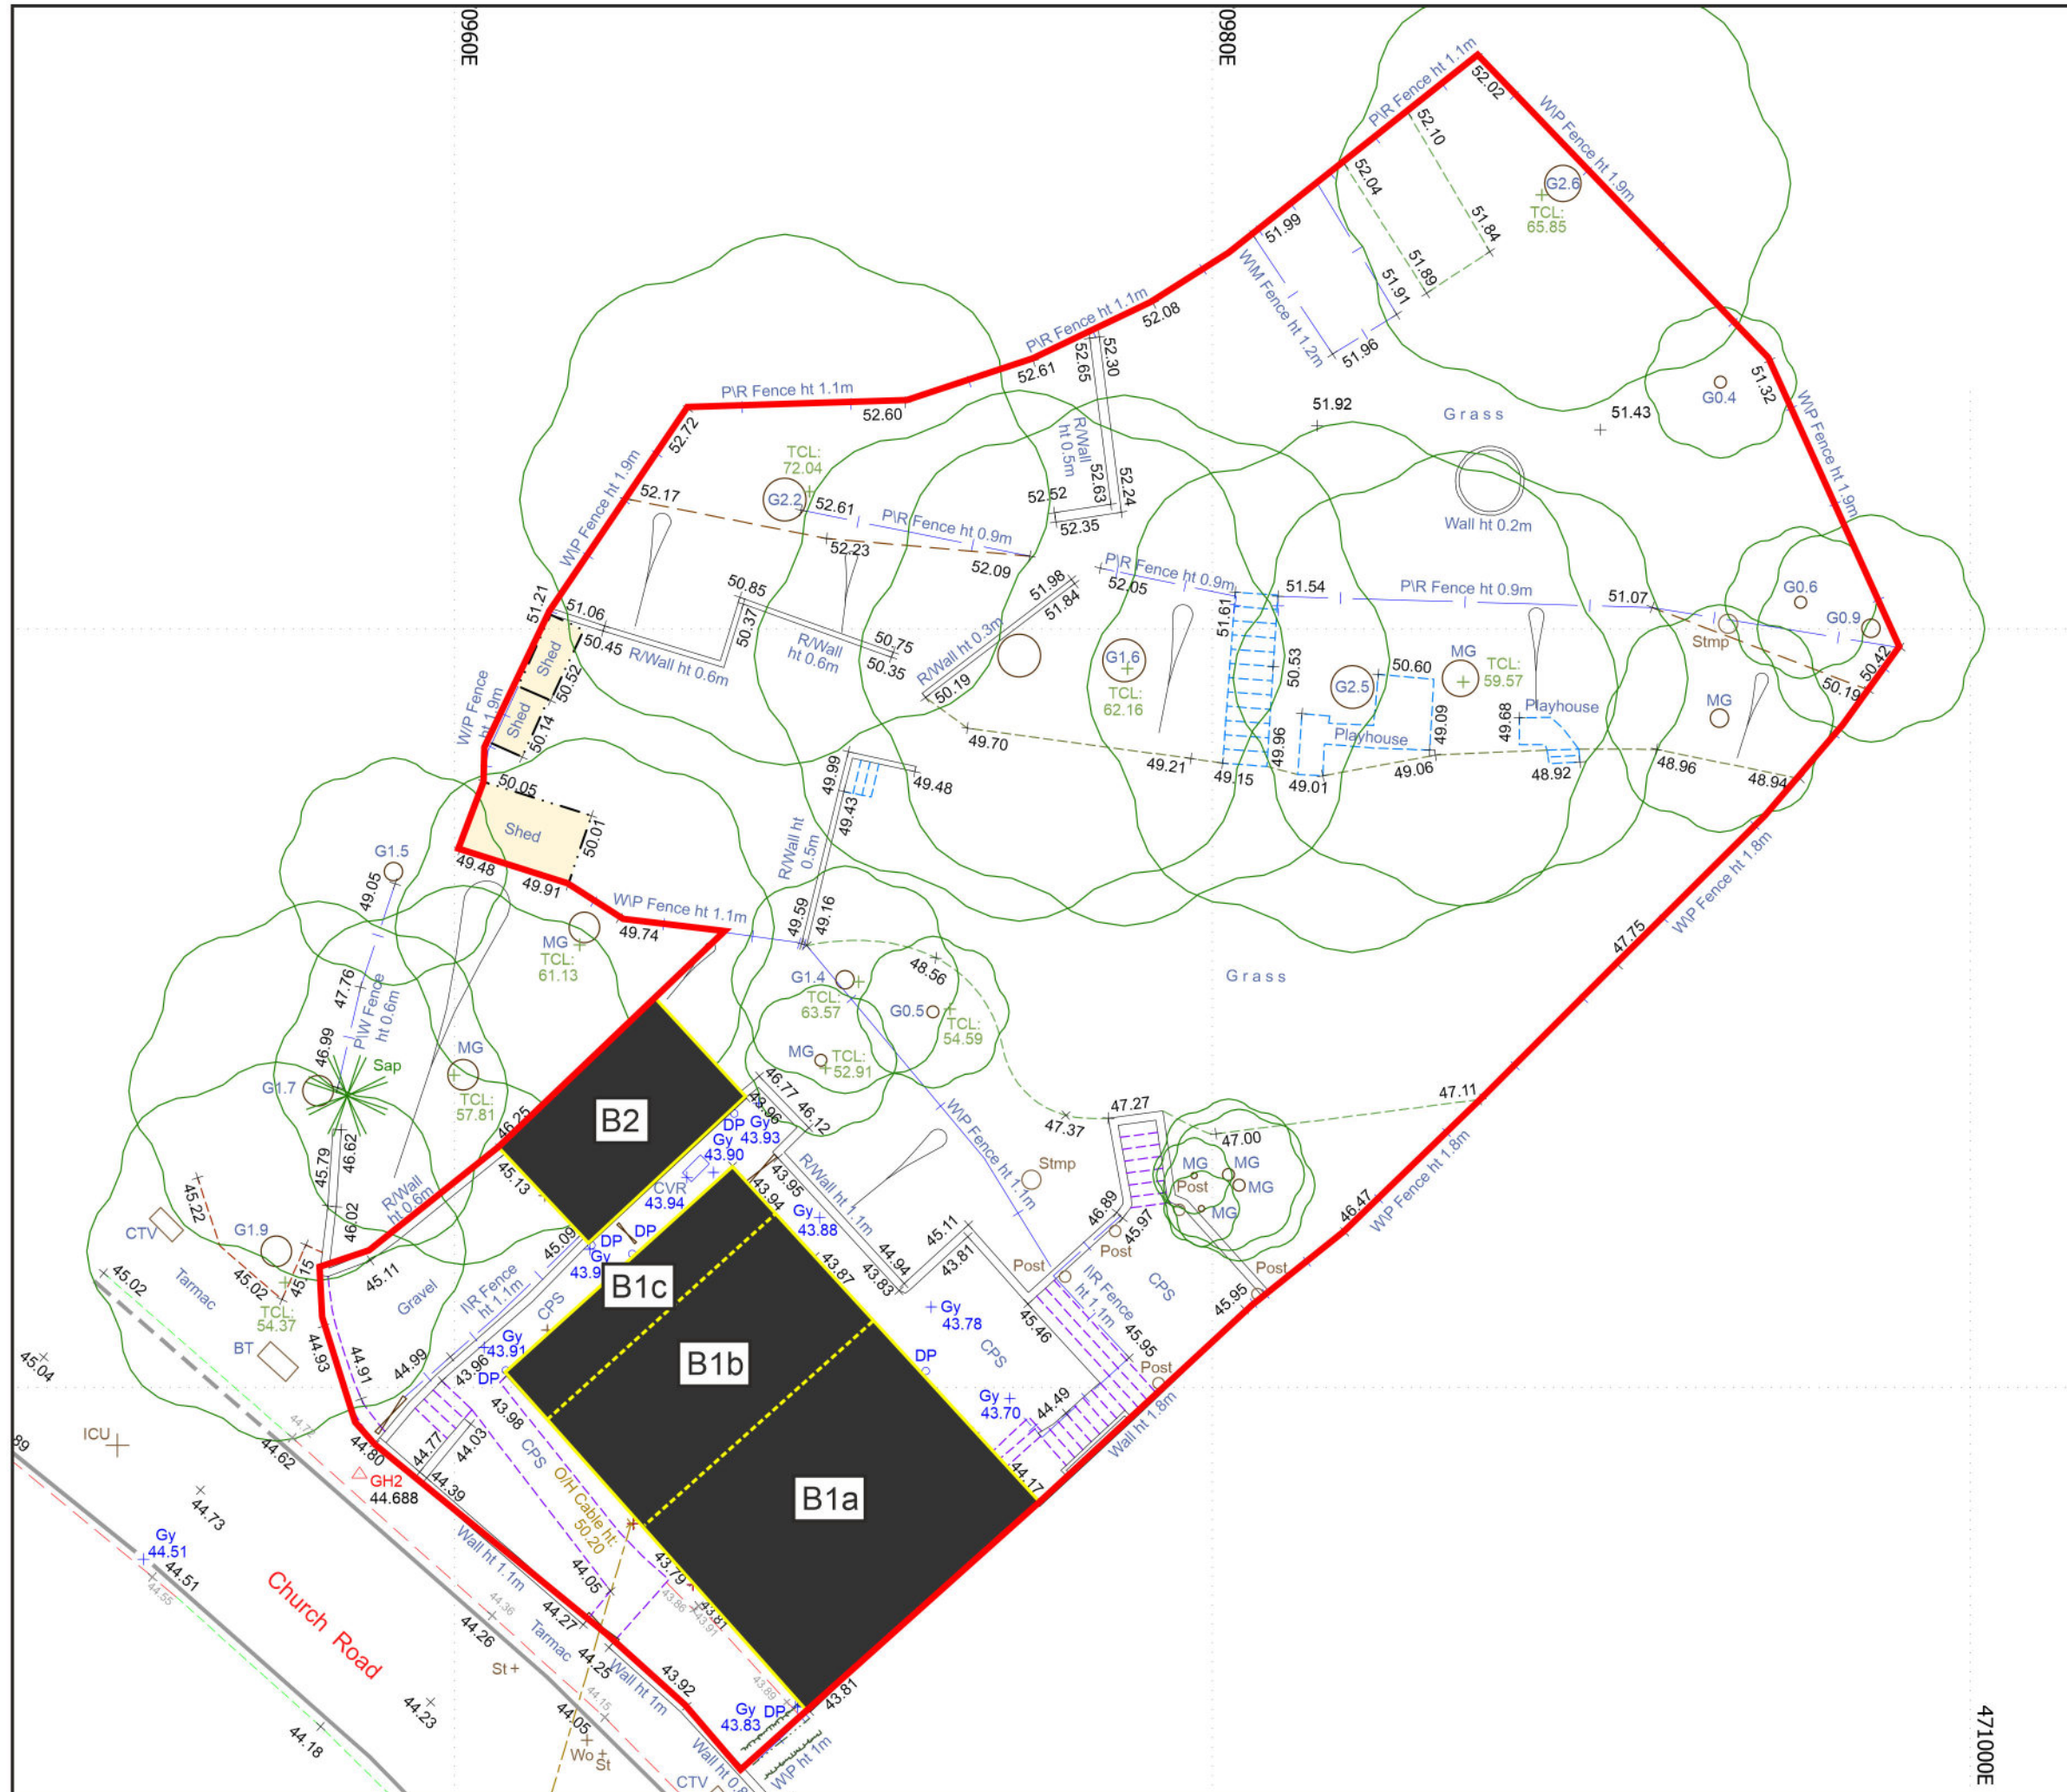
## **PLAN ECO1**

6. There are two buildings on site. Full descriptions of the buildings are detailed below. The buildings locations and positioning are shown at Plan ECO1.
