**No 27/33 Christchurch Road,**

**Reading, Berkshire**

**Listed building Appraisal and Heritage Impact assessment**

**J F Missenden CEng FRSA**

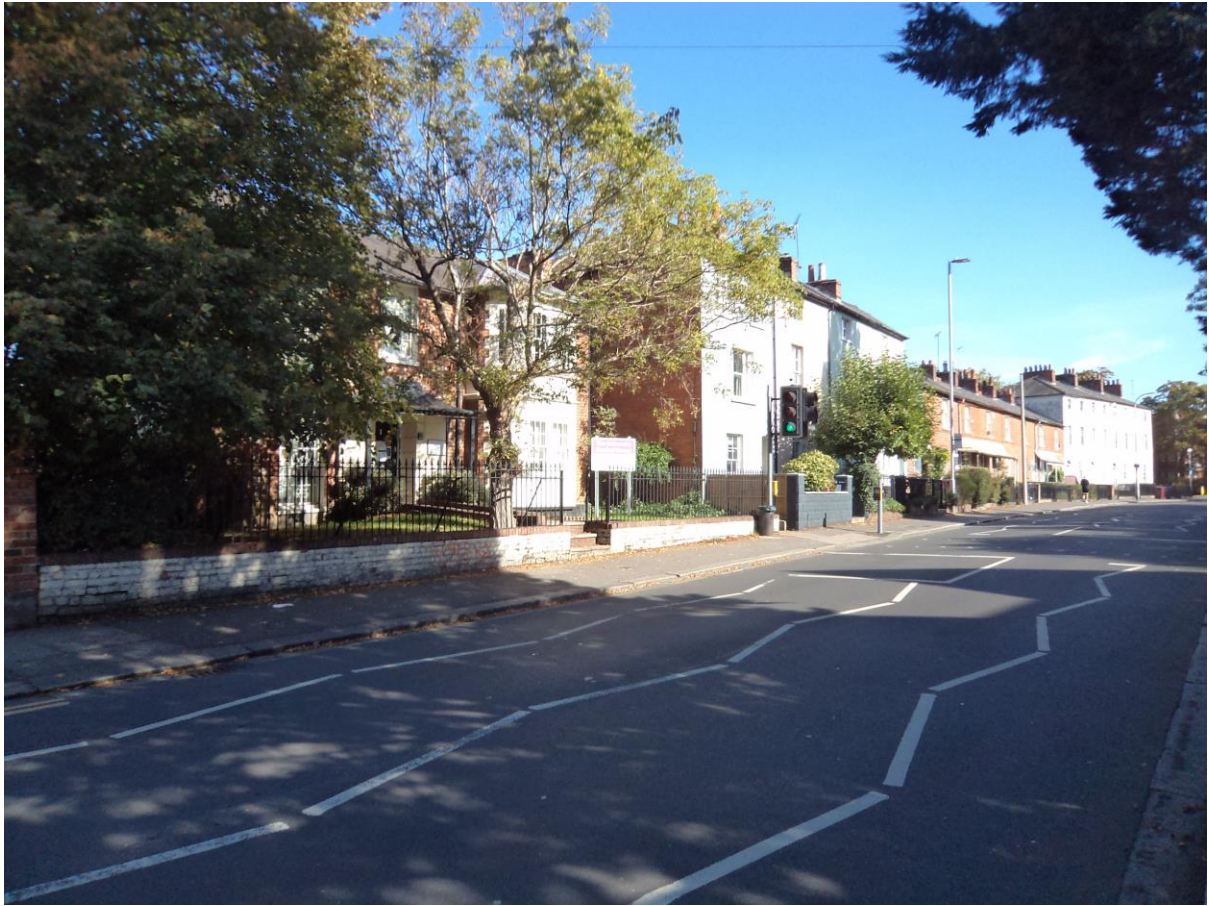
**Figure 1: Whitley Crescent, South view**

The buildings lie on an East - West Axis on the north side of Christchurch Road diagonally opposite the parish church. The terrace forms part of a larger feature; Whitley Crescent and its South facade is shown in Figure 1, looking East, with the buildings in question at the far end. The buildings are architecturally described in Appendix 2. This was developed progressively, after Whitley Villa, the listed three bay detached house on the corner of Highgrove Street. Nos 5,6,7 were the first of the terrace, followed in two stages by Nos 9 – 11, then 13 - 25, finally this present group of four houses, with with better details. No 3 was added last, with later discordant Victorian details (reportedly in 1887, for a previous owner of Whitley Villa).

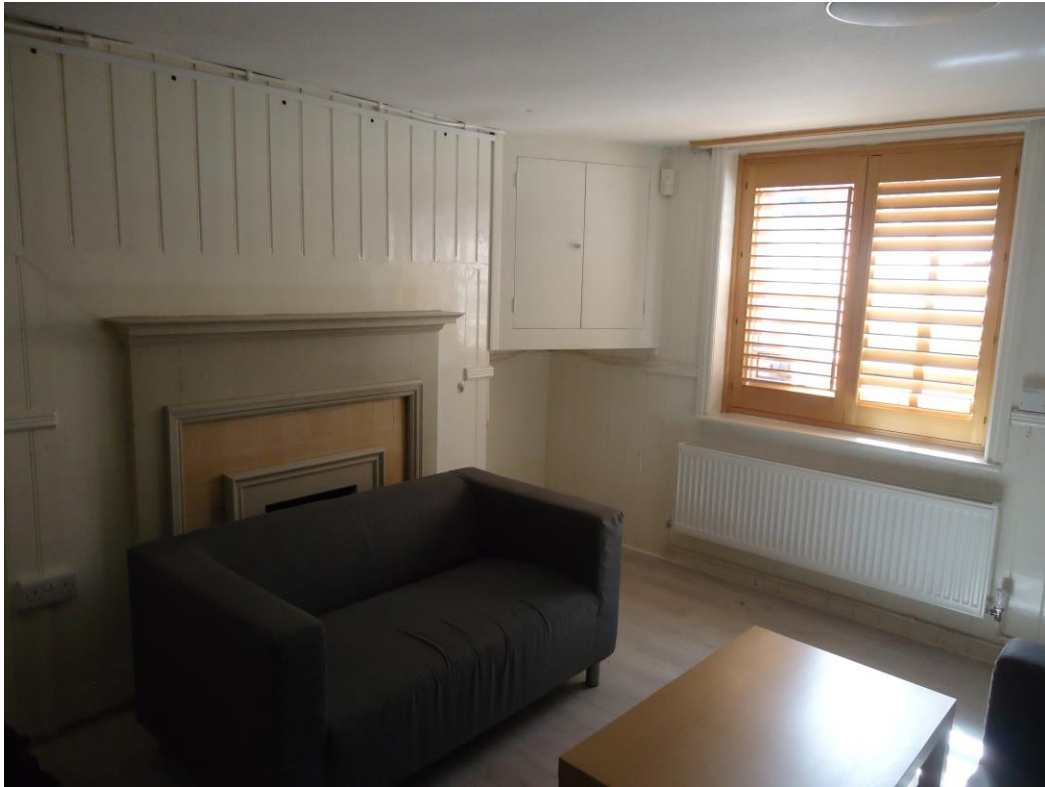
**Figure 5: Basement room**

No 29 has the least changes internally and has some good if simple interior fittings, shown below in Figure 4, 5. Not shown is the chimney piece and staircase Newell post.
