**87 Balmore Drive  
Caversham  
Berkshire  
RG4 8NN**

# **Preliminary Bat Roost Assessment**

**Ref: R2757a**

**April 2021**

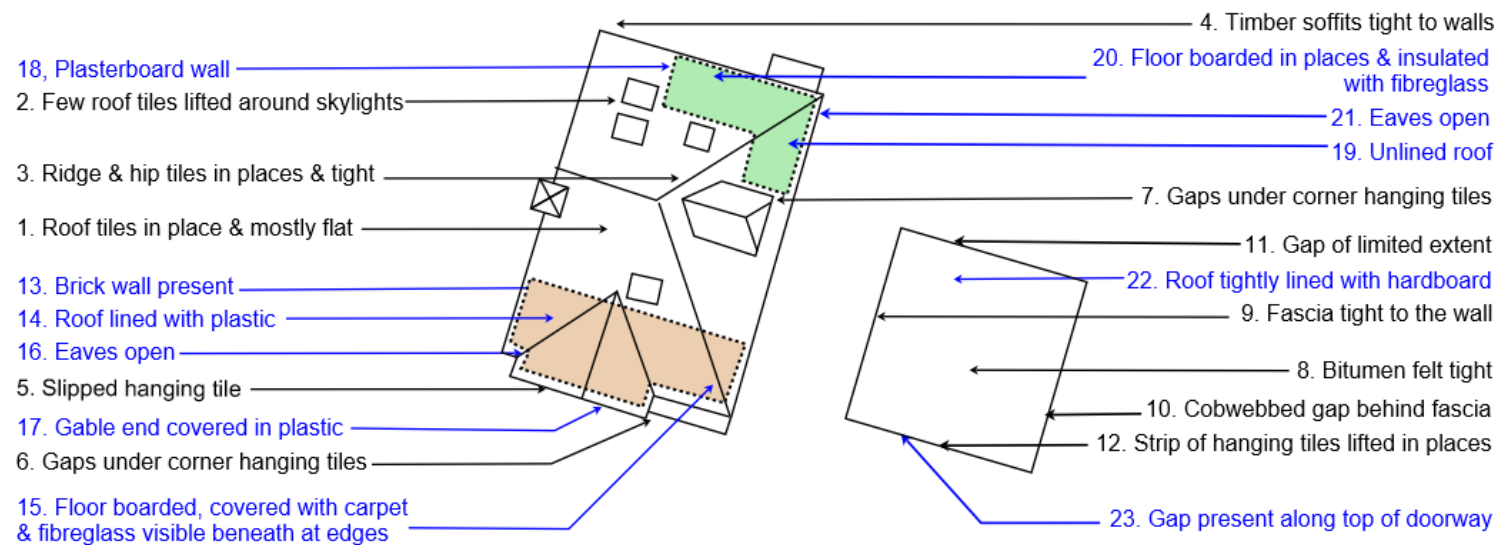
## APPENDIX 2 – PRELIMINARY BAT ROOST ASSESSMENT FINDINGS

- 4.1.2** Externally, the house had features suitable for use by crevice-dwelling species such as the pipistrelles (*Pipistrellus* spp.) and/or small *Myotis* species. These features included the gaps under and behind the hanging tiles, in particular to the eastern side and front of the house. No evidence of roosting bats (i.e. staining or droppings) was visible on the exterior of the house during the inspection.

**4.2.1** Further survey of the house should be carried out to determine if roosting bats are present, and if present, the status of the bat roost(s). The surveys should comprise of at least two emergence and/or re-entry surveys. A third survey may be necessary if bats are found to be present during the first two surveys to help characterise the roost. The surveys should be completed within the period between May and September inclusive with at least one of the surveys carried out in the peak season for recording maternity roosts i.e. May to August, and at least two weeks should separate the surveys (Collins 2016).
