# Existing Culvert Condition Survey

Green Park Village, Reading

**St. Edwards**  
**Ref:** 11056  
**Date:** Jan 2021

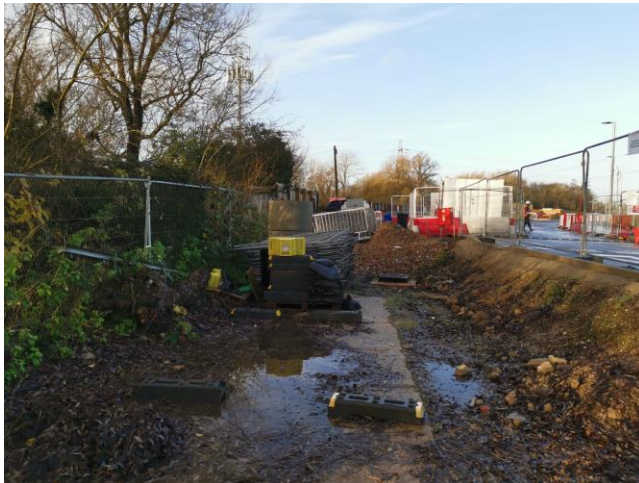
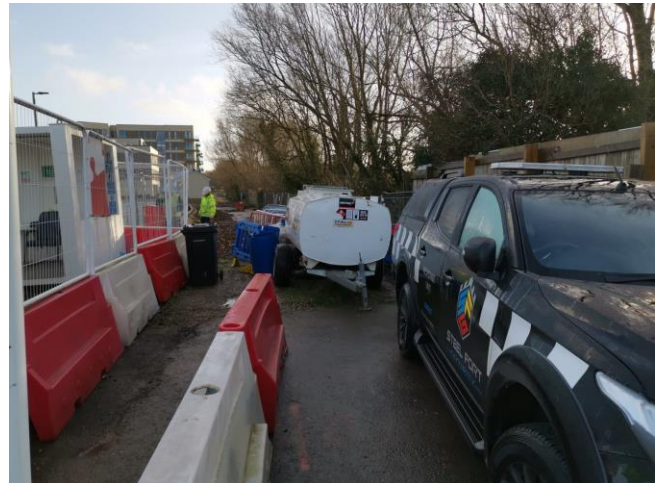
The existing condition of the culvert looks good, there are no signs of any cracks or weakening of the inner lining of the pipe. There are signs of silt buildup at the bottom of the pipe which is natural and expected. Upstream of the pipe (Western Boundary) there is an existing tree branch which is growing inside the pipe and is restricting the natural flow of water through the pipe causing the water levels to rise slightly.

- Vegetation clearance works including the removal of the tree stump
- Temporary Sandbag gap to block the flow temporarily to clear the inside of the pipe
- Water tanker to remove the water and silt
- Material removal by security
- Building of new access ramp to allow water tanker
- Camera survey of culvert once cleaned and cleared
