**14 The Rise  
Caversham  
Reading  
Berkshire  
RG4 8NZ**

# **Preliminary Bat Roost Assessment**

**Ref: R2944/a**

**November 2021**

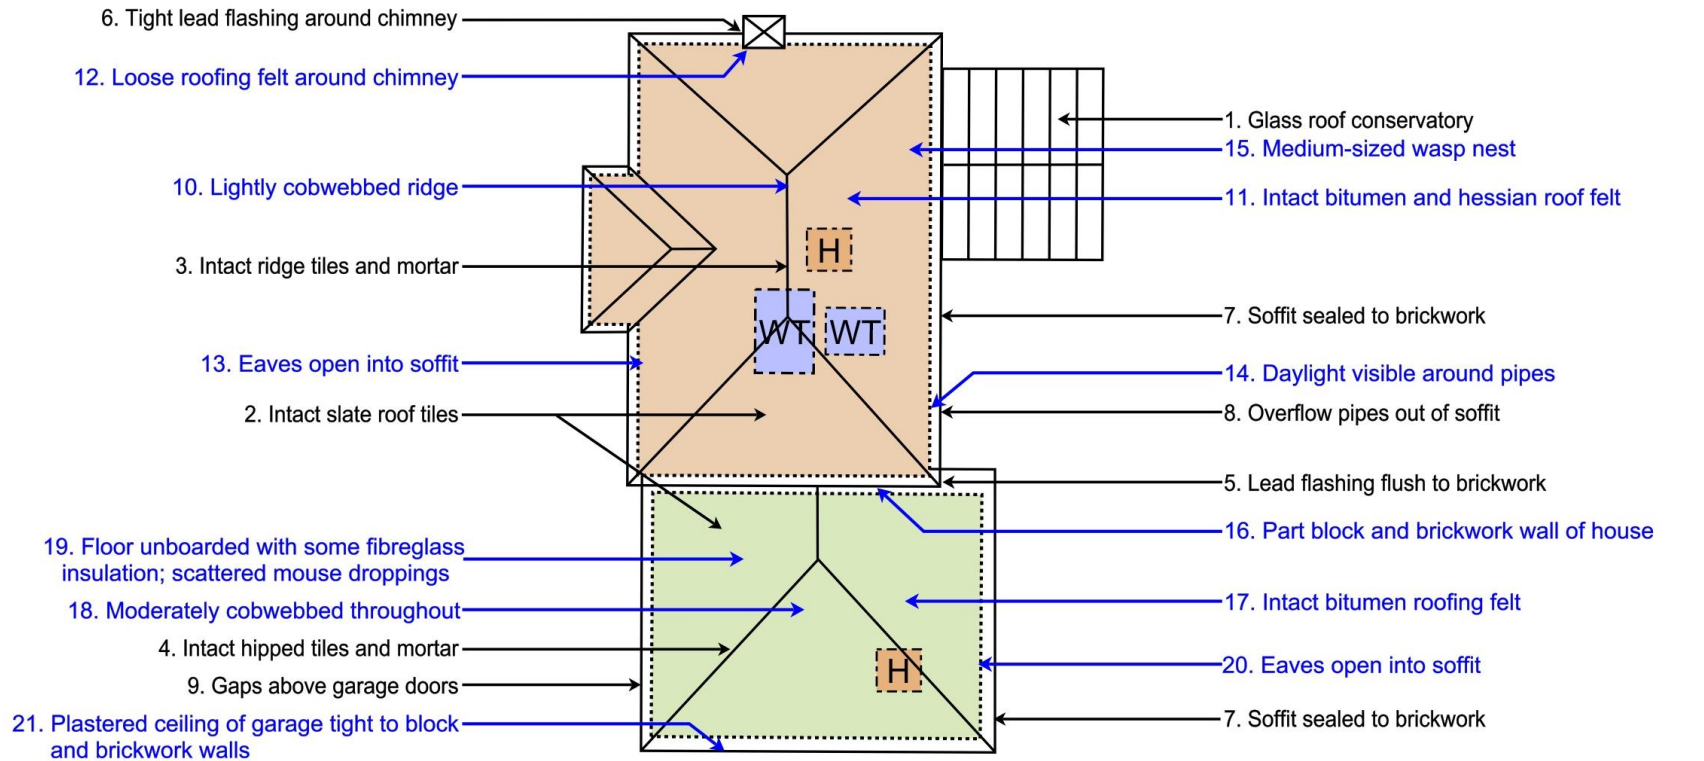
APPENDIX 2 – PRELIMINARY BAT ROOST ASSESSMENT PLAN

- 4.2.2** No evidence of roosting bats was observed at the time of the external inspection of the house and garage.

**4.3.3** No signs of roosting bats were observed during the internal inspection of the house and garage.
