**129 WHITEKNIGHTS ROAD, READING,  
BERKSHIRE**

**PRELIMINARY BAT ROOST  
ASSESSMENT**

Report No: RT-MME-156393

Date: December 2021

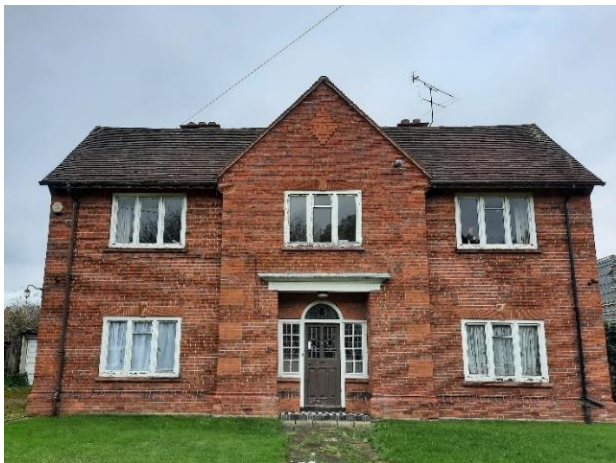
**Plate 4.1: Front of building (south-west elevation)**

The main building at 129 Whiteknights Road was large two-storey residential brick-built detached house, built in early 1900s. The building was in relatively good state of repair and was un-occupied at the time of the survey. The building had pitched clay tiled roof and chimney. It was brick built with single glazed windows in wooden frames (Plates 4.1 and 4.2).

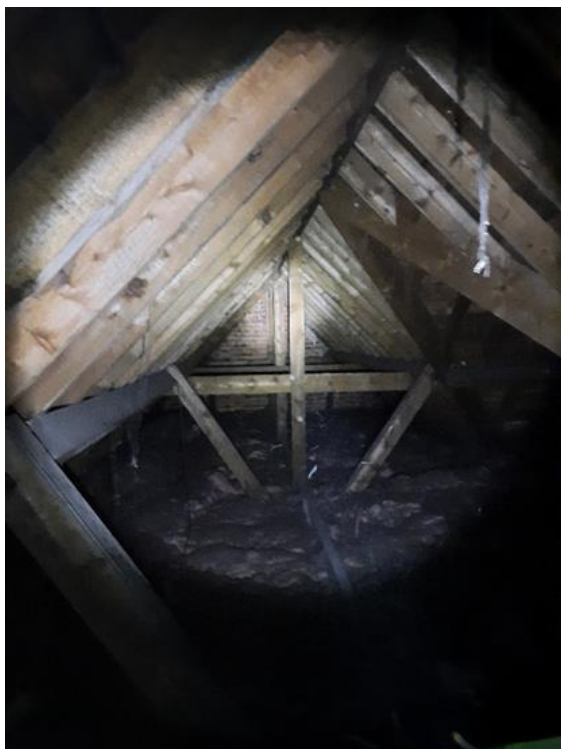
**Plate 4.15: Main loft void with fibre glass insulation**

The main loft space formed a large U shape, measuring approximately 2 metres high from ridge beam to floor, approximately 13 metres in length north-west to south-east (Plate 4.15) and 12 metres and 9 metres in length north-east to south-west (Plates 4.16 and 4.18). The loft void was constructed from wooden timber rafters, supported by a wooden ridge beam with wooden sarking boards (Plate 4.17). The loft was uncluttered and not used to store any personal items and was internally insulated with fibre glass. Only a small section of the floor around the loft hatch was boarded.

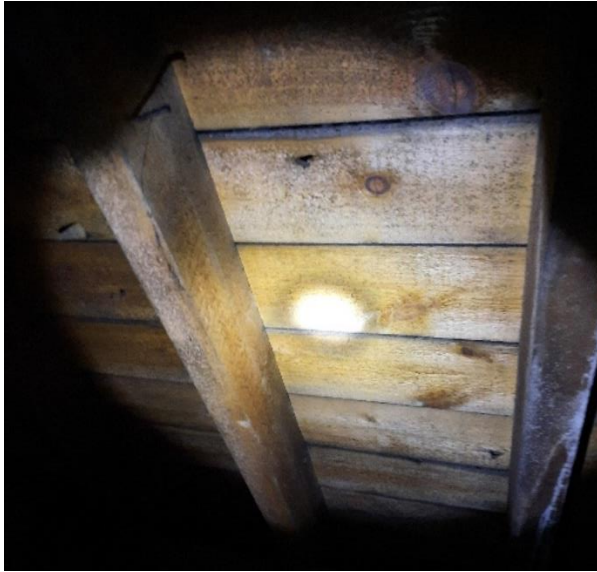
During the previous assessment only a small section of the main loft void was inspected; however, during the updated assessment all the internal gable ends, chimneys and the length of the ridge beams were inspected. Whilst no evidence of bats, e.g. droppings, urine staining or scratch marks, was recorded during the internal inspection of the building, it was only deemed safe to walk beneath the ridge beam and therefore the area around the eaves could not be inspected in detail. In addition, the space between the sarking boards and roof tiles could not be inspected by the surveyor.

**Plate 4.17: Wooden sarking boards on wooden ridge beams**

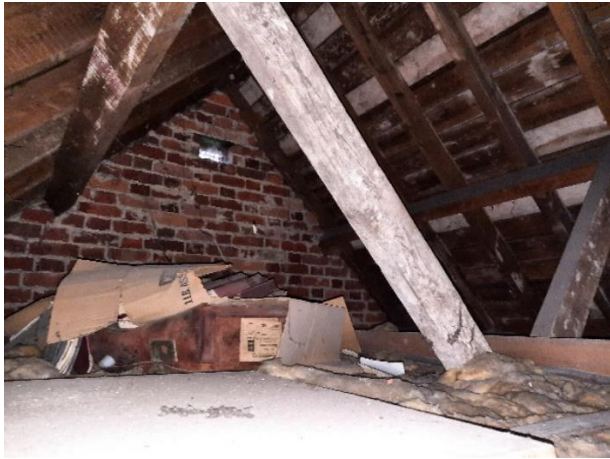
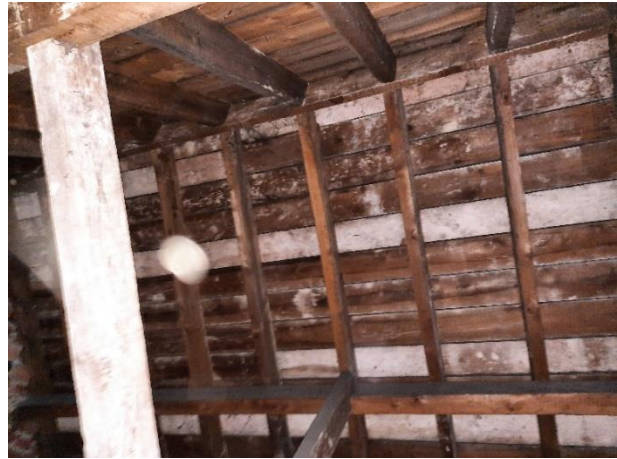
Plate 4.20: Loft void above kitchen extension

The loft had the same construction as the main loft void with wooden rafters, ridge beam and sarking boards (Plates 4.20 and 4.21) and fibre glass insulation on the floor. A small vent was present on the gable end providing a potential direct access into the void. The space was uncluttered and heavily cobwebbed indicating the space had not recently been used by flying fauna. Evidence of rodents was however noticed.

The length of the ridge beam and gable end was inspected and no evidence of bats, e.g. droppings, urine staining or scratch marks, was recorded during the internal inspection of the building. However, it was only deemed safe to walk beneath the ridge beam and therefore the area around the eaves could not be inspected in detail. In addition, the space between the sarking boards and roof tiles could not be inspected by the surveyor.

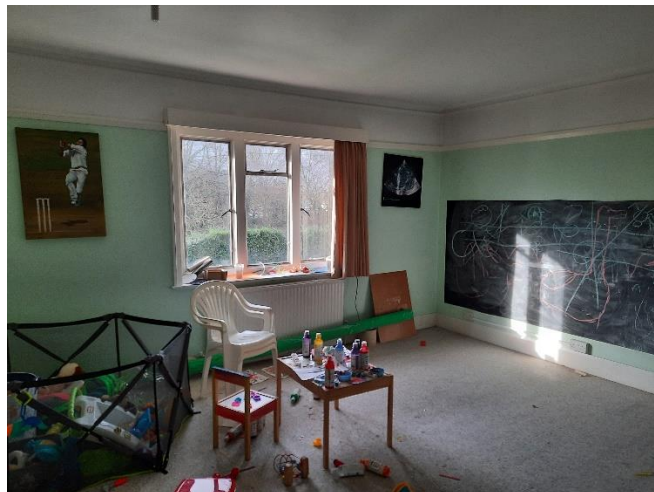
Plate 4.22: Example of internal room

During further internal assessment, the spacious internal rooms with large windows provided significant levels of ambient lighting (Plate 4.22). Along the remaining floors, all rooms had large windows and were in moderate state of repair. No evidence of bats, e.g. droppings, urine staining, feeding remains or scratch marks, was recorded during the internal inspection of the building.

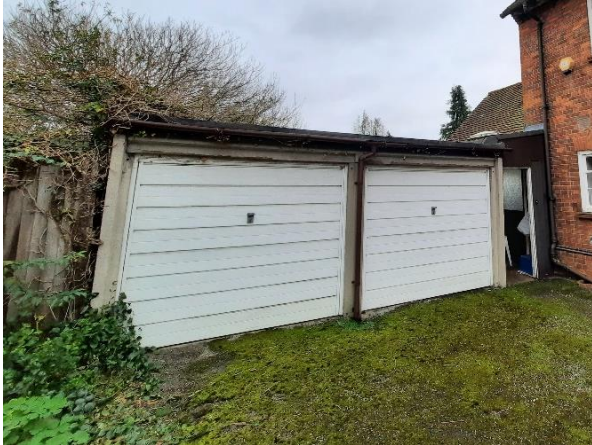
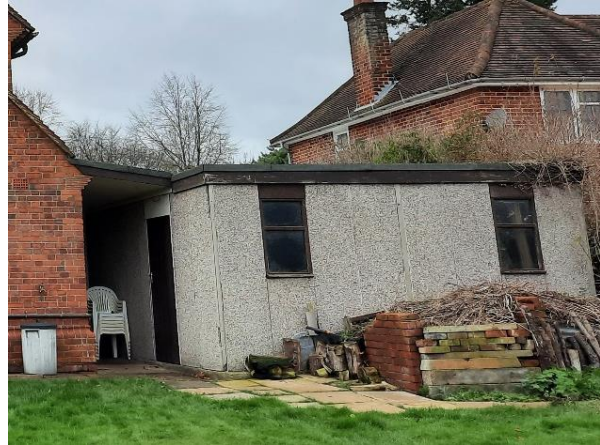
The garage was single storey and in good state of repair with roofing felt flat roof which was partly covered by English ivy *Hedera helix* on the northern elevation (Plates 4.23 and 4.24). Since the previous assessment, the extent of ivy cover appeared to have been reduced. Ivy growth was not substantial to form gaps and crevices between stems and concrete blocks. Large double vehicular doors to the front and two single glazed wooden framed windows to the rear were present. There were no gaps between concrete blocks and doors and windows. The garages had no potential ingress points for bats to utilise and no evidence of bats were recorded during external inspection.

**Plate 4.23: Front of garage (south-west elevation)**

**Plate 4.24: Rear of garage (north-east elevation)**

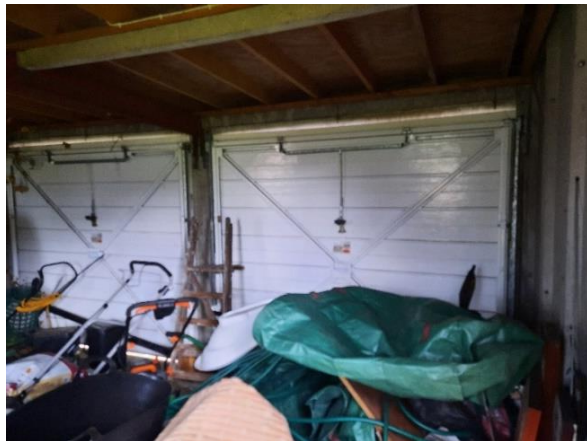
At the time of the survey the garage was used to store personal items and gardening tools (Plate 4.25). The walls were constructed from smooth concrete. The ceiling was made of smooth wooden boards on timber beams which were fully inspected (Plate 4.26). No gaps were noted between the boards and the beams that could be used as roosting features and no evidence of bats, e.g. droppings, urine staining, feeding remains or scratch marks, was recorded during the internal inspection of the building.

**Plate 4.25: Garage - internal**

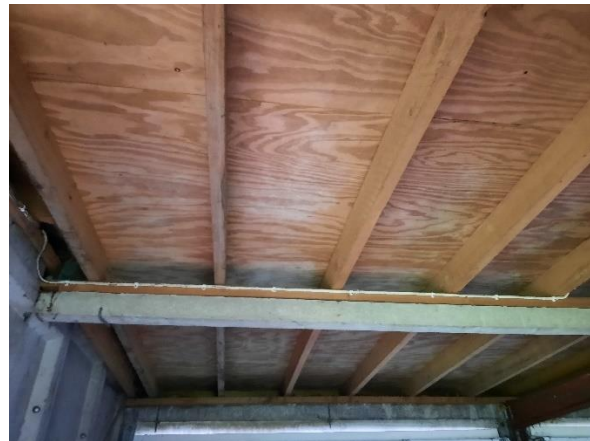
**Plate 4.26: Garage - ceiling construction**
