# Clive Hudson Associates

Our ref: 216061/ Rowberry Morris Solicitors - 17 Castle St, Reading – boundary wall / Structural Inspection - Rev O  
Your ref:

### **Re: Structural Inspection – Boundary wall at 17, Castle Street, Reading**

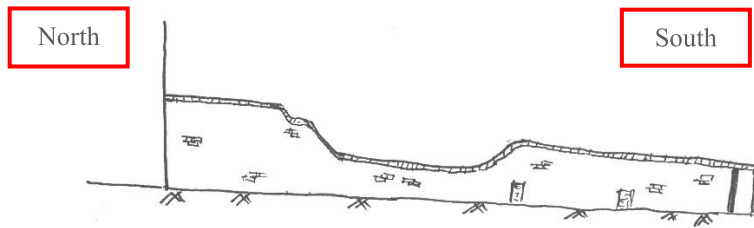
Figure 3. Indicative elevation of the boundary wall (as viewed from No. 17)

The section of wall runs in an approximate north-south direction and is approximately 21m in length (Fig. 3). The wall varies in height along its length. At its northern end the wall is approx. 2.7m high, in the middle the wall is approx. 1.3m high, and at the southern end the wall is approx. 2m high.

The wall is primarily of brick construction and is generally one brick thick (225mm). There are two integral historic brick piers in the southern section of the wall, and two relatively modern brick piers have been added on the east side. The wall would have originally been built using a traditional lime-based mortar. However, much of the wall is now pointed in a cement-rich mortar, which is generally not compatible with the softer historic brickwork. (Traditional buildings and their materials were built to be 'breathable' – allowing moisture to penetrate the fabric and then evaporate when the conditions were appropriate. The application of non-porous, cement-

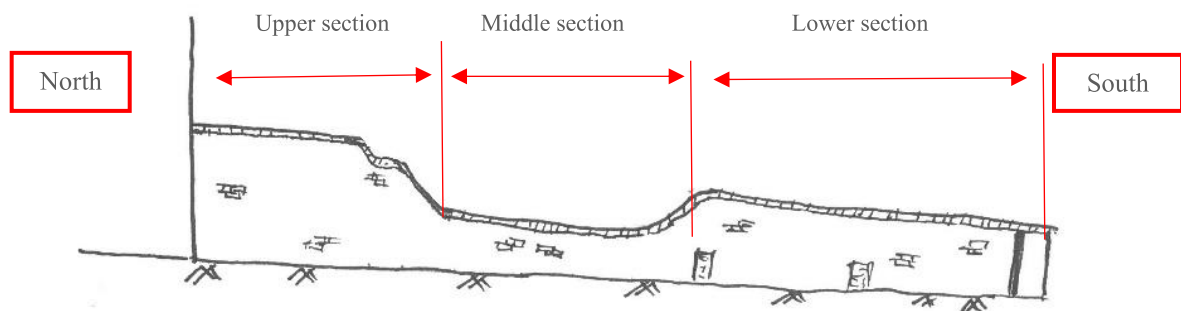
Figure 7. Wall sections

For simplicity, we have divided the wall into three sections: - upper, middle, and lower.

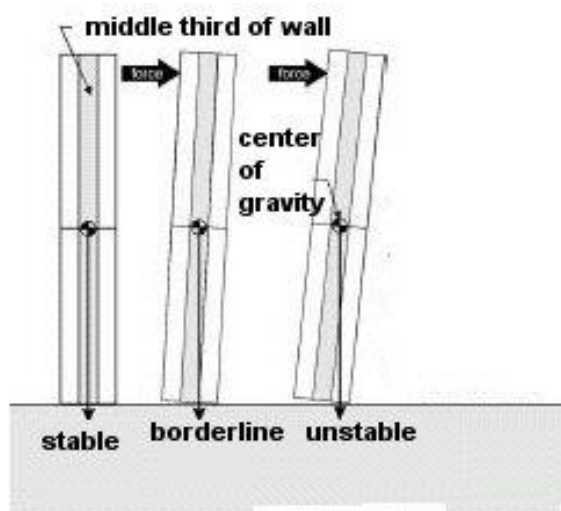
Figure 15.  
Middle-third rule

- vii. Structural movement was observed within this section of wall with the wall both bulging on plan and leaning eastwards. On No. 15's side the wall was found to be out-of-plumb by approximately 80mm towards the centre of this section.

A wall is considered theoretically unstable if it leans to such an extent that a plumb line passing through its centre of gravity (CoG) falls outside of the middle third of its base (Fig. 15); in this instance  $\frac{1}{3}$ <sup>rd</sup> of 225mm = 75mm.

While this section of wall has continuity with the upper and lower sections and has obviously been leaning for a number of years without failing, we would consider the wall to be just above the threshold for it to be classified as theoretically stable, and the movement is likely to deteriorate with time. Consequently, we would recommend this section of wall is propped as soon as possible, and the area is defined as off-limits until temporary works that secure the stability of the wall are in place. Beyond this, we would propose dismantling this section of wall and re-building it off new foundations.
